**REPORT OF AN INVESTIGATION
INTO THE FIRE AND LOSS OF
“FV HORIZON”
OFF THE OLD HEAD OF
KINSALE, CO. CORK
14 MAY 2021**

**REPORT NO. MCIB/309
(No.3 OF 2022)**

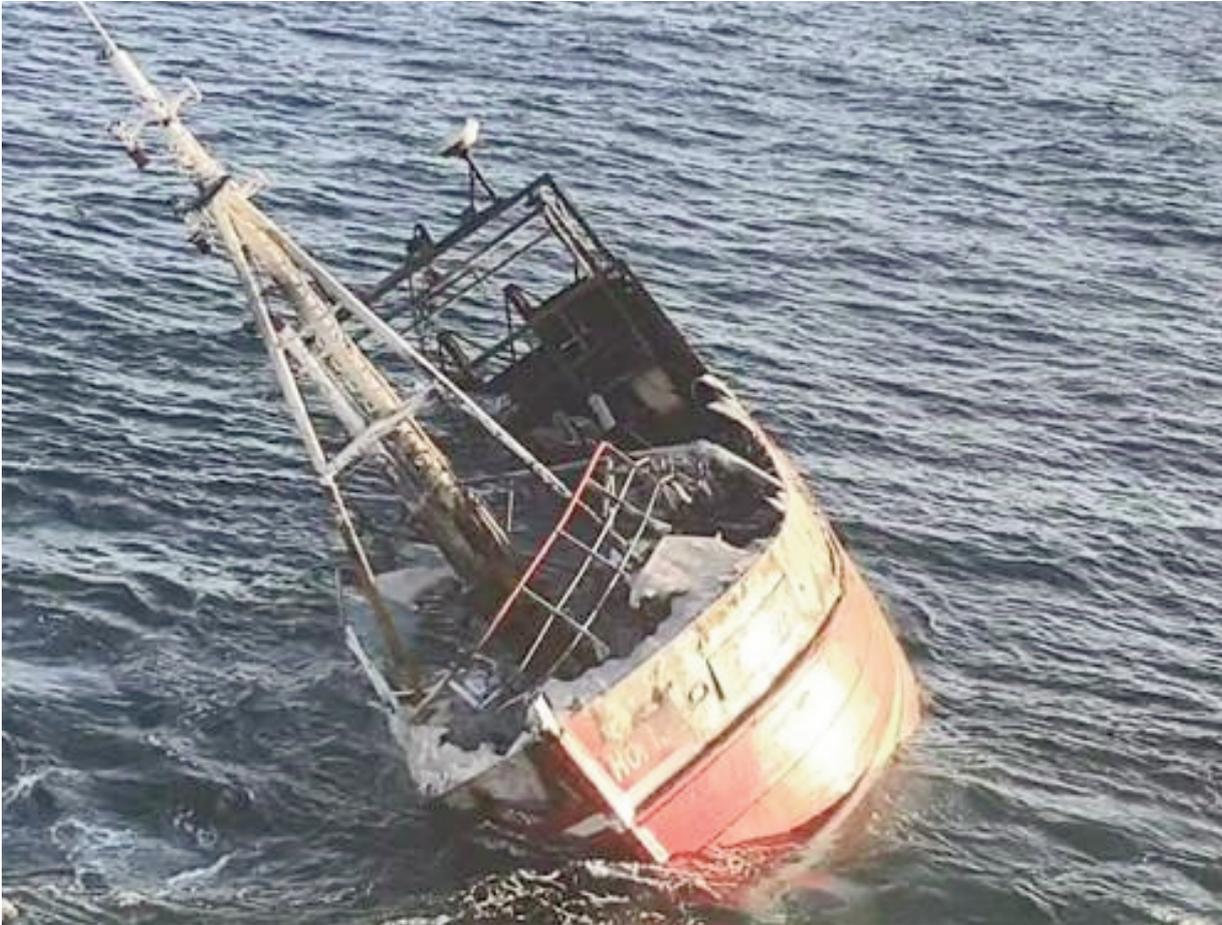
- 4.6.2 The Skipper stated that the main engine and the fish hold refrigeration system were cooled each with seawater drawn directly through two separate pipe systems from the sea through the vessel's hull mounted seawater inlet valves located on the hull beneath the vessel's water line. These systems had sections of reinforced flexible plastic hoses connecting the pipework from the seawater valves to the machinery cooling systems. These hoses, when exposed to fire, melt and fail allowing an uninterrupted flow of seawater into the engine room compartment. The seawater flowing into the engine room would fill into the adjoining compartments as the bulkheads were burned through and eventually the water would fill the vessel which would sink. It can therefore be deduced that the fire was a causative factor in the sinking of the "FV Horizon" in that the intense heat of the fire melted the plastic components of the vessel's machinery cooling systems which lost their watertight integrity allowing seawater into the vessel to the extent that "FV Horizon" filled with seawater and sunk.

Appendix 7.14 Photograph No. 2 - "FV Horizon" Awash

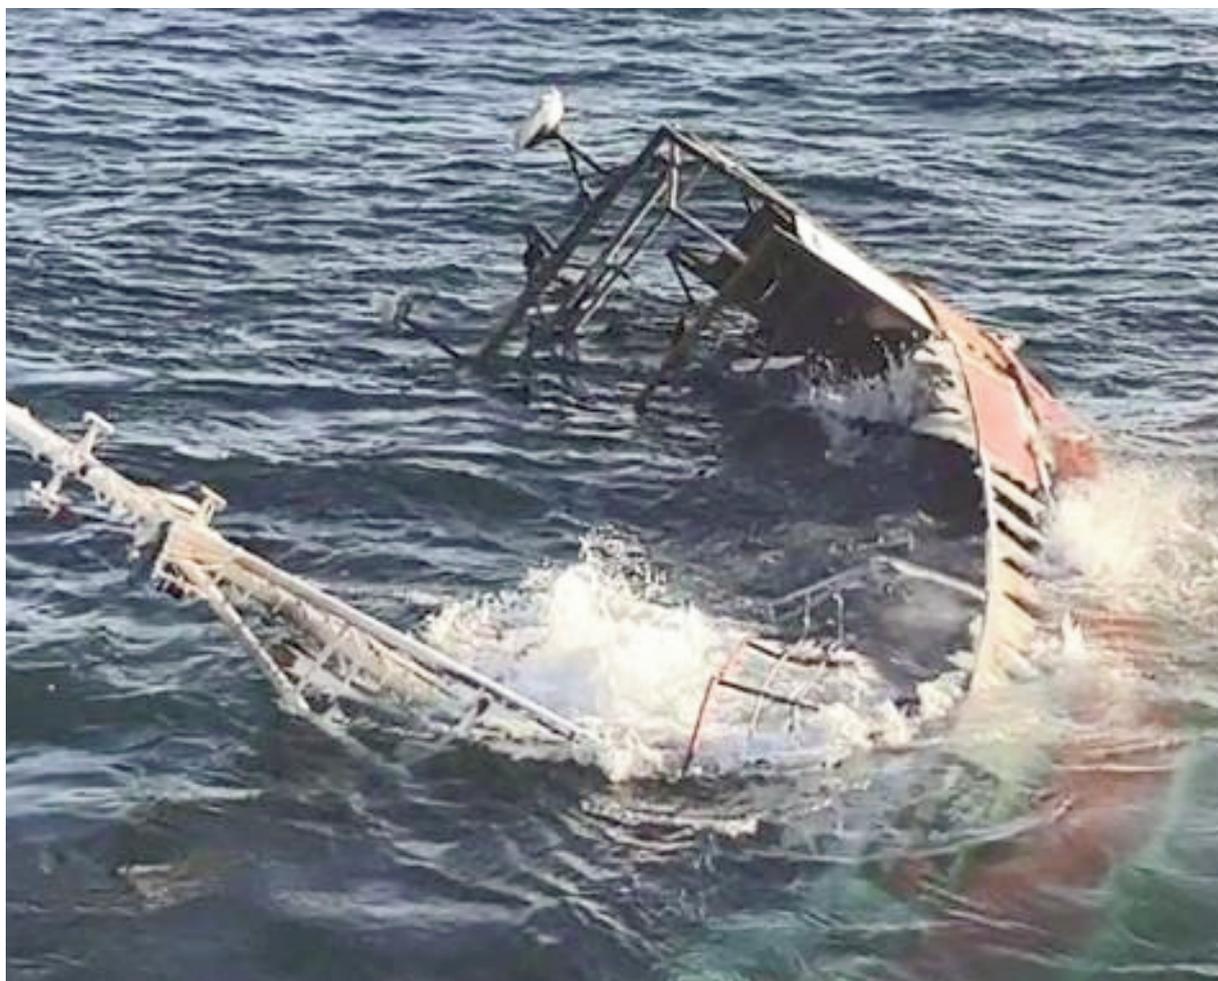
- 4.6.3 For the same reasons outlined in paragraph 4.5 it can also be deduced that the absence of fire proofing materials in the flexible hose components of the vessel's machinery cooling systems (connecting the cooling systems to the sea through the hull mounted sea valves), caused these to melt. It is deduced that, as the hoses melted, the sea was allowed to flood into the vessel through the cooling systems hull mounted sea valves and was a causative factor in the sinking of the vessel.

Appendix 7.15 Photograph No. 3 - "FV Horizon" Sinking

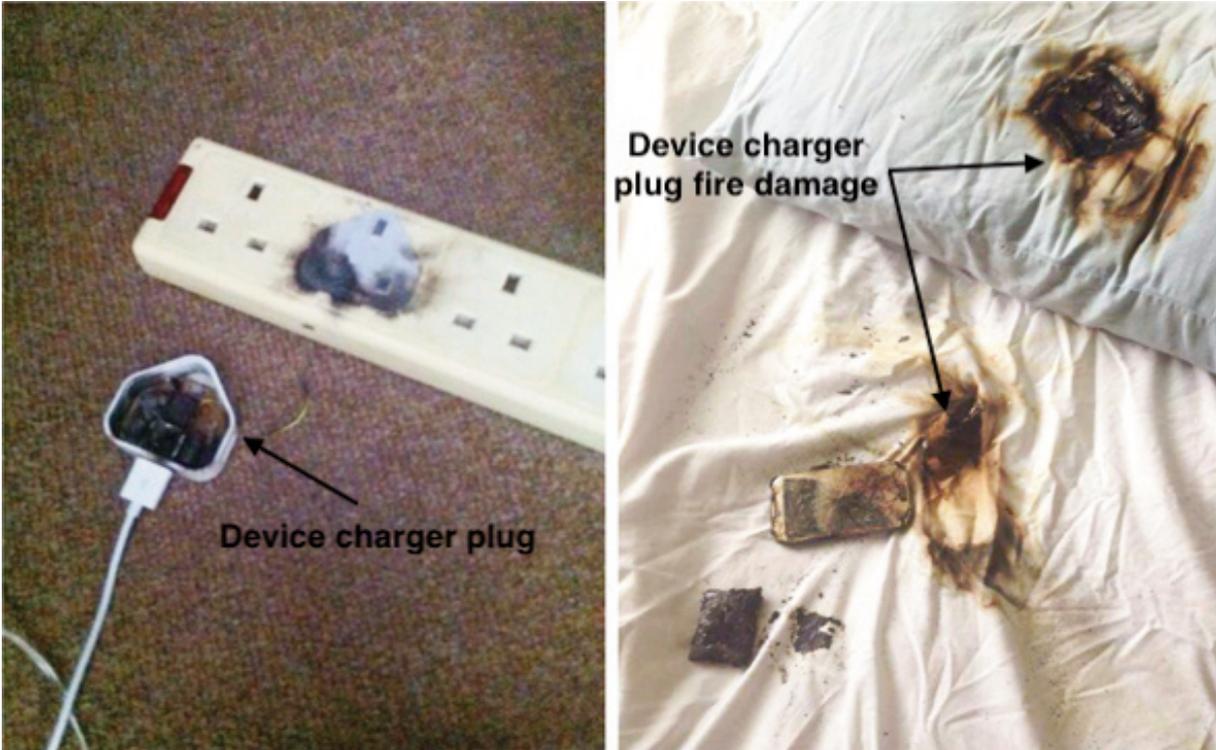
- 4.4.2 The crew each had mobile phones. These electronic devices contain lithium batteries and require re-charging, usually from a 240V AC electrical power socket and there was a 240V AC circuit in the cabin with sockets. It was probable that electronic devices were in the cabin as the vessel was 30 NM offshore (and likely out of mobile phone coverage) and therefore not in use by the crew. Lithium batteries are commonly damaged when overcharged and become prone to overheating and even igniting in some instances. Electronic device battery chargers also carry a risk of overheating and igniting and should not be operated near combustible materials or left unattended. The galley and accommodation cabin 240V AC sockets were regularly used by the crew for charging the batteries of their electronic devices. It is surmised that one or more of these devices were in the accommodation cabin and may have been plugged into the 240V AC sockets, unattended, while the crew were working on deck. It would be reasonable to deduce that an unattended mobile phone or other similar electronic device in the process of being charged and/or an electronic device battery charger may have been the source of ignition for this fire and may therefore, present a causative factor for the fire onboard the vessel.

Appendix 7.16 Image No. 1 - Electronic Device Battery Charger Fire Damage

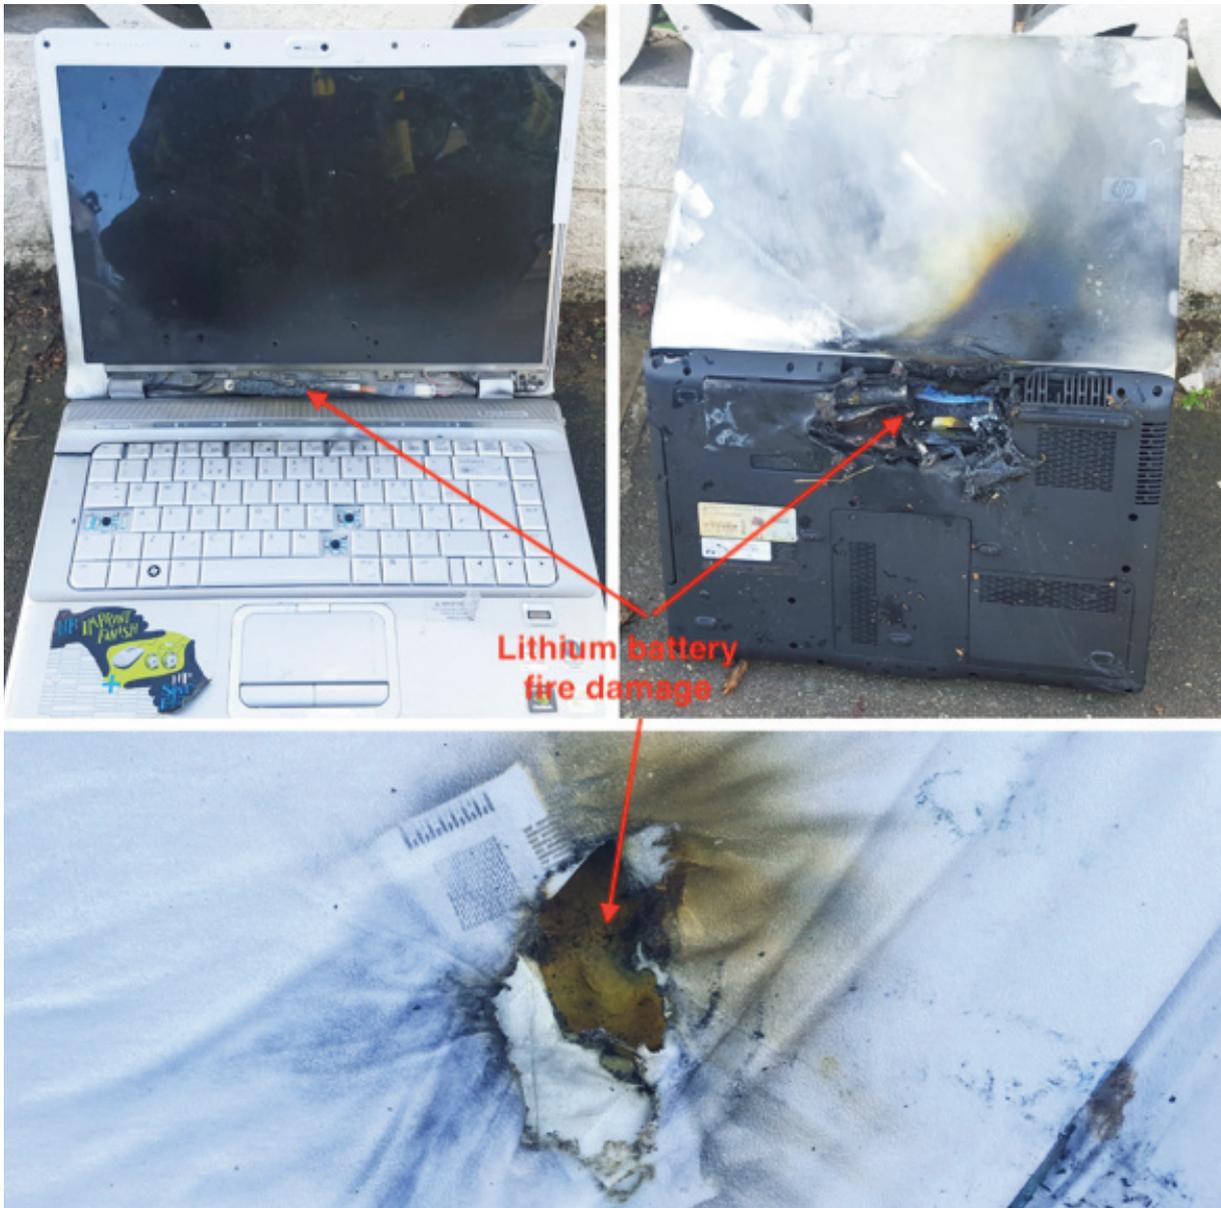
Appendix 7.17 Image No. 2 - Lithium Battery Fire Damage
