**REPORT OF AN INVESTIGATION  
INTO THE FIRE AND LOSS  
OF THE YACHT BLACK MAGIC  
OFF THE  
SOUTH COAST OF CORK  
13 DECEMBER 2021**

**REPORT NO. MCIB/313  
(No.2 OF 2023)**

Report MCIB/313 published by the Marine Casualty Investigation Board.  
23rd March 2023.

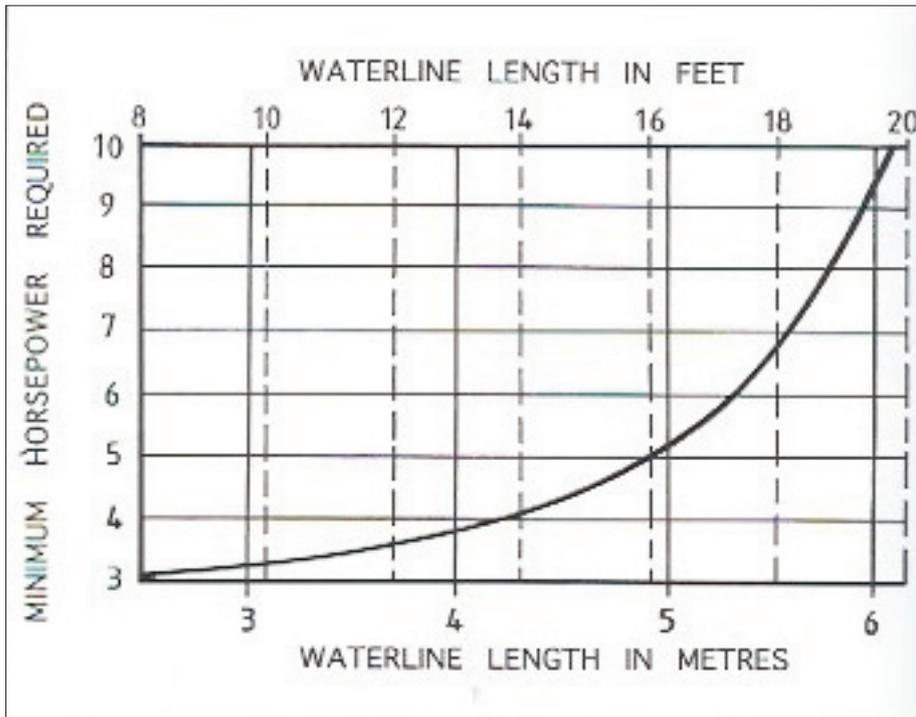
Page 132 The Boat Data Book

It can be seen from the graph that the maximum measurement on the waterline axis is 20 ft, and 10 hp is the recommended minimum horsepower required to achieve six miles per hour (5.2 kts). At 8 ft waterline length the minimum horsepower required to achieve 5.2 kts is 3 hp.

By extrapolating the curve, it is estimated that for a craft of approximately 22 ft waterline length (such as yacht Black Magic), the minimum horsepower required to achieve 5.2 kts is in excess of 10 hp.

4.3.2 The engine power standard recommended by the reference book “The Boat Data Book” for a yacht with approximately 22 ft waterline length is depicted graphically in both graphs contained in paragraphs 2.4.2.1 and 2.4.2.2. The graph shown in paragraph 2.4.2.1 indicates that a yacht such as yacht Black Magic with a waterline length of approximately 22 ft would require an outboard engine significantly more than 10 hp to achieve 5.2 kts. The graph shown in paragraph 2.4.2.2 indicates the power required from an inboard engine for the same size of yacht would be in the region of 6-7 hp. The Skipper required an average speed of 4.2 kts over the ground to reach the destination on time. Therefore, it is estimated that a yacht such as yacht Black Magic would require an outboard engine with a power capacity in the region of at least 8 hp to achieve 4.2 kts.

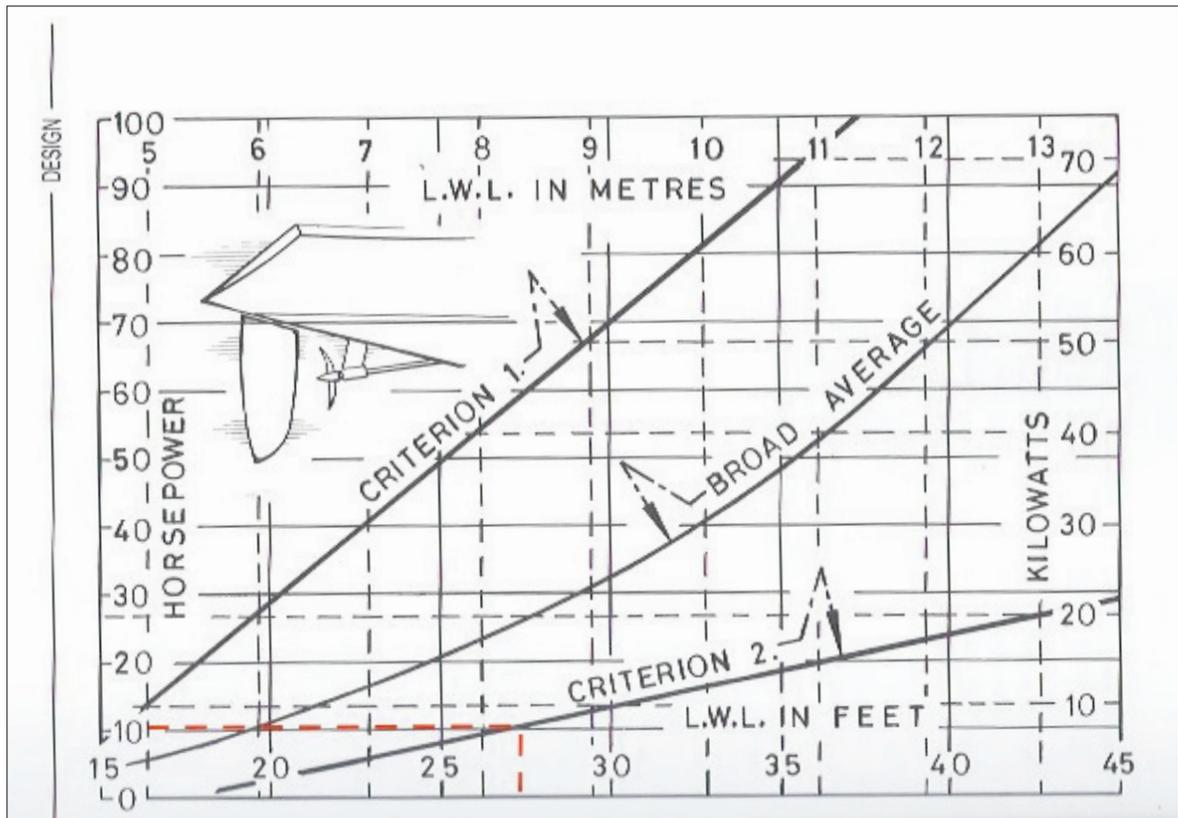
Page 163 Boat Data Book

The book states “The bottom curve, labelled CRITERION 2 shows the size of engine sometimes fitted in racing craft, and on sailing yachts with good light weather performance. It (the engine) should give power to charge the batteries and get the yacht home in windless conditions. It is economical but may not be powerful enough to deal with adverse tides. In quite small waves, progress may be halted.”

This graph indicates that a yacht with a waterline length of approximately 22 ft would require a 5-6 hp inboard engine to charge the batteries and get the yacht home in windless conditions.

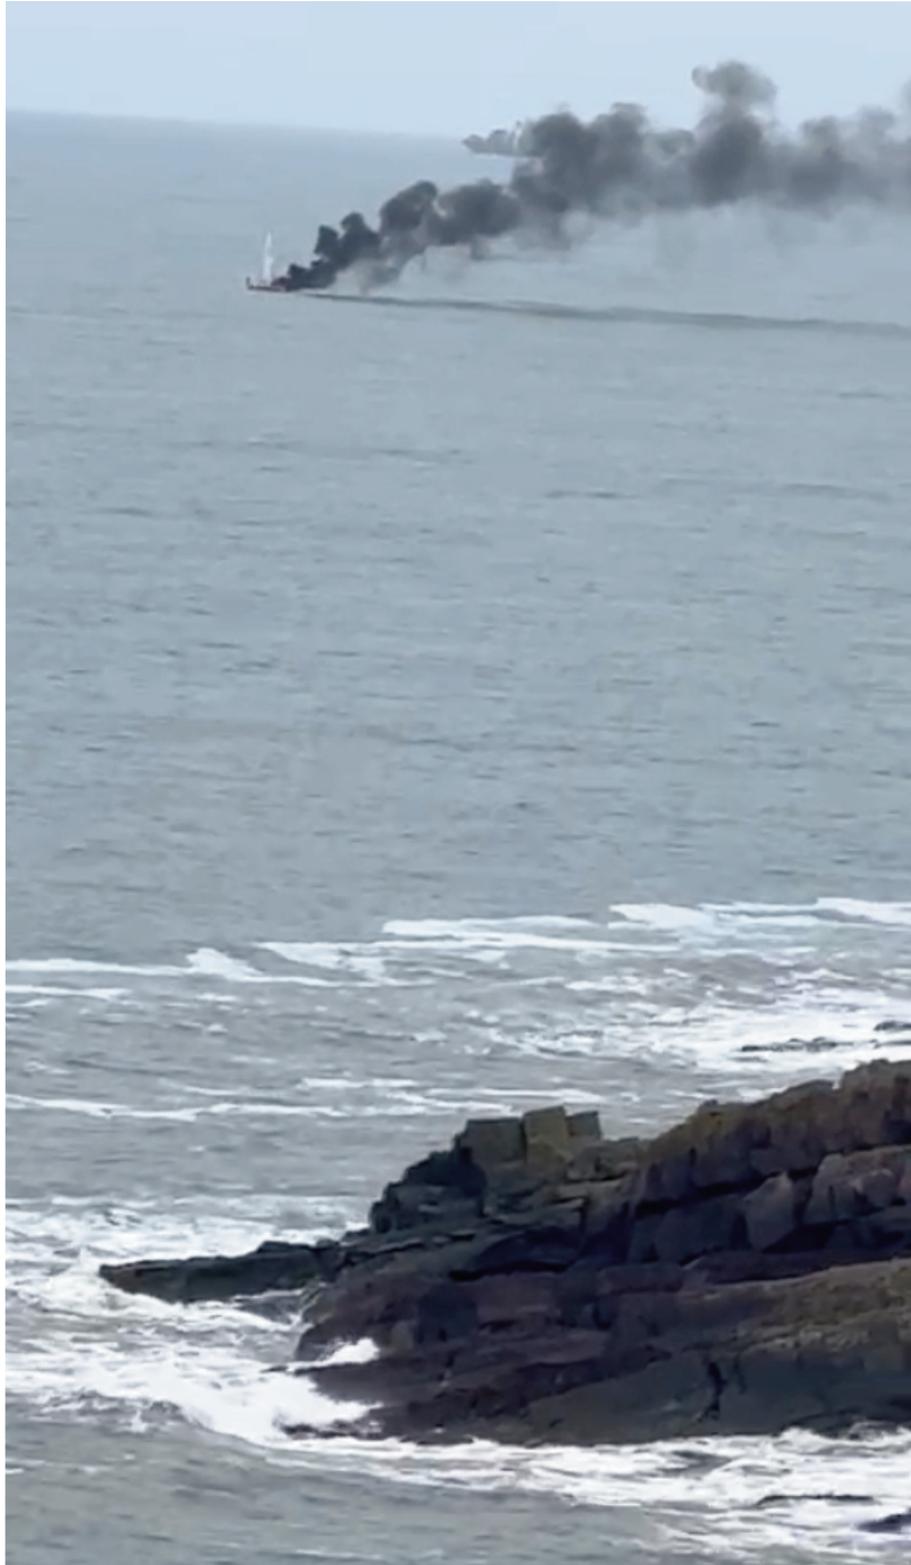
Appendix 7.2 Photograph No. 2 - Burning Yacht Black Magic off Ringabella Bay

*of the engine and a bang*". A fire started at the engine and immediately spread to the spare drums of petrol fuel adjacent to the open transom stern of the yacht's cockpit. The Skipper evacuated the cockpit onto the deck to escape the flames which had spread to the transom and cockpit area. He did not enter the cabin as he was afraid the petrol fuel tanks would explode and trap him inside. The fire spread quickly, as the GRP materials of the yacht's structure began to burn with a considerable amount of dense black smoke and flames. The engine had stopped, and forward motion had ceased. The light easterly wind caused the yacht to point up to the wind blowing the dense black smoke away from the bows area. The Skipper had made his way forward and was now standing at the bow on the foredeck. This position allowed him to keep clear of the flames from the burning hull and black smoke which blew downwind and astern of the yacht.

- 4.1 The fire onboard yacht Black Magic was central to this incident. The yacht was on passage to Kinsale Boatyard under power when a fire broke out and quickly consumed the yacht which eventually sank off Ringabella Bay. There are several factors that must be considered to understand how the fire originated, ignited and eventually caused the loss of the yacht.

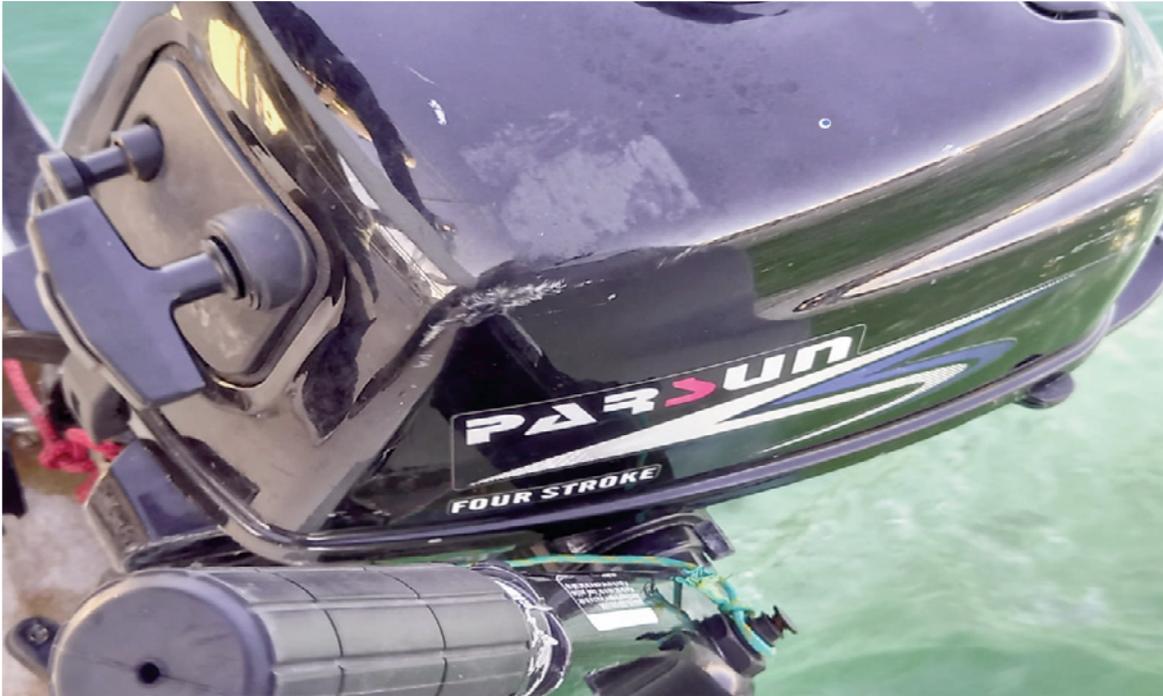
Appendix 7.3 Photograph No. 3 - Outboard Engine Fitted to Yacht Black Magic

- 4.4.4 The Skipper recounted that the fire started when there was a "*flame out of the engine and a bang*" approximately 15 minutes after topping up the engine's fuel tank located on top of the engine. It is surmised that if the fuel had spilled directly onto the engine hood top it would be prevented from leaking into the engine by a correctly fitted and serviceable heat shield barrier plate and immediate ignition of the petrol fuel vapours would be avoided. The Skipper recounted that the fire started approximately 15 minutes after he topped up the fuel tank. This time span is inconsistent with the likelihood of fuel vapours directly igniting as a result of spillage from the refuelling operation. However, the presence of spilled fuel in and around the engine and transom area was very likely. Spilled fuel from the refuelling operation was very likely a contributory factor in the fire and loss of yacht Black Magic.

- 4.5.1 The Skipper recounted that the fire started when there was a “*flame out of the engine and a bang*” approximately 15 minutes after topping up the engine’s fuel tank located on top of the engine. This description indicates that some mechanical failure occurred within the engine body and ignited either fuel or lubricating oil and/or ignited the vapours from spilled fuel ignited in or on the engine.

- 4.5.2 The likelihood of mechanical failure of an engine increases if the engine is overdue a service. The likelihood of mechanical failure is further increased if the engine is run continuously at or beyond its design criteria. Given that the engine was operated at or above its maximum operating criteria, and the unknown service history and condition of this engine, the likelihood of it suffering a significant mechanical failure was likely. It is surmised that the continuous operation of the engine at its maximum design capacity was a causative factor in the fire and subsequent loss of the yacht.

- 4.6.1 Such failures may manifest in a variety of ways. A compromised or blown cylinder head gaskets allowing very hot exhaust gasses to escape into the engine hood compartment or a piston or piston ring failure allowing hot exhaust gases into the oil vapour laded crankcase. The above scenarios are typical mechanical failures associated with operating engines above the design criteria.

- 4.6.2 It has already been deduced that it was likely the engine suffered a mechanical failure. The flashpoint of oil is the minimum temperature at which the oil gives off flammable vapour which, on the application of a flame, will cause momentary ignition. A typical flashpoint for lubricating oil is approximately 230°C (closed flash point test). The fire point of an oil is the temperature at which the volatile vapours given off from a heated sample of the oil is ignitable by flame application and will burn continuously. The fire point temperature can be anything up to approximately 40°C higher than the closed ‘flashpoint’ temperature for oils. Gasoline or petrol has a very low flashpoint of -23°C. This means that petrol is explosive at normal ambient temperatures and under almost all conditions there is an explosive atmosphere directly above petrol. The engine features flexible fuel hoses connecting the fuel tank to the carburettor adjacent to and inside the engine hood. It is surmised the fuel and lubricating oil temperatures in the PARSUN outboard engine exceeded their flash and ignition points. It is surmised that the outboard engine suffered a mechanical failure resulting in exposed engine parts in the proximity to fuel system parts or oil vapours causing petrol fuel or oil lubricant vapours to ignite. The ignition of a fire in the outboard engine was a causative factor in the fire and loss of the yacht Black Magic.

- 5.1 The continuous operation of the outboard engine onboard yacht Black Magic as it made passage from Crosshaven marina to the vicinity off Ringabella Bay at the engine's maximum design capacity, caused the engine to suffer a significant mechanical failure. The mechanical failure of the engine was such that hot engine components were exposed to petrol fuel and oil lubricants which spontaneously ignited and caused a fire onboard the vessel. The fire consumed the vessel which subsequently sank off Ringabella Bay.

- 6.1 The Minister for Transport should amend or update the Code of Practice: The Safe Operation of Recreational Craft advising owners and operators to ensure auxiliary engines fitted to racing yachts adequately provide the necessary power to allow safe inshore or coastal passage particularly when adverse weather or sea conditions prevail.
- 6.2 The Minister for Transport should publish a Marine Notice highlighting the risks associated with refuelling operations or decanting volatile flammable liquids, at sea or alongside, to or from open containers in the vicinity of hot and exposed surfaces.

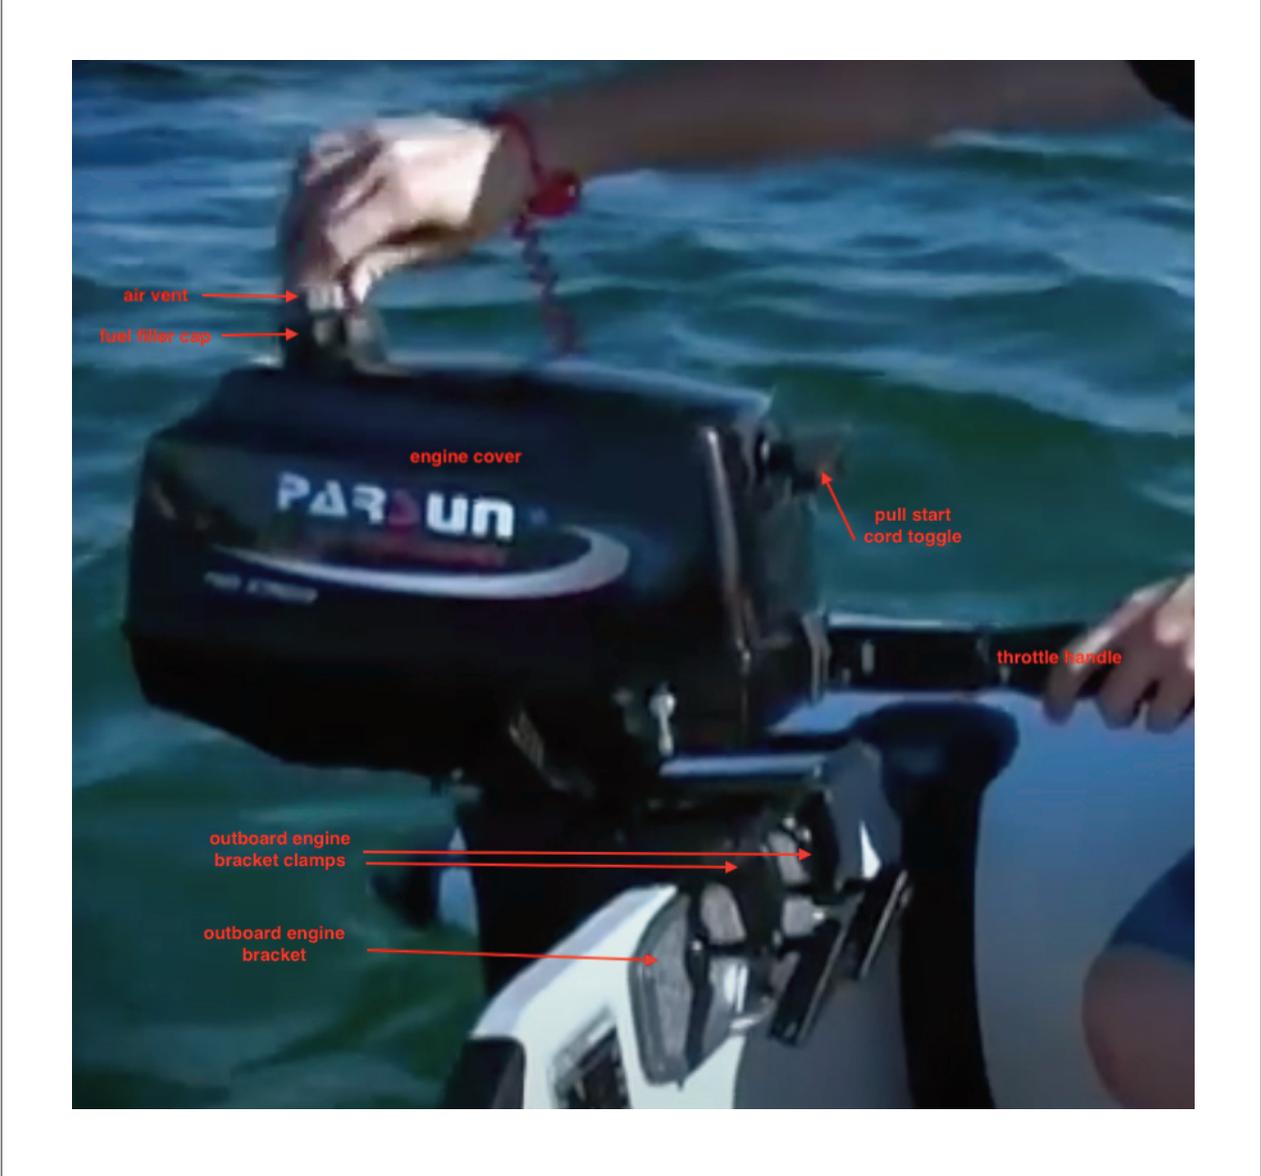
Appendix 7.6 PARSUN F2.6 Engine Fuel Arrangement

- 4.4.3 The design of the PARSUN F4 and F2.6 engines incorporates a heat shield barrier plate which separates the fuel tank filling arrangement from the engine's hot surfaces when the engine hood is properly fitted and secured. This barrier plate is positioned to seal any fuel spillage at the fuel tank filling point from leaking down onto the hot engine surfaces of the engine's crank/cylinder head.
