**REPORT OF AN INVESTIGATION
INVOLVING THE MERCHANT VESSEL**

“ARKLOW CLAN”

**AT THE PORT OF ABERDEEN,
SCOTLAND**

**REPORT NO. MCIB/315
(No.5 OF 2022)**

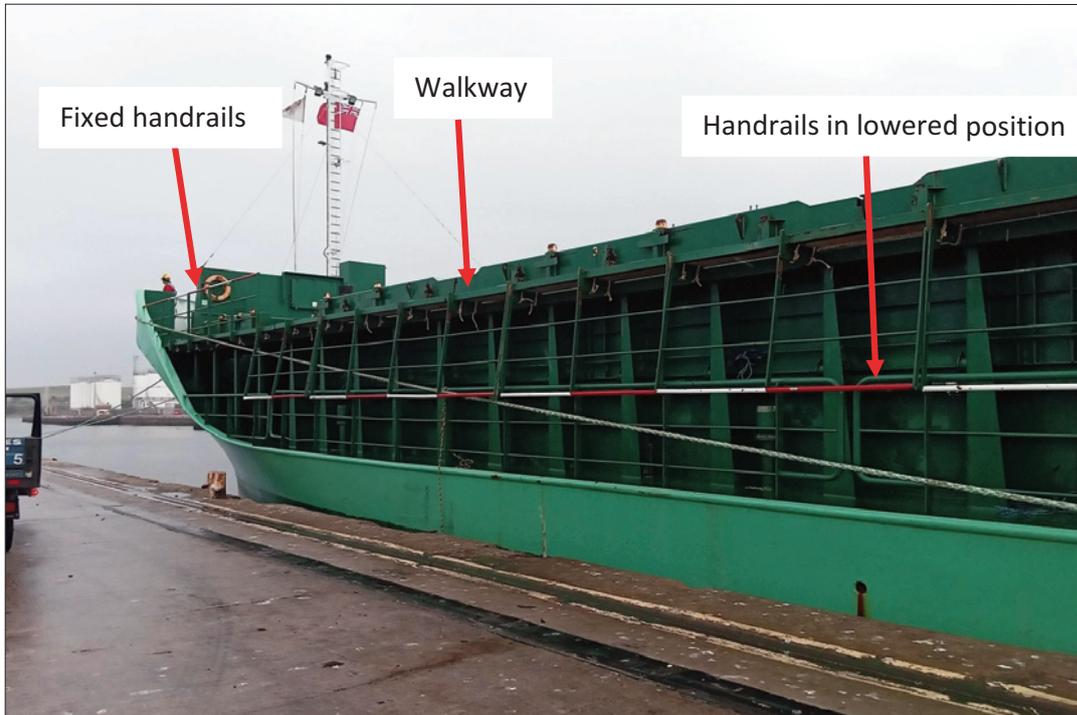
Photograph No. 1 - Taken by Vessel Crew on 11/08/2021 Post Incident

See Appendix 7.2 - Photographs of the Handrails Lowered in the Down Position (photographs taken post incident).

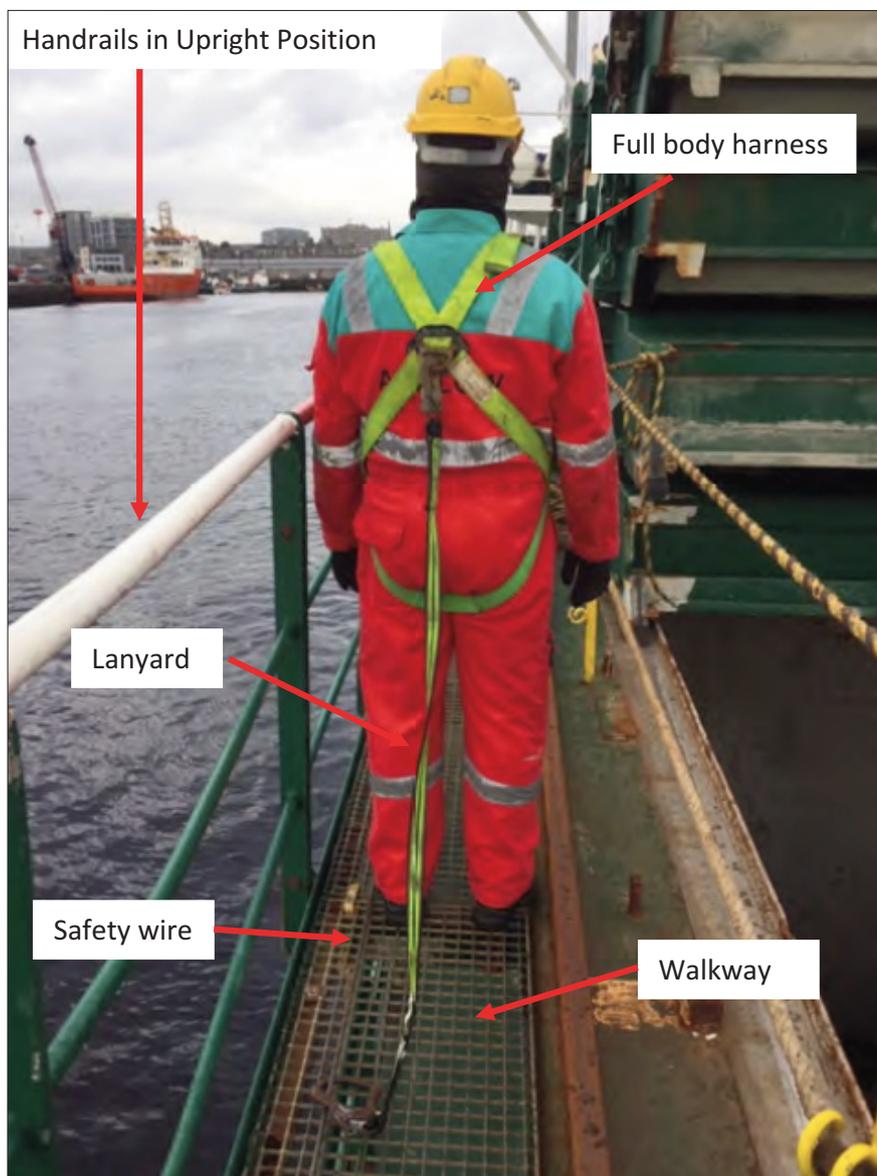
Photograph No. 1 - Crewmember Correctly Wearing PPE

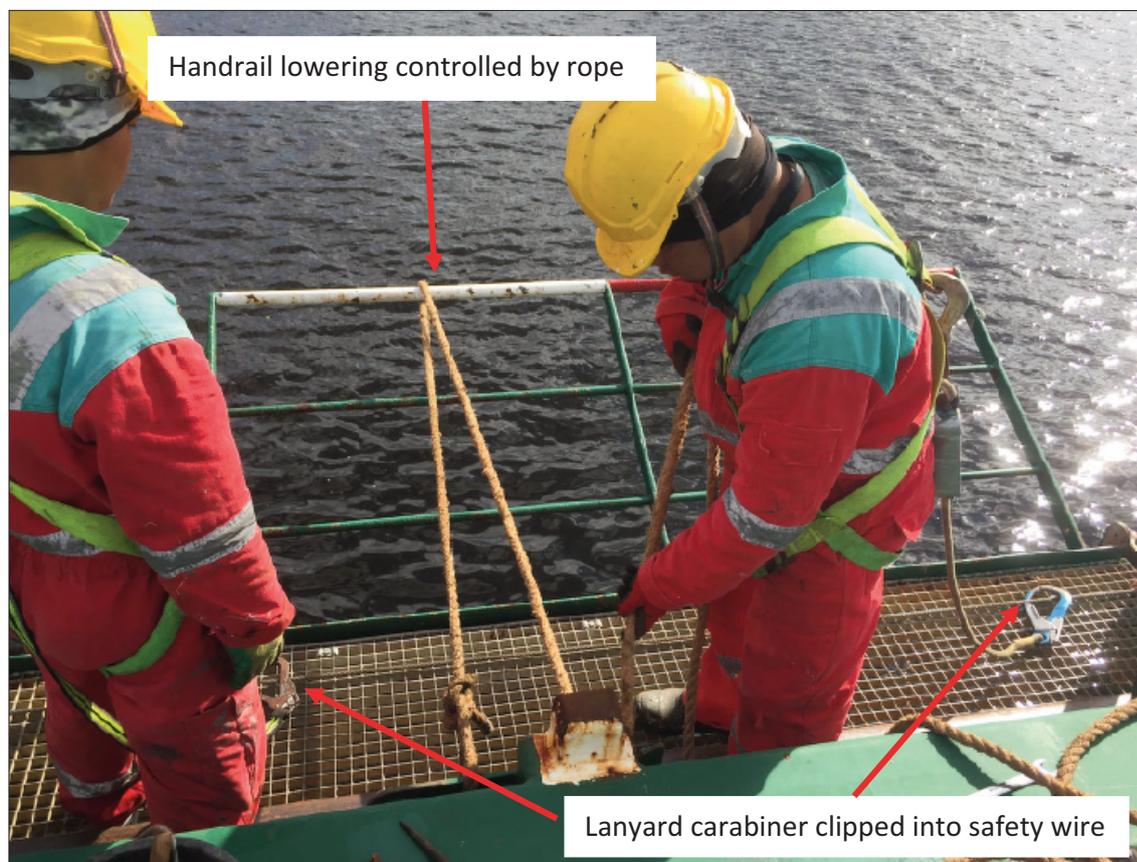
Photograph No. 2 - The Correct Method for Lowering Handrails

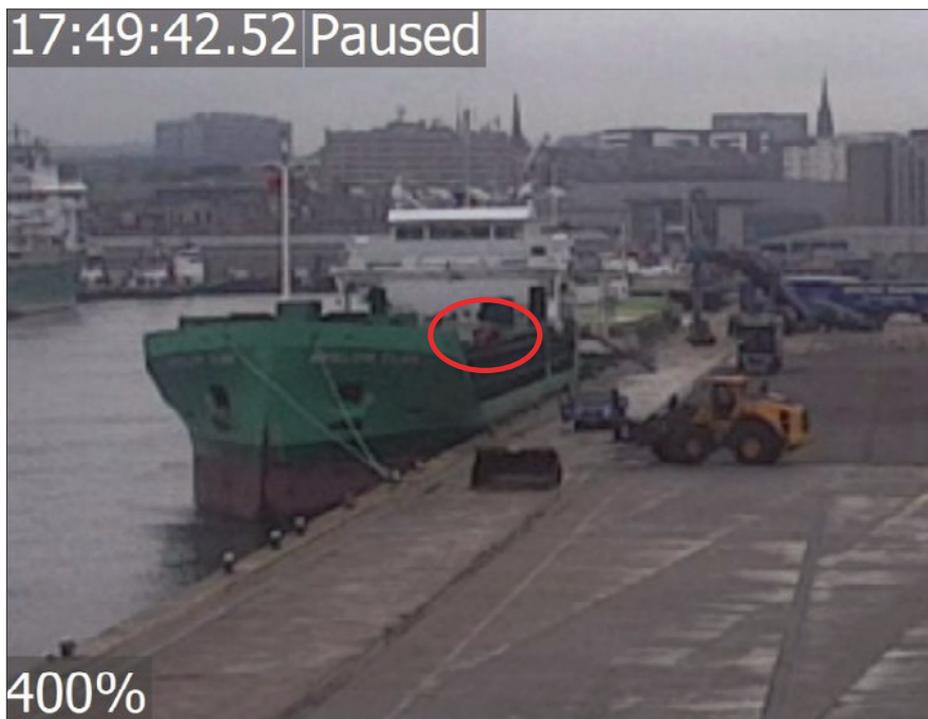
- 3.9 Almost immediately after completing mooring operations, starting at approximately 17.40 hrs working from aft and moving forward on the port side of the vessel, the Second Officer and AB 1 commenced removing the five nuts and bolts for each handrail section, each working on alternate bolts. AB 2 followed behind lowering the handrails with a rope. The witness accounts differ as to the exact sequence of events which followed. At around 17.49 hrs the Second Officer recalled standing up from the crouched position and losing his footing, in a bid to steady himself he grabbed the nearest handrail, but as the nuts and bolts had been removed the handrail gave way, causing him to fall overboard. AB 1 and AB 2 recalled observing the Second Officer leaning against a loosened handrail, before losing his balance and falling overboard.

Photograph No. 1 - Crew Working on Deck Pre-fall

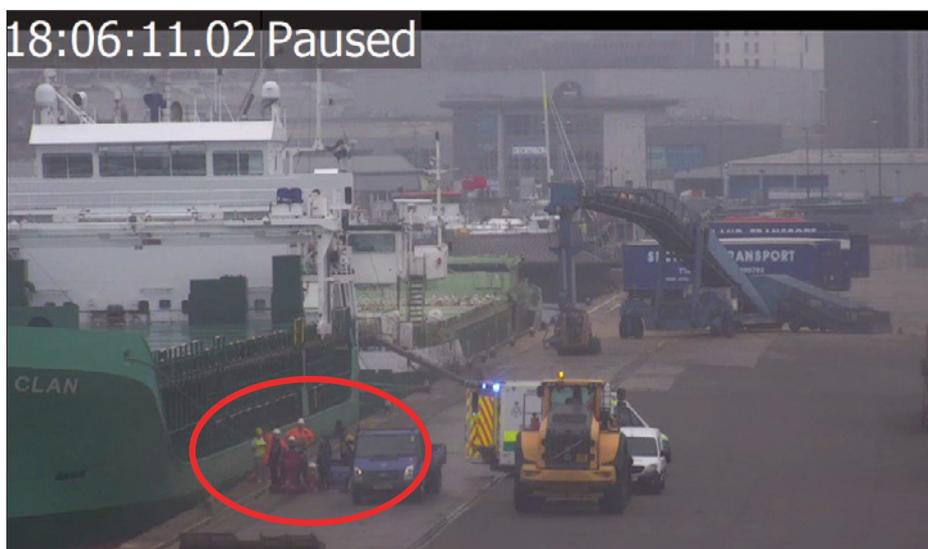
- 3.10 The net result was the same, at 17.49 hrs the Second Officer found himself falling towards the tarmacked quay below, a height of approximately 3.6 m. In a split second, he made the decision to rotate his torso and take the impact with his legs extended.

Photograph No. 2 - Second Officer Receiving Medical Attention on the Quay on Post-fall

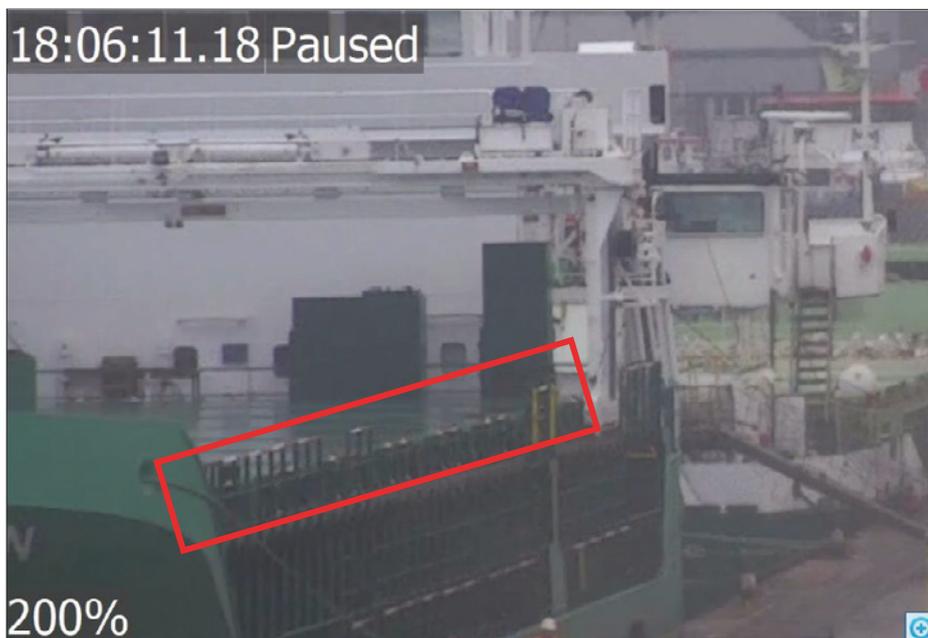
Photograph No. 3 - Position of Railings Post-fall. Partially in Down Position

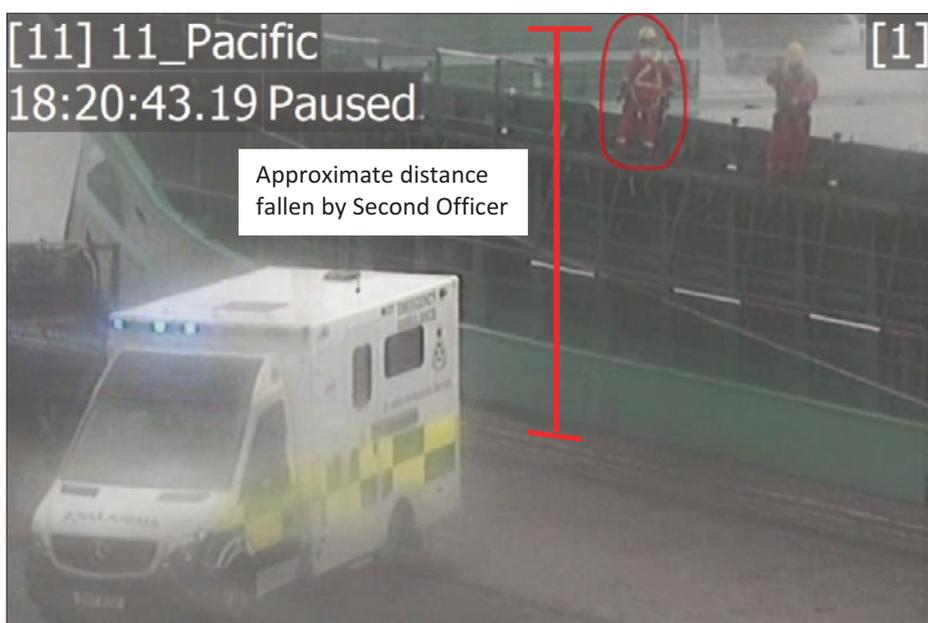
- 3.12 After stabilising the Second Officer's injuries, at 18.54 hrs the ambulance departed the scene. Two crew recommenced lowering the handrails, but they now wore the full body harnesses. During the lowering operation, at times they unclipped their lanyards to move, not fully utilising the safety wire and therefore limiting the effectiveness of the fall arrest protection, notwithstanding that crew had received onboard training in the use of harnesses when joining the vessel.

Photograph No. 4 - Crew Resume Lowering Handrails Post-fall
