REPORT OF AN INVESTIGATION
INTO A MARINE CASUALTY
INVOLVING THE FISHING VESSEL
JOHN B
OFF HOWTH, CO DUBLIN
17 JULY 2020

REPORT NO. MCIB/316 (NO. 8 OF 2023) The Marine Casualty Investigation Board (MCIB) examines and investigates all types of marine casualties to, or onboard, Irish registered vessels worldwide and other vessels in Irish territorial waters and inland waterways.

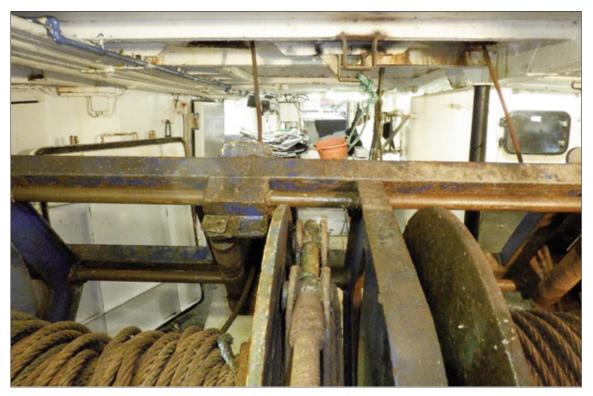
View from Winch Operator's Position

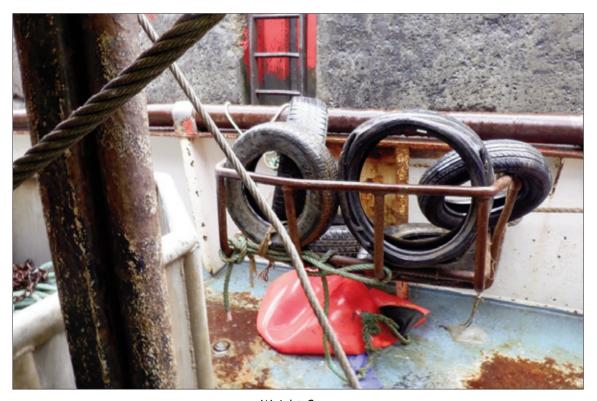
4.1.1 The vessel and her equipment were noted to be in good condition and the vessel had valid certification. However, the Casualty alleges that the chain on the clump weight was not in good condition at the time of the incident and that it had since been replaced. The chain is not considered to be a causative factor in the casualty.

Weight Cage
