**REPORT OF AN INVESTIGATION
INTO AN INCIDENT
INVOLVING TWO PASSENGER FERRIES
ENGAGED IN A
CLOSE QUARTER INCIDENT
AT ROSSLARE HARBOUR
CO. WEXFORD
16 MARCH 2022**

**REPORT NO. MCIB/317
(No.6 OF 2022)**

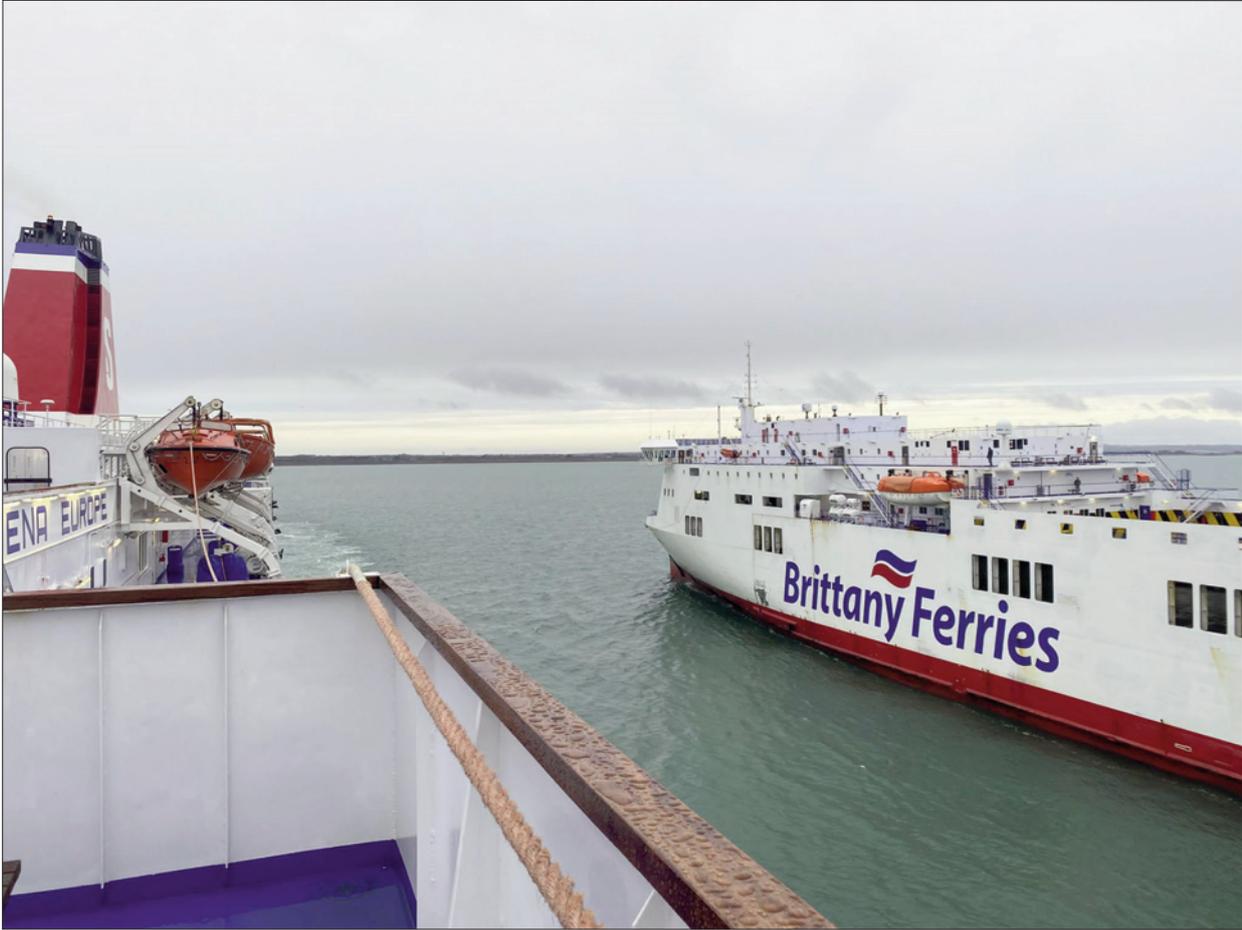
Appendix 7.1 Photograph taken from the Bridge Wing of the Outbound Vessel “Stena Europe” Showing the Inbound Vessel “Connemara” Passing Approximately 100 m Clear

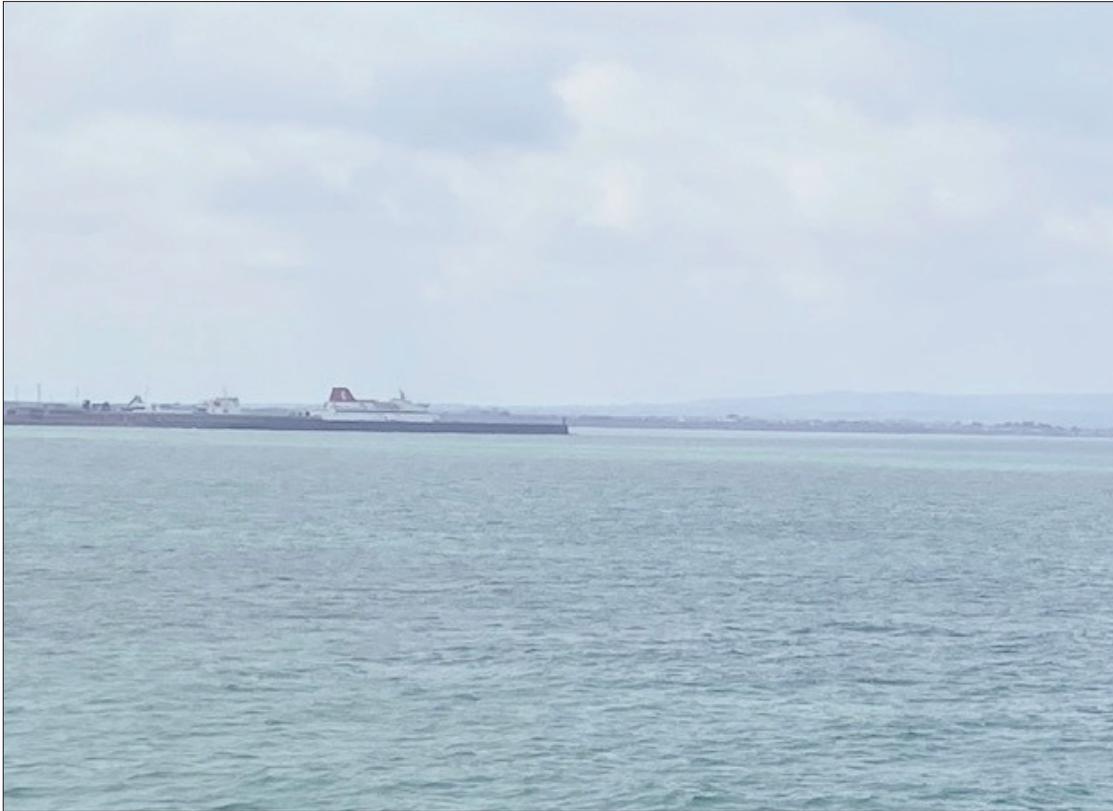
Appendix 7.6 Photograph taken from a Ferry Approaching Rosslare Harbour

Showing the breakwater and a vessel in the approximate position "*Stena Europe*" would have been in when the "*Connemara*" was approaching.

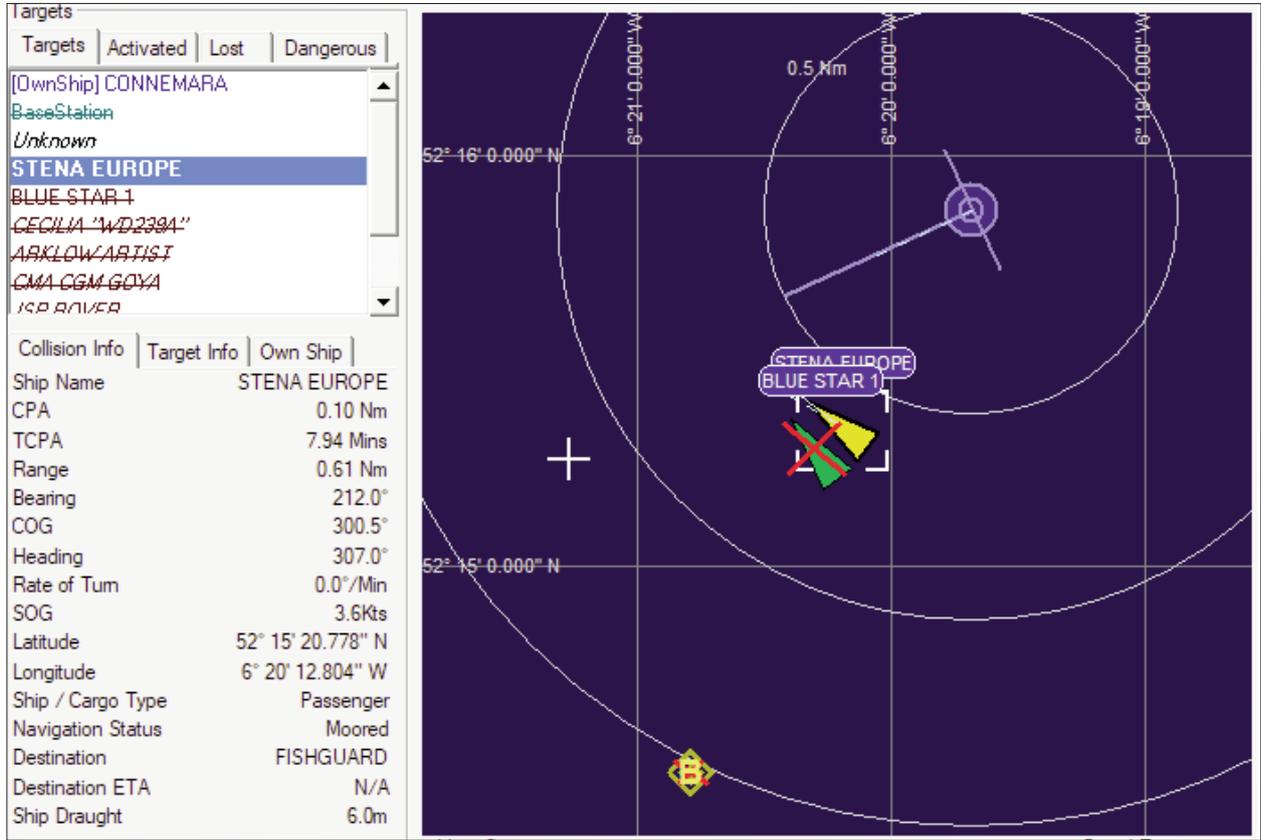
Appendix 7.7 Screen Shot of the AIS Display from “Connemara” at 07.26 hrs

“Stena Europe” can clearly be seen to be moving.

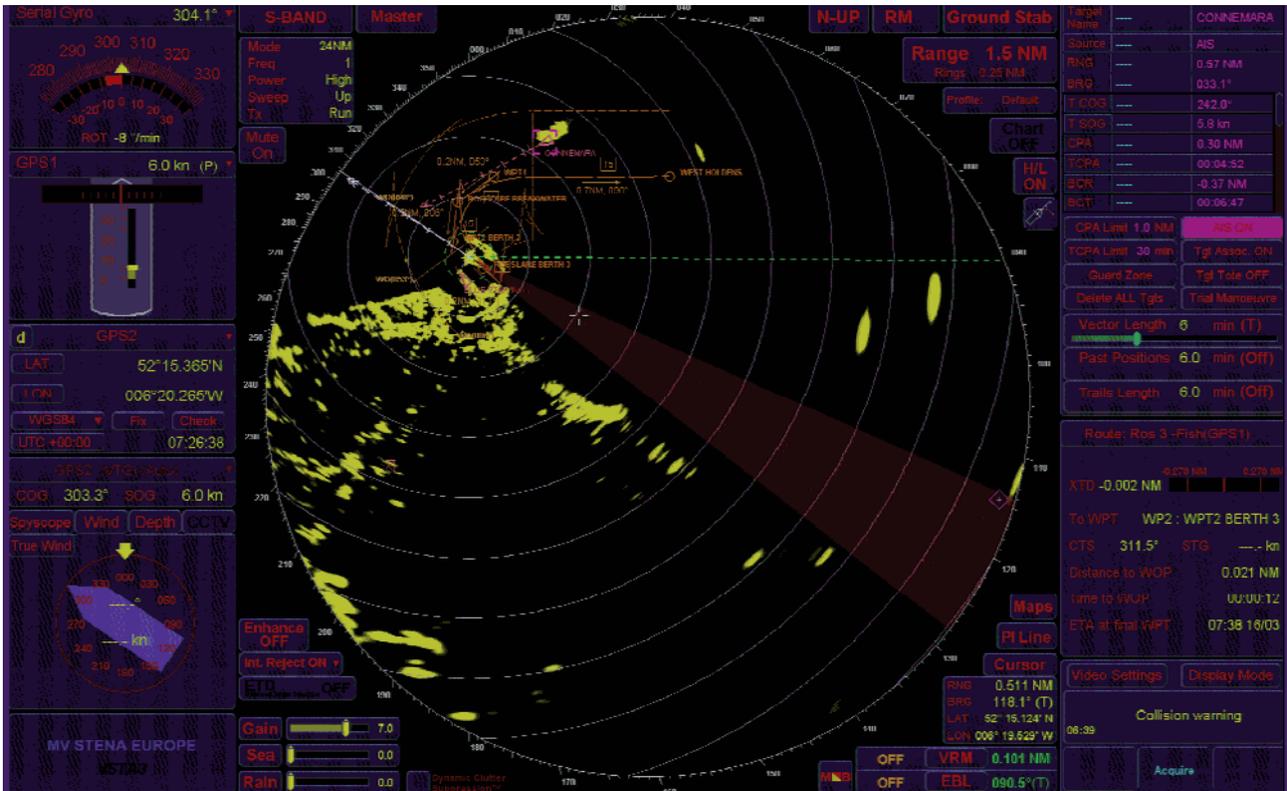
Appendix 7.8 Screen Shot of the Radar on “Stena Europe” with AIS Overlay at 07.26 hrs

It is clearly evident that “Connemara” has not held position at West Holdens and is on a course towards the harbour entrance.

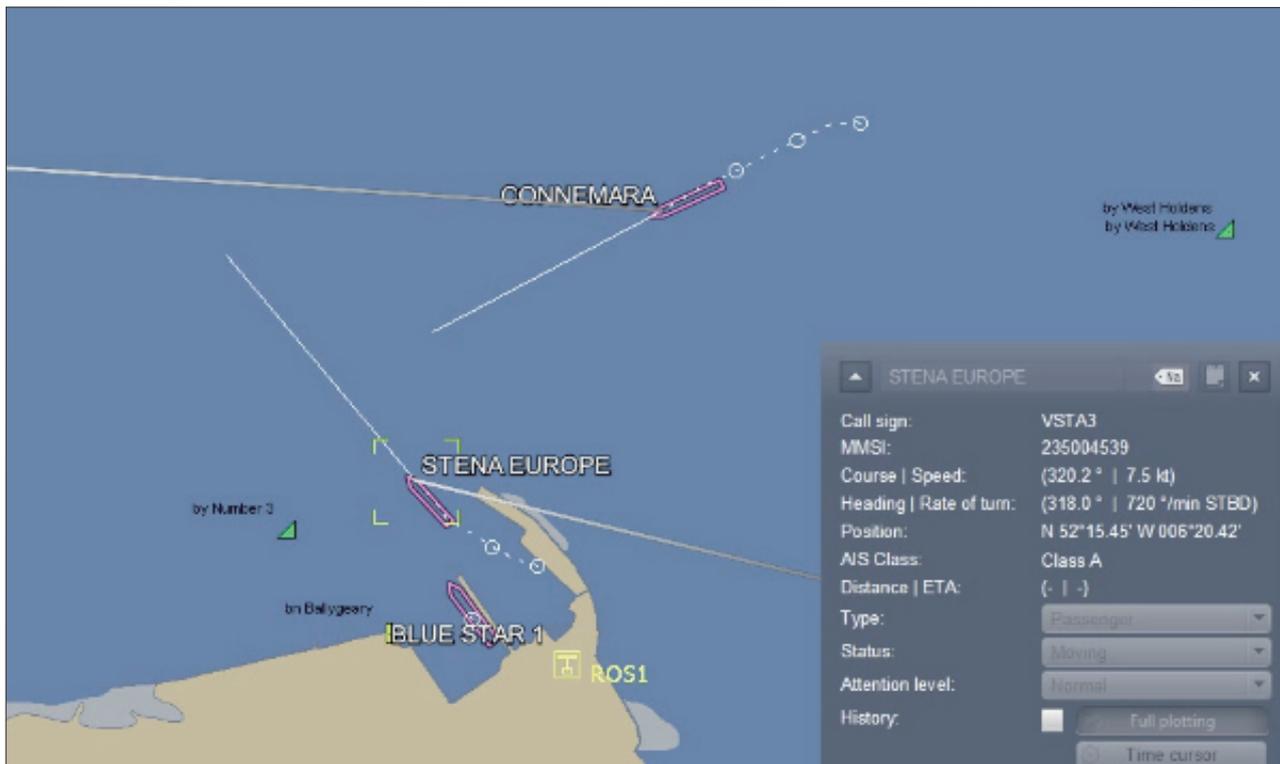
Appendix 7.10 Screen Shot from Rosslare Port Control

Taken six minutes after the last VHF contact with “*Connemara*” when they were informed that “*Stena Europe*” would be departing in the next minute or two and 24 minutes after “*Connemara*” was asked to wait in the vicinity of West Holdens buoy.
