**REPORT INTO THE LOSS OF
THE FISHING VESSEL
"ST. OLIVER" ON THE
17TH SEPTEMBER, 2004.**

The Marine Casualty Investigation Board was established on the 25th March, 2003 under The Merchant Shipping (Investigation of Marine Casualties) Act 2000

Published by The Marine Casualty Investigation Board
22nd December 2005

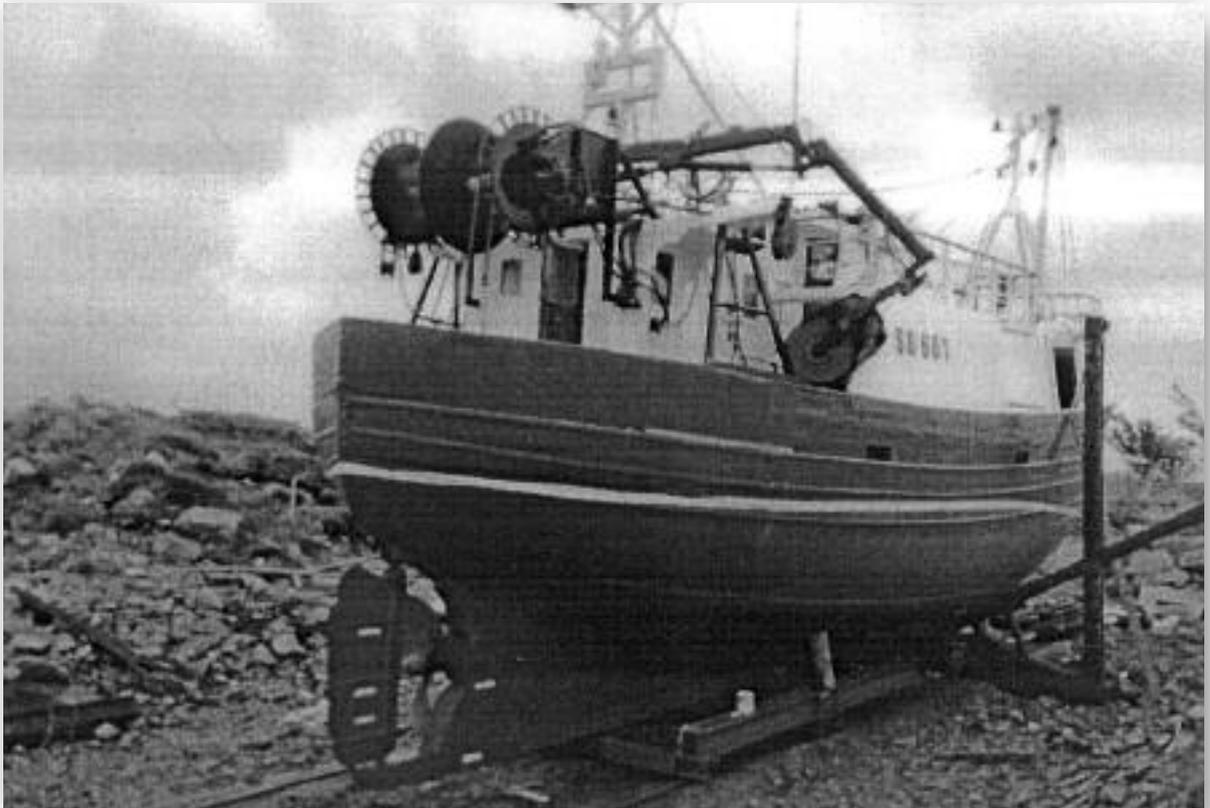
Appendix 8.1

Description: Shelterdecked wooden hull of iroko planking on oak frames, cruiser stern, engine room forward with steel wheelhouse aft. The shelter deck was fabricated and installed by Mooney (Boats) Ltd. Killybegs, Co. Donegal in 1990/1991. The vessel was painted dark blue with white superstructure, red anti fouling and a white water line. The vessel is described as multipurpose used in trawl and seine net fishing (See photograph at Appendix 8.1).

The photo below was taken prior to launching.

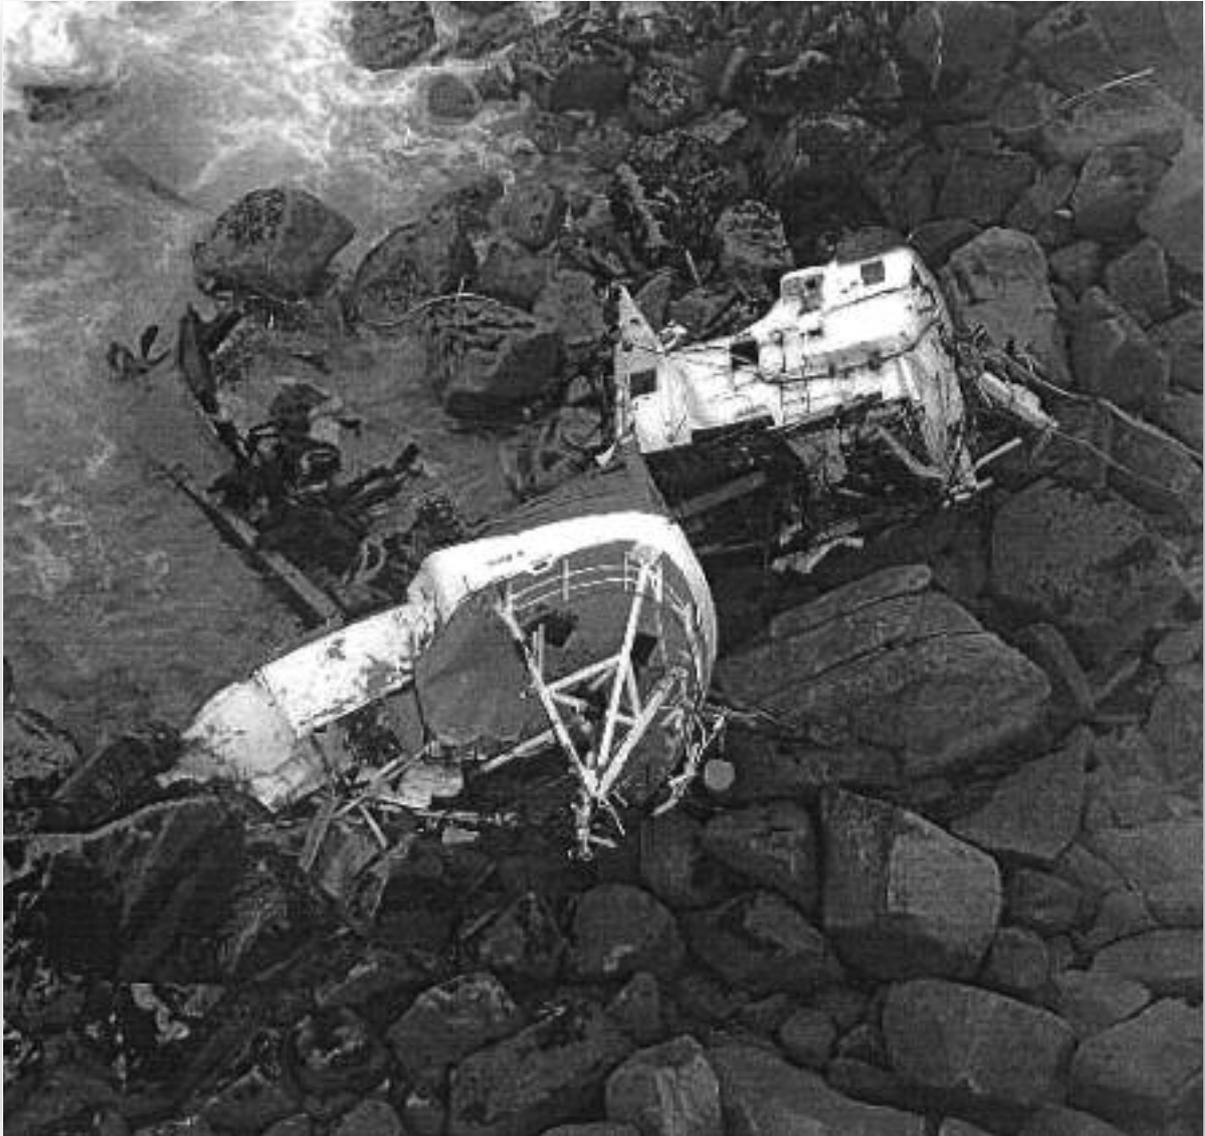
Appendix 8.1

- 5.6 Inspection of the wreckage:
The wreck was located on the Southern side of Duck Island in the vicinity of Mweenish Island. The vessel had broken up into a number of sections that remained in the locality of the grounding (See photograph at Appendix 8.3).

5.6.3 On the main keel section (midships - for'd) there is evidence of point of impact damage. The steel keel box has split open and the underlying timber keel has suffered extensive damage. It was not possible to access this section due to tidal conditions. The gearbox and adjacent planks on this section do not appear to be damaged and the paintwork was in good condition.

This is supported by the point damage to the keel, which on impact splayed the keel box open; there was relatively little underwater paint damage or planking damage either side of the keel.

The photo below was taken the morning after the incident.
