**REPORT OF THE INVESTIGATION
INTO THE SINKING OF THE
“MFV IÚDA NAOFA”
OFF THE BUTT OF LEWIS,
ON
20th JANUARY 2015**

**REPORT NO. MCIB/243
(No.11 OF 2015)**

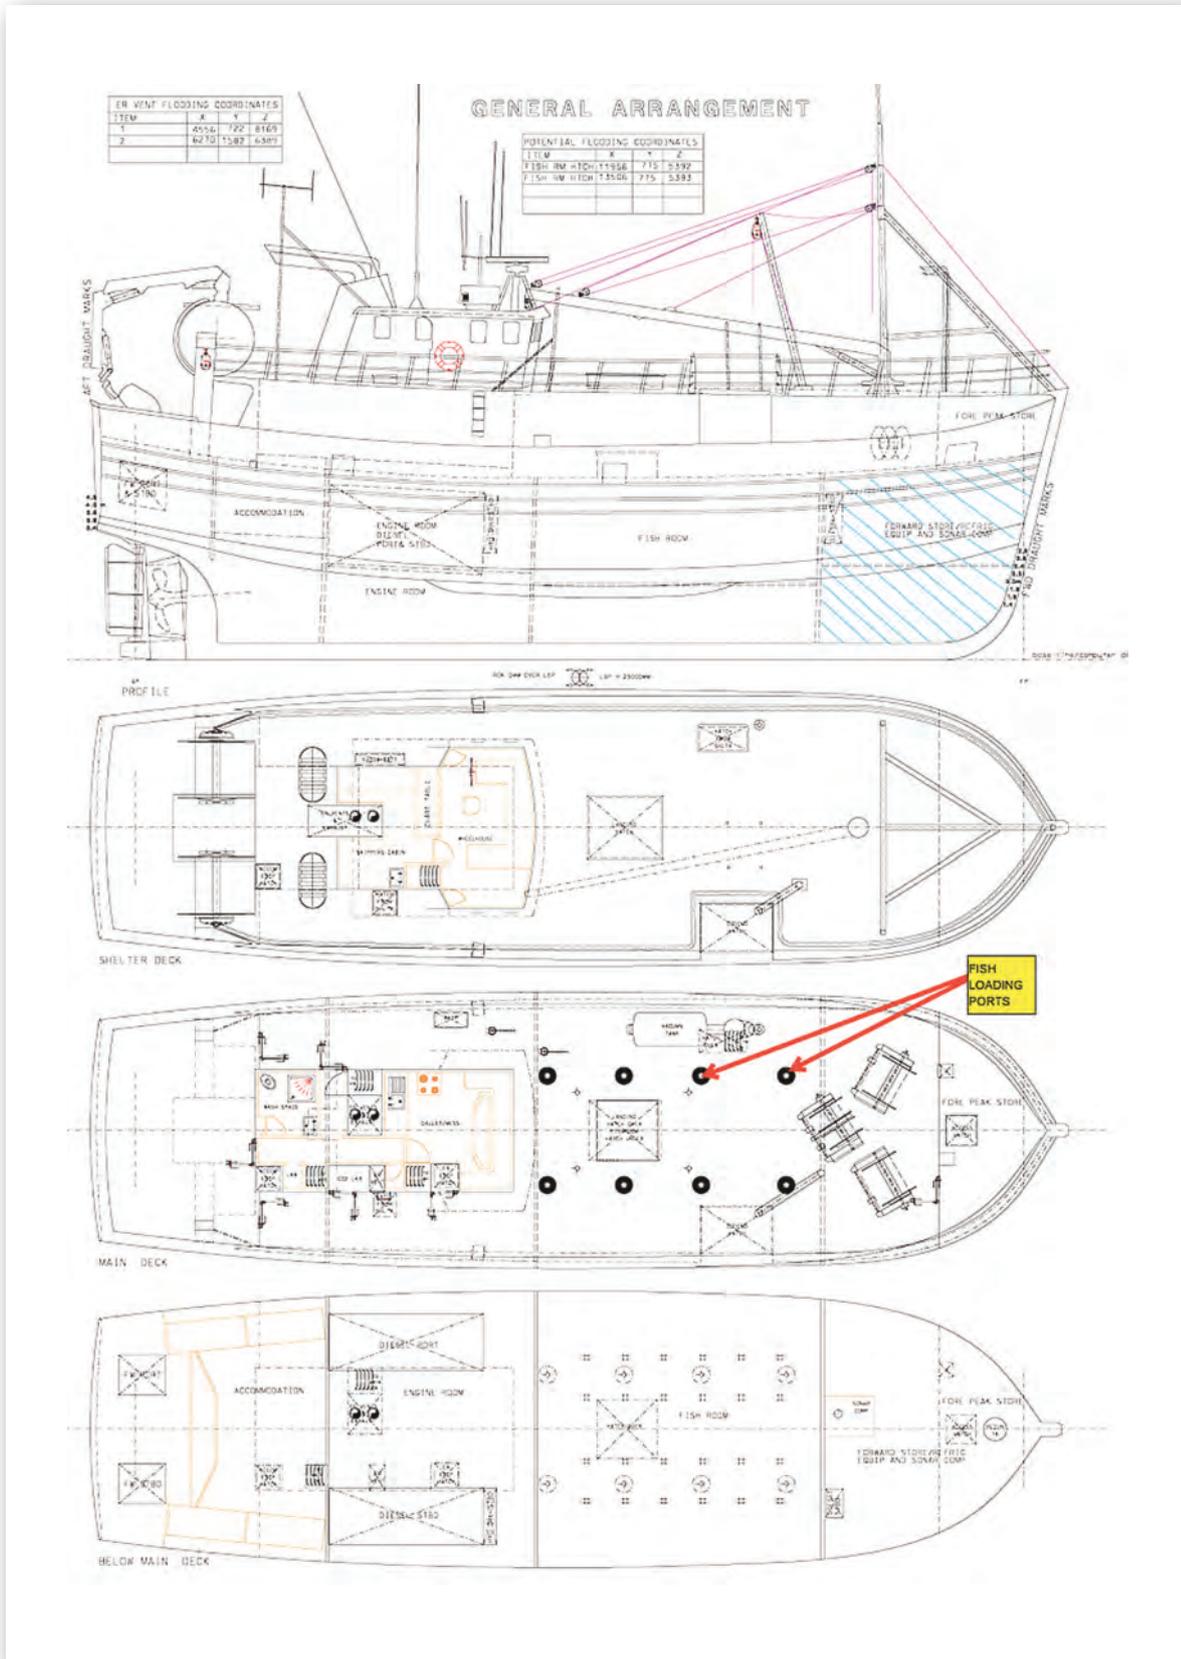
Appendix 7.2 General Arrangement of Vessel.

Between 09.00 hrs and 09.30 hrs the bilge alarm in the forepeak sounded and water was observed in the bilge but its source could not be identified as it was deep below sole boards (See shaded compartment on Appendix 7.2 General Arrangement Plan).

The initial source of water ingress was through the hull below the sole of the forepeak.
