**REPORT INTO A  
FATAL INCIDENT  
INVOLVING A RECREATIONAL  
POWERBOAT  
OFF COONANNA PIER,  
CO KERRY  
30th SEPTEMBER 2018**

**REPORT NO. MCIB/282  
(No.6 OF 2019)**

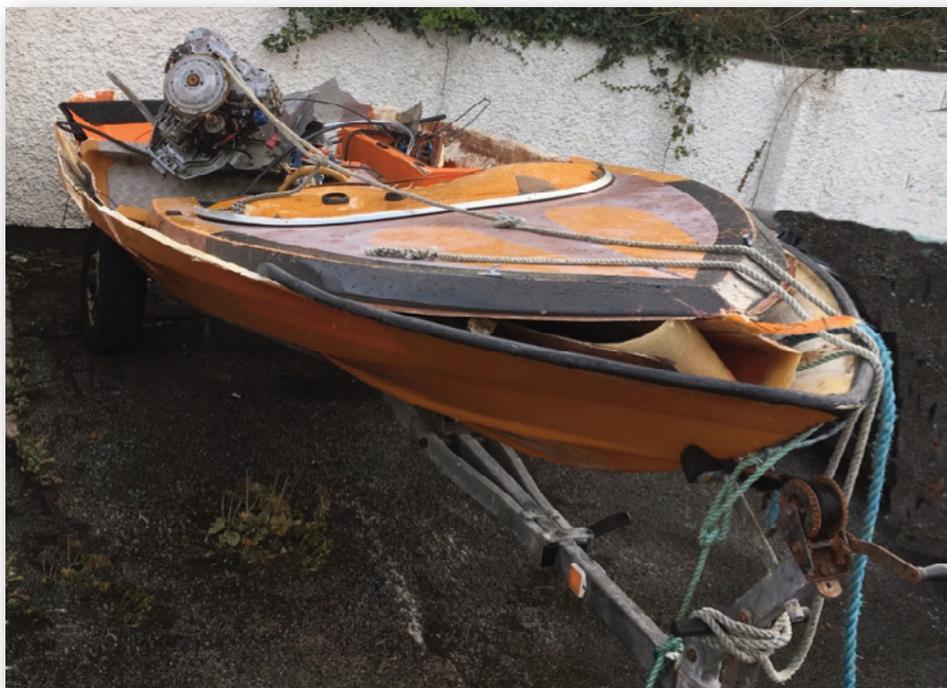
- 3.9 The vessel was on a two-wheel trailer and the following observations were recorded:
- The hull and deck mouldings had become separated (see Appendix 7.1 Photograph No. 1).

- The stern of the boat was broken up with the transom detached from the hull.
  - Lumps of polystyrene foam which had become detached from inside the bow.

- The main outboard engine was still attached to the transom.
  - The top cover of the engine was missing and there was no manufacturer's plate.
  - The engine was an old model and had been repainted.

- There was the fractured remains of an outboard bracket on the starboard side of the transom.
  - The approved plastic fuel tank was three-quarters full (approximately 10 litres).

Photograph No. 1: The remains of the boat.

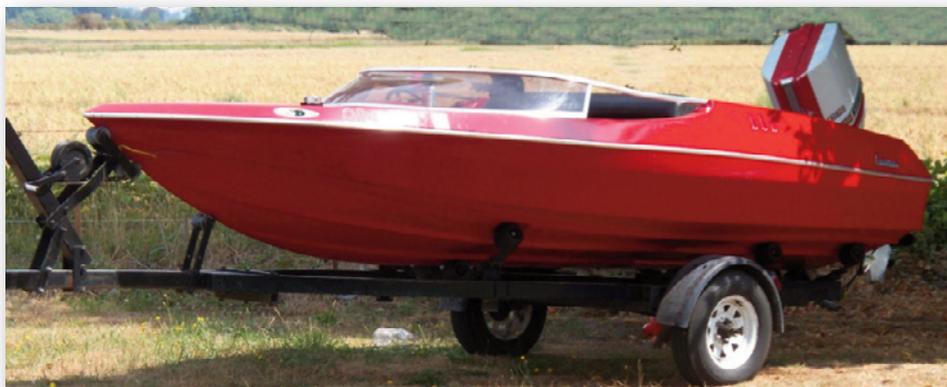
The vessel was a 16ft GRP ski boat with a foredeck and open cockpit aft with wheel steering and engine controls on starboard side (see Appendix 7.1 Photograph Nos. 1 and 2).

Photograph No. 2: Similar boat.

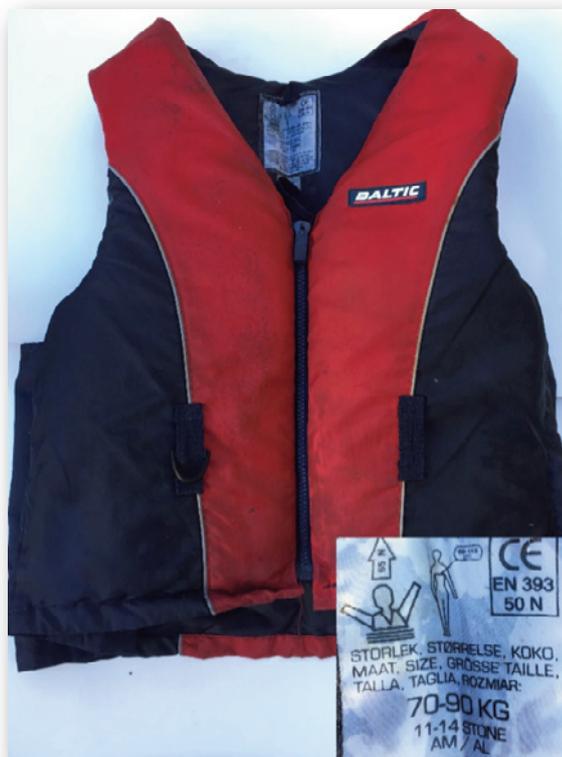
- The plastic pack for four beer cans.
- 3.10 The PFDs were buoyancy vests rated at 50 newtons but did not have whistles attached (see Appendix 7.1 Photograph No. 3).

- 4.6 The crew wore buoyancy vests which are sleeveless jackets without a collar (see Appendix 7.1 Photograph No. 3). Unlike a lifejacket which completely supports the body and keeps the head back and out of the water a buoyancy vest only provides limited support. Each member of the crew had layers of clothing on their upper bodies but lower body and legs had only track suit trousers. The Casualties would have quickly succumbed to cold in the water. The Skipper was found some distance from the boat and further inshore which indicates he may have attempted to swim to shore but became exhausted before reaching it. Marine Notice No. 10/2016 outlines the regulations for wearing PFDs/lifejackets in small boats (see Appendix 7.5 Marine Notice No. 10 of 2016). The regulations state that ‘a suitable PFD must be worn at all times by anyone on board a moving pleasure craft that is under 7 meters in length’.

Photograph No. 3: The buoyancy aids used by the three crew.

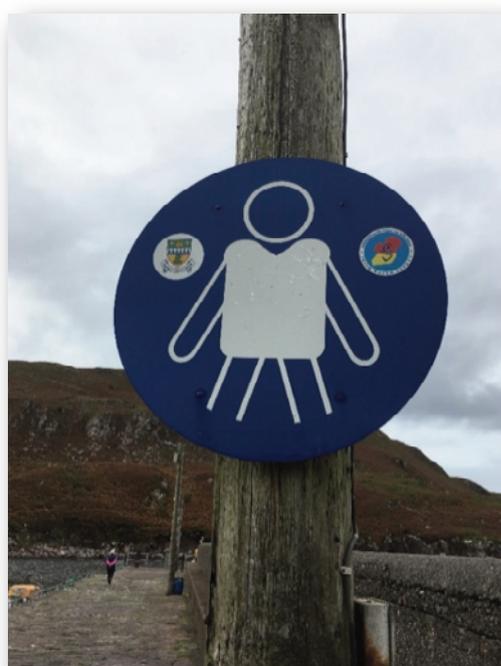
- 3.11 On Coonanna Pier there was a sign in compliance with the International Standards Organisations Standard ISO 20712 (1, 2 and 3) on graphic symbols to prompt the wearing of PFDs (see Appendix 7.1 Photograph No. 4). All three bodies were recovered wearing flotation devices.

Photograph No. 4: Sign on Coonanna Pier.
