**REPORT OF AN INVESTIGATION  
INTO THE SINKING OF  
FV ANNA LOUISE  
NEAR GLENGARRIFF HARBOUR,  
BANTRY BAY,  
CO. CORK  
2 JULY 2022**

**REPORT NO. MCIB/319  
(No.3 OF 2023)**

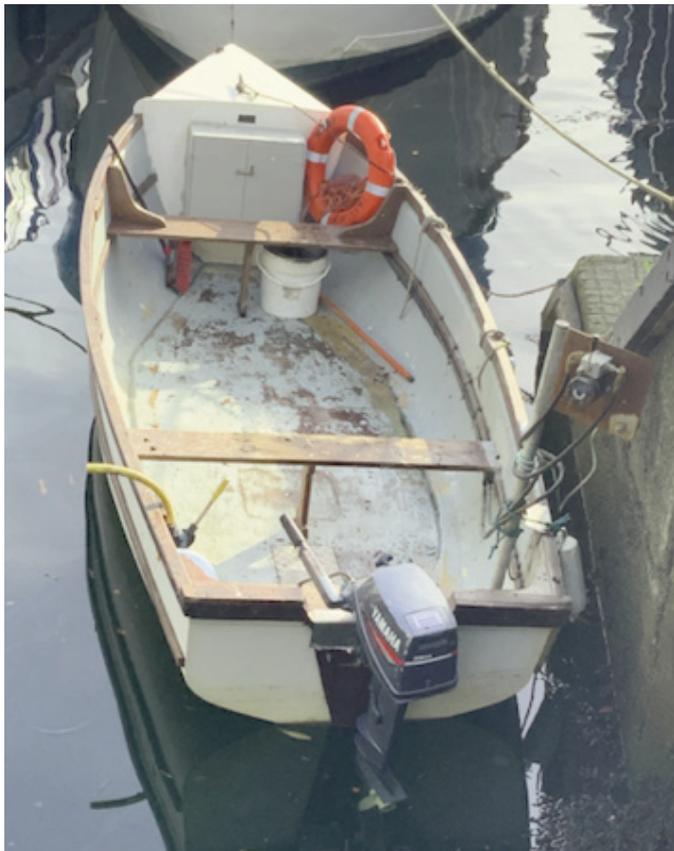
Photo of the boat taken by Code of Practice (CoP) Surveyor 17 November 2020.

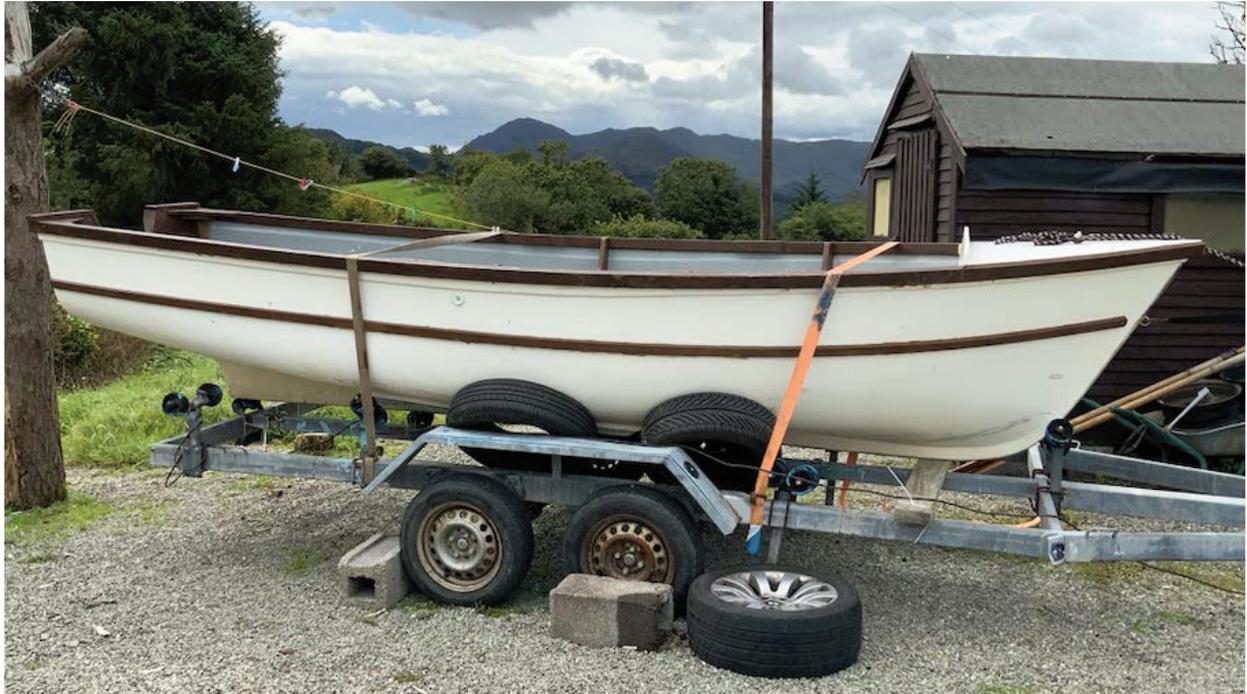
- 4.6 A comparison was made with the boat in the salvaged condition and the photos of the boat that were taken at the time of the CoP survey and several important differences were noted. These differences increased the weight of the boat and reduced the working freeboard. The differences are noted below and are considered a contributing factor in this casualty:

Photograph No. 1 - FV Anna Louise on Trailer at Time of CoP Survey 17 November 2020.

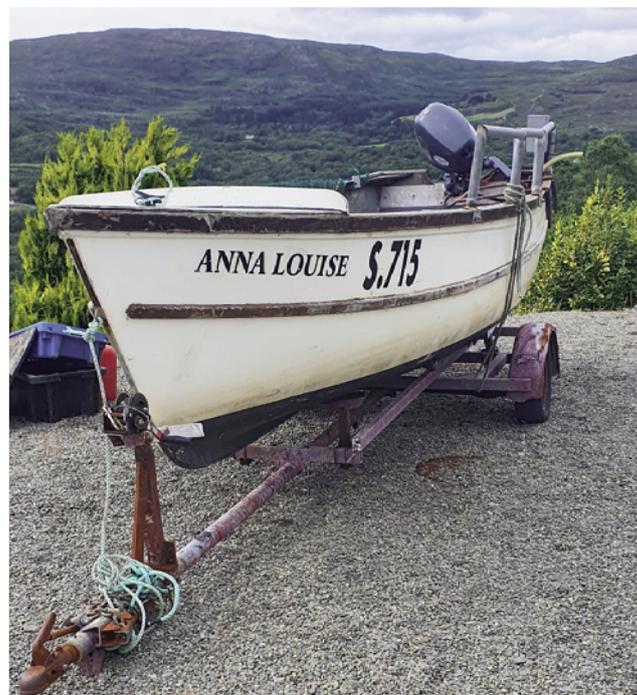
- 4.5 The salvaged boat was inspected, and the hull was seen to have minor chaffing marks on the starboard side of the bottom forward of midships and no other structural damage. This excludes the possibility of collision or grounding on rocks as a cause of the sinking. There were also some small knocks on the propeller.

Photograph No. 2 - FV Anna Louise after Salvage with Boat on the Trailer.

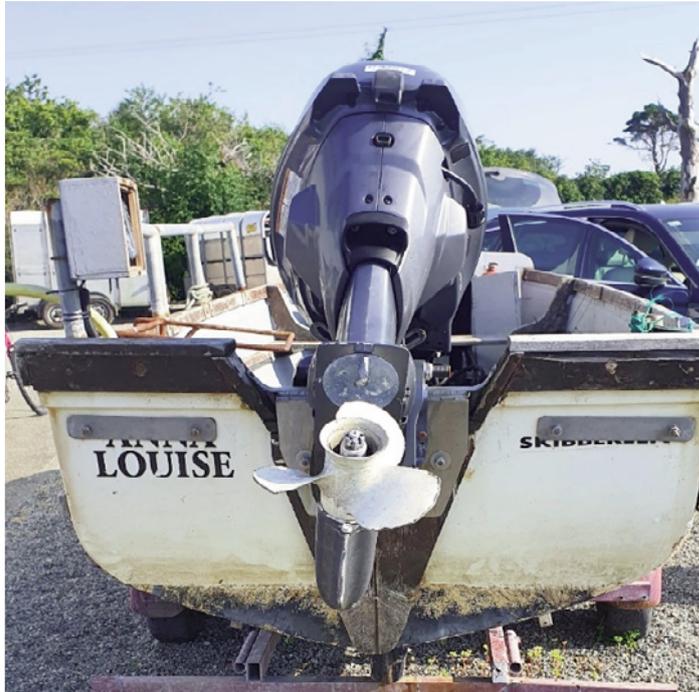
- The outboard engine had been changed from 6 hp to 25 hp (+38 kilogram (kg)).
  - A new steel transom bracket had been fitted to stiffen the area for the engine (+15 kg).

Photograph No. 3 - Stern View with Larger Engine (note the flat bars with bolts securing new bracket).

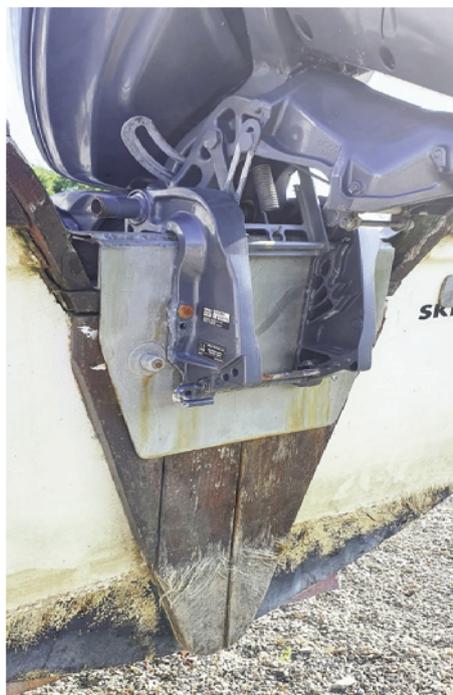
Photograph No. 4 - New Steel Bracket Fitted.

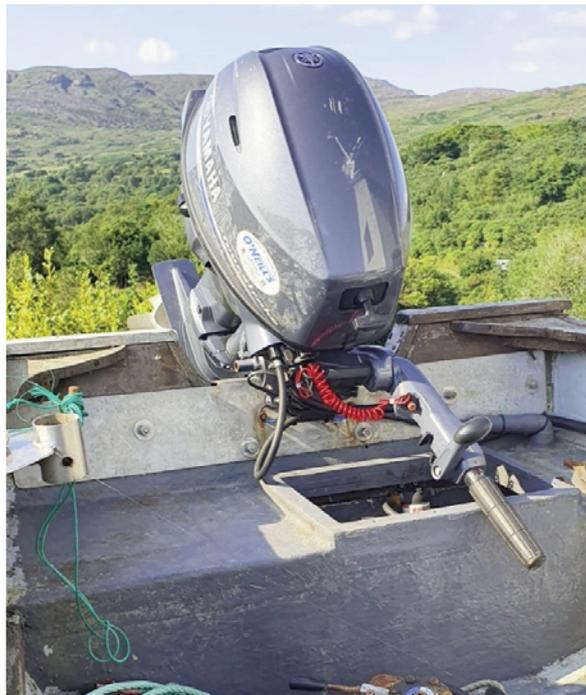
Photograph No. 5 - Inside the Boat with New Engine and Steel Bracket Fitted and Open Aft Locker.

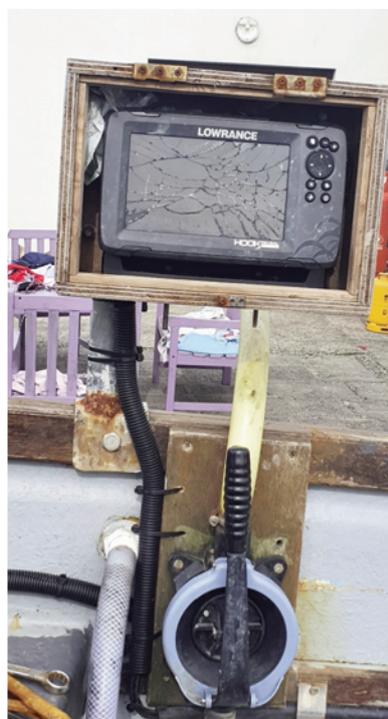
- A new echo sounder/plotter had been fitted along with box and cables (+ 2 kg).
- Bulwark handrails had been fitted on the top of the gunwale port side (+ 10 kg).

4.10 The boat was fitted with an electric bilge pump and a hand operated bilge pump in accordance with the requirements for the boat but neither of these could quickly clear the amount of water that came in over the stern of the boat.

Photograph No. 6 - Sounder/Plotter and Hand Bilge Pump Fitted.

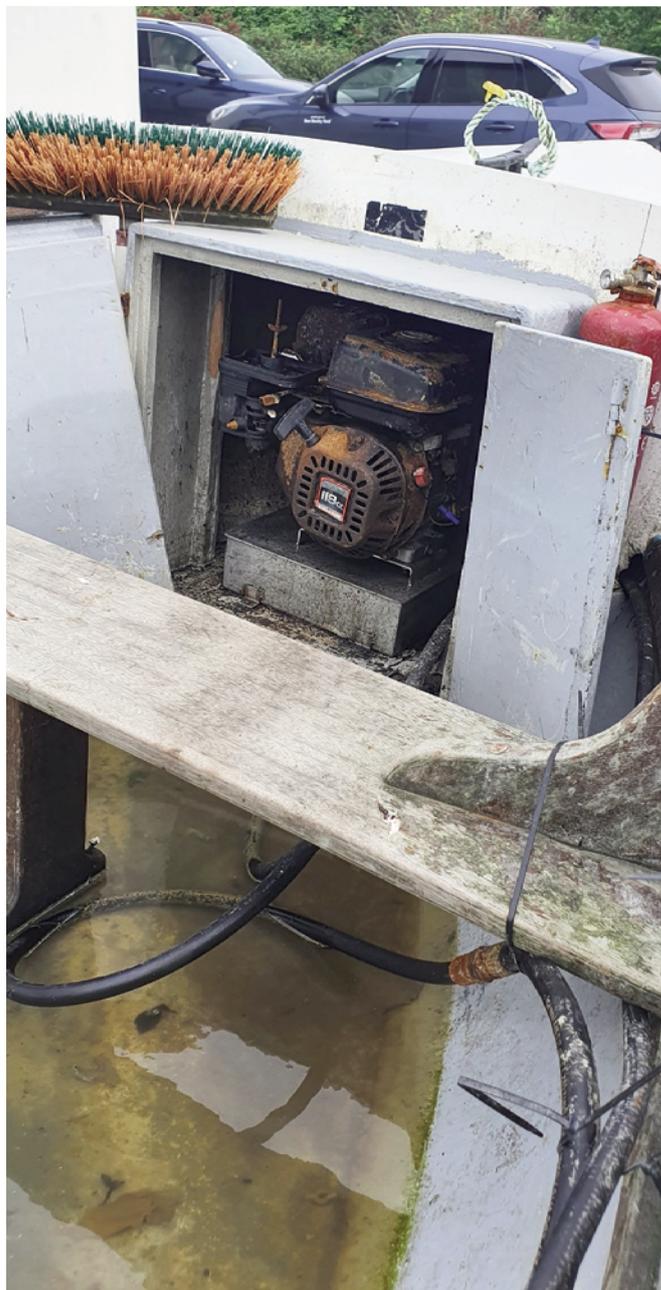
- 4.11 The original build had a locker forward which can be considered reserve buoyancy, but this locker had a generator and battery fitted inside and no sealing doors and therefore cannot be considered reserve buoyancy. There was a locker aft that contained the fuel tank and cannot be considered as reserve buoyancy. The lack of reserve buoyancy is considered a contributing factor in the casualty.

Photograph No. 7 - Open Forward Locker with Generator Fitted.

- 6.2 The Minister for Transport should introduce rules for open commercial fishing boats < 15 m to assign a minimum freeboard based on the boat size and to ensure open boats have sufficient reserve buoyancy to allow the boat to stay afloat if swamped with sea water.

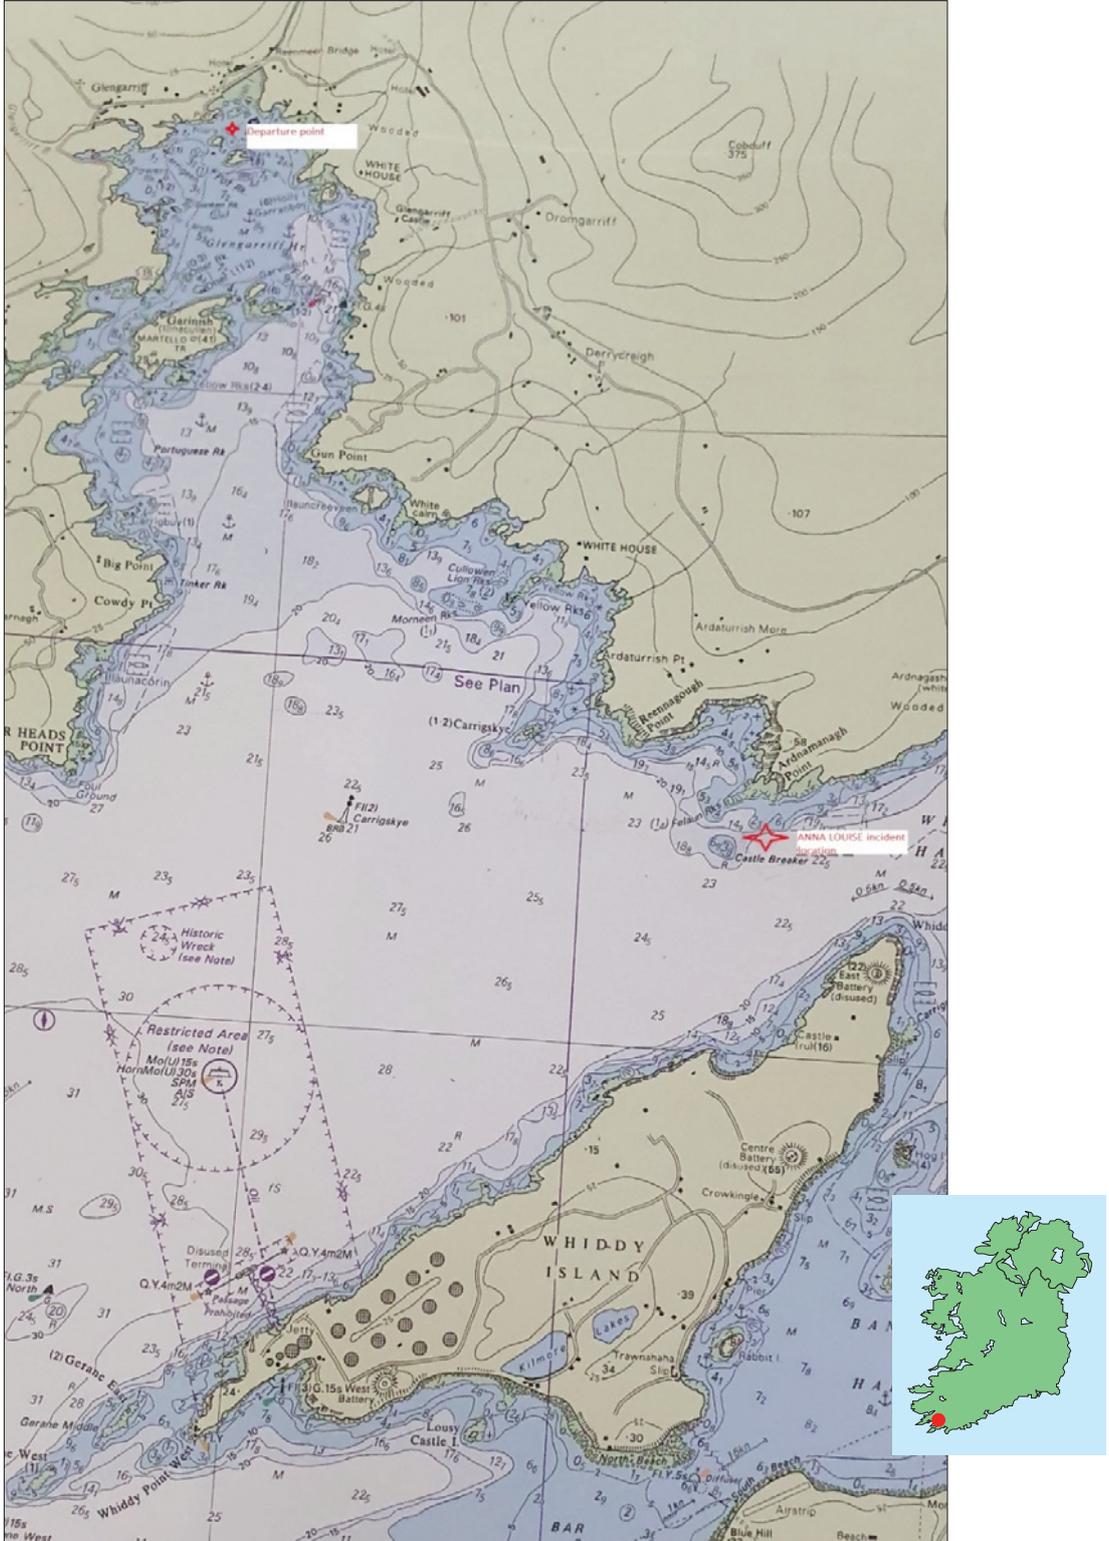
Chart No. 1 - Section of Admiralty Chart 1838 Showing Position of the Casualty.

- 3.3 The EPIRB had floated free and activated. The signal was received by Valentia MRSC and they coordinated a rescue response. The local community lifeboat from Bantry was tasked to attend, as well as the Castletownbere lifeboat. Rescue Helicopter R115 was also sent from base to assist. The EPIRB and a lifebuoy were retrieved from the water, and a message was received that the Casualty was safe and well and the rescue craft was stood down. The boat was salvaged on 4 July from 12 m of water in the location shown (see Appendix 7.3 - Charts of the Area in Bantry Bay - Chart No. 1).

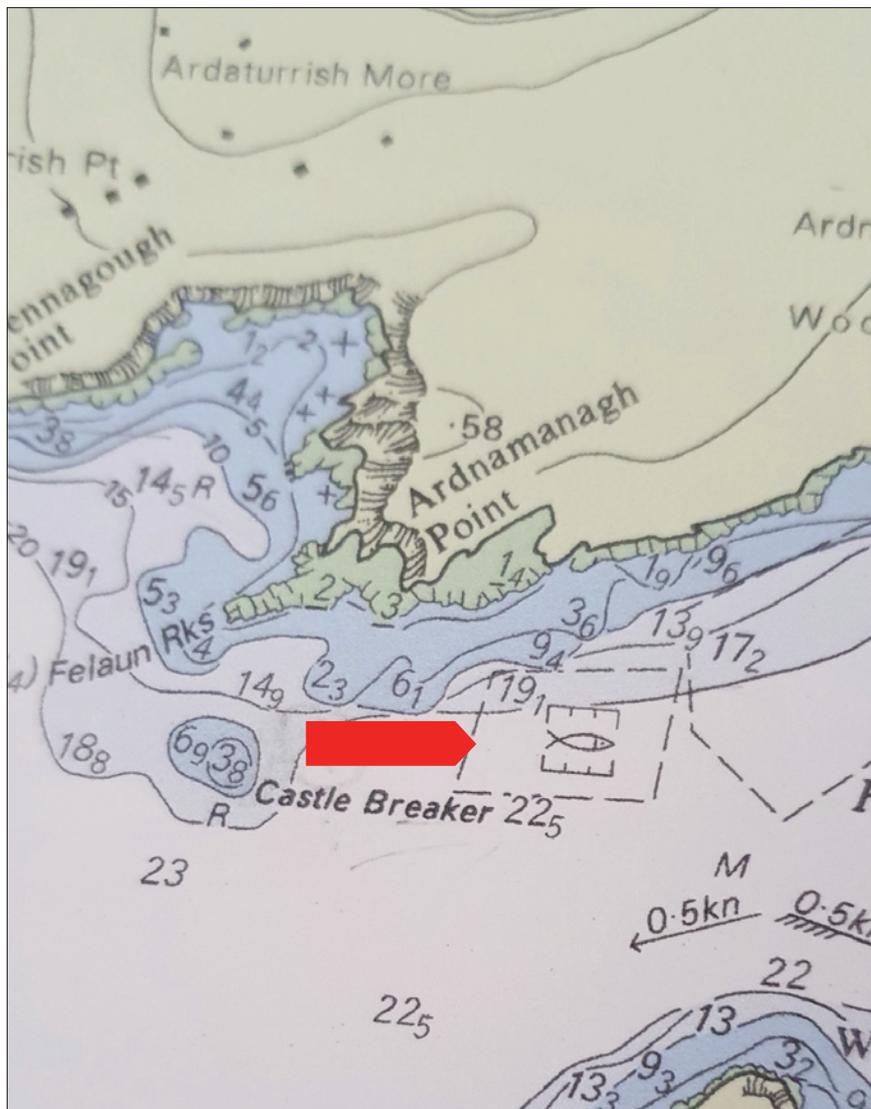
Chart No. 2 - FV Anna Louise Position and Orientation at Time of Sinking (from Chart 1838)

- 3.2 At this time the vessel was stern-to the Castle Breaker with the bow facing east (see Appendix 7.3 - Charts of the Area in Bantry Bay - Chart No. 2). The Skipper was hauling in the rope with the marker buoy when a wave came over the stern and deposited a large amount of water into the boat. The Skipper rushed forward, past the stowed pots, to retrieve the bailing bucket but a second large wave came over the stern and swamped the boat. The boat filled with water and started to sink quickly. The Skipper jumped into the water and kicked off the wellington boots he was wearing. His PFD inflated automatically, and he swam to the rocks on the shore. He sat on the rocks for a while to get his breath back and then made his way through rough terrain to the nearest house, which was empty. He proceeded to the next house and made a call to his brother to advise he was safe.

4.9 At the time of the incident the boat was in a position with the stern near the Castle Breaker rocks and as the tide was changing there were rollers/breakers coming off the rock area towards the stern of the boat. This is considered a causal factor in this casualty.
