**REPORT OF AN INVESTIGATION
INTO A MARINE CASUALTY
INVOLVING A
RECREATIONAL CRAFT
IN OR AROUND
LACKEN PIER, BELTRA,
CO. MAYO
16 JULY 2023**

**REPORT NO. MCIB/329
(No.6 OF 2024)**

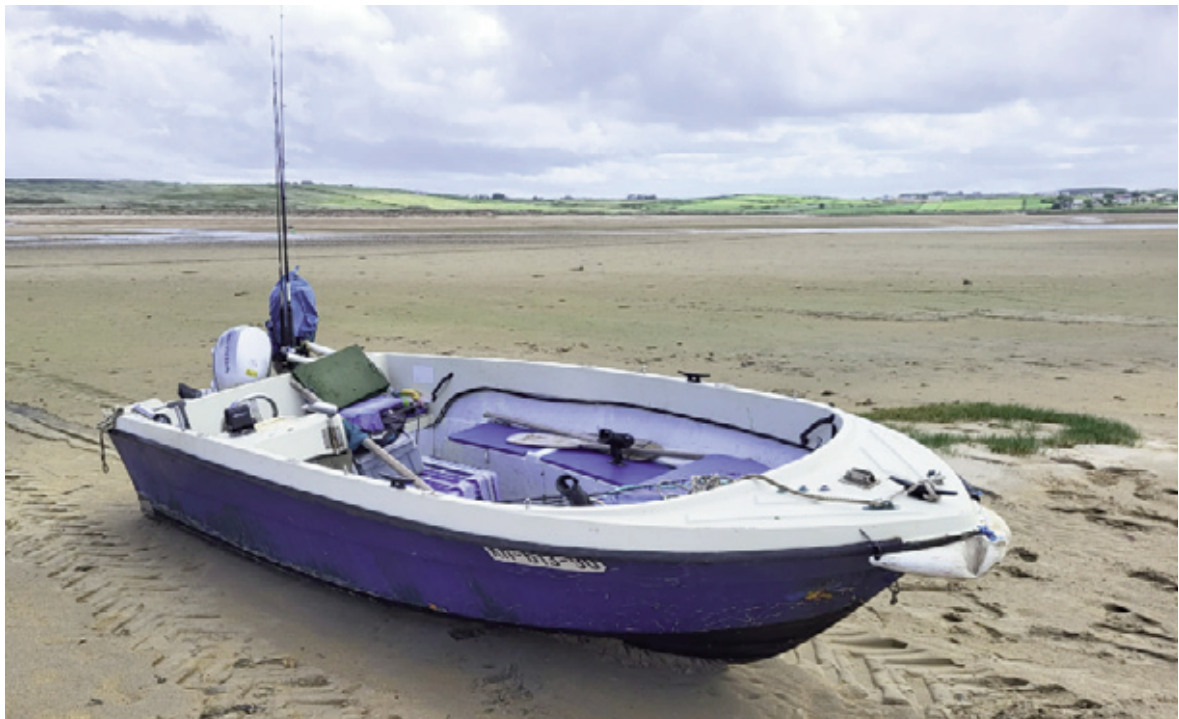
The recreational boat.

- 2.1.1 The boat was operated from the coxswain position on the starboard quarter. Controls included key-start with kill-switch and cord, throttle, and steering wheel. The engine trimming was manually operated with a lock mechanism located on the starboard side of the engine.

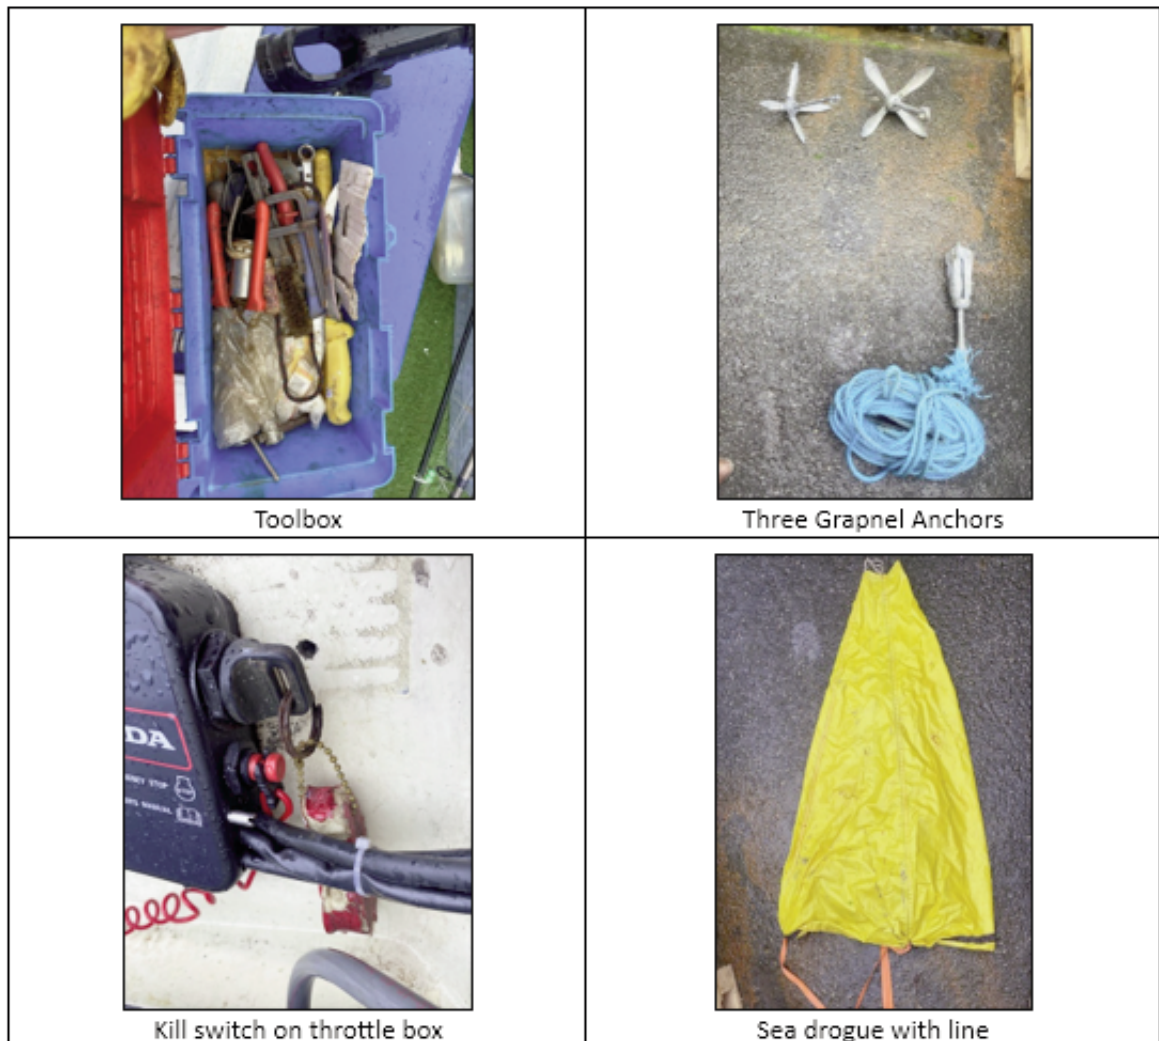
- One main engine, Honda 20hp outboard 4-stroke engine in good condition, secured in the trimmed-up position.
- One fuel tank that was half full for use in the main engine.
- One auxiliary engine, Yamaha 4hp outboard 2-stroke engine in good condition, secured in the trimmed-up position.
- One fuel tank that was full for use in the auxiliary engine.
- Three orange lifejackets with whistles, two of which were 110 newtons (N).
- Three grapnel anchors with anchor lines.
- One sea drogue with lines.
- One engine toolkit.
- One set of oars.
- One boat hook.
- Six fishing rods.
- One Lowrance brand fish finder.
- Fresh food, water.
- Wet gear.

A selection of items of equipment onboard the boat.

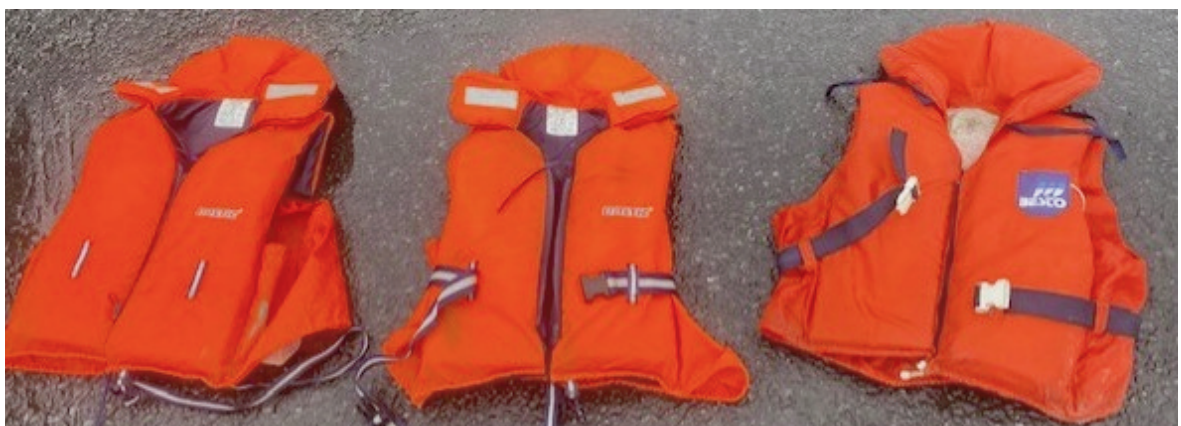
- 2.4.2 Three lifejackets in good condition were fitted with whistles and were stowed in a forward compartment of the boat. Two of the lifejackets were rated at 110 N, one of the lifejackets was rated for between 70 kilogram (kg)-90kg.
- 2.4.3 Lifejackets were not worn by either person at the time of the incident.

Two of the lifejackets were 110 N, and the third rated to 70kg-90kg.

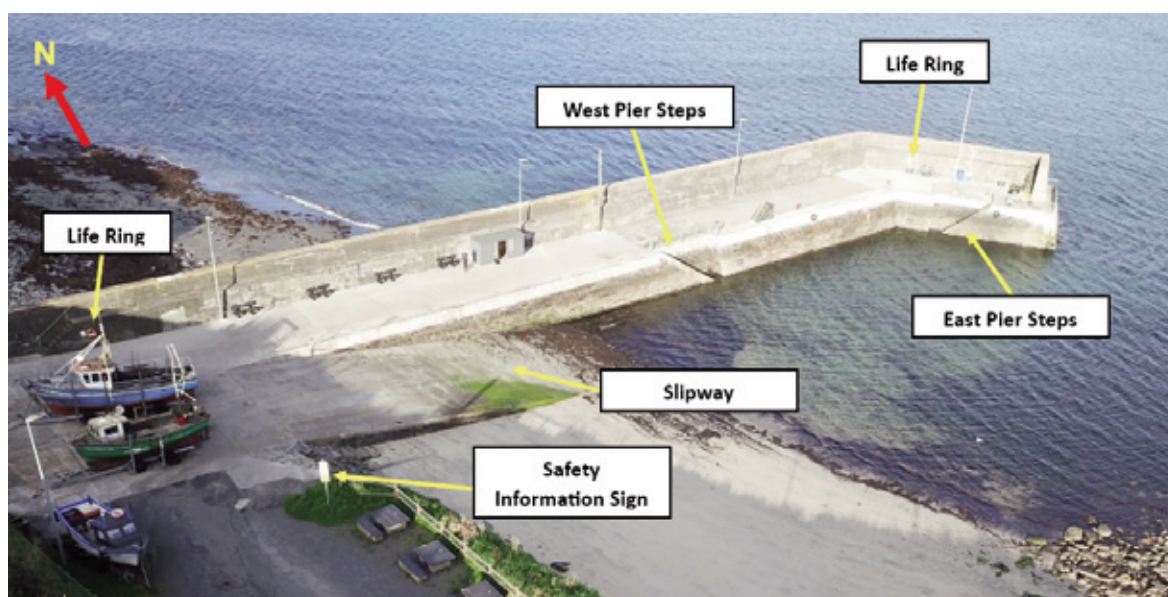
- 2.6.2 During low spring tide the West Pier steps are not accessible by boat due to shallow water. Due to sand deposition and erosion around the East Pier, the seabed at the steps was uneven and undulated. As the Casualty planned to board at the East Pier steps, the depth of water at the steps must have permitted this but deepened quickly as one moved seawards away from the pier.

Lacken Pier showing slipway and access steps.

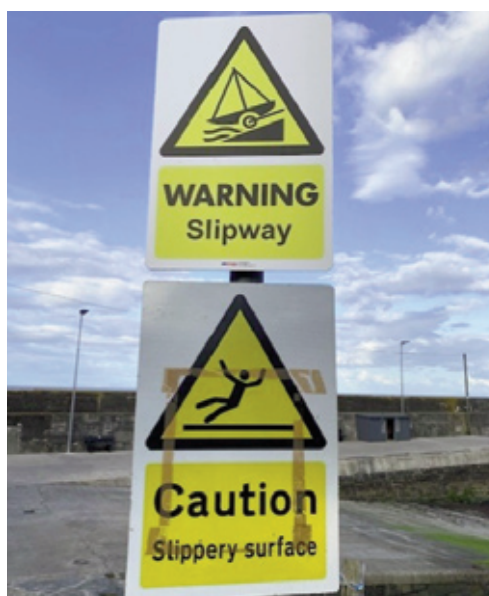
- 2.6.3 At the access to the slipway, there was a safety information sign that included “Warning Slipway” and “Caution Slippery surface”. There were two life rings in good condition on the pier with one at the foot of the pier, and one at the head of the pier - both accessible.
- 2.6.4 Lacken Pier is a local authority owned amenity and as such the maintenance, upkeep and safety of the pier and slipway is the responsibility of Mayo County Council.

Safety signage at Lacken Pier.

- 5.5 The presence of signage requiring wearing of lifejackets by persons on the pier may have prompted the Casualty and Survivor to don the lifejackets that were available to them.

The Chief Executive of Mayo County Council is recommended to consider conducting a review of the safety signage posted at Lacken Pier and in particular the erection of signage or any other communications considered to be useful, advising the wearing of lifejackets at Lacken Pier and slipway.

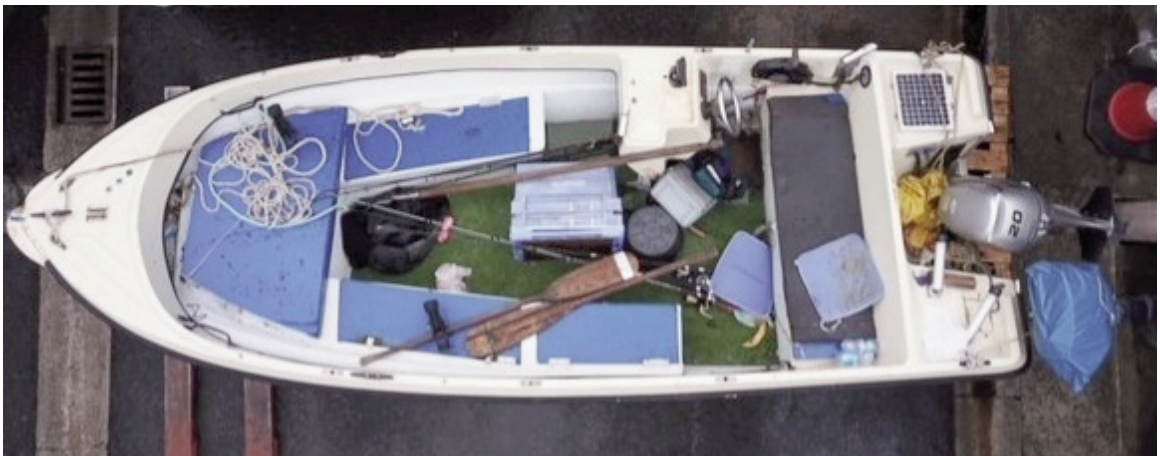
Photograph taken after boat was transported to the Garda secure location, showing equipment onboard including main and auxiliary engine.

- 3.12 On 21 July the boat was inspected by an MCIB Investigator and was found to be in reasonable condition with the hull fully intact and no sign of a hull breach.
- 3.13 The cause of death is a matter to be determined by the coroner.
