**REPORT OF AN INVESTIGATION
INTO A MARINE CASUALTY
INVOLVING THE
FISHING VESSEL SÉIMI
IN OR AROUND
ARRANMORE ISLAND,
CO. DONEGAL
4 FEBRUARY 2023**

**REPORT NO. MCIB/326
(No.7 OF 2024)**

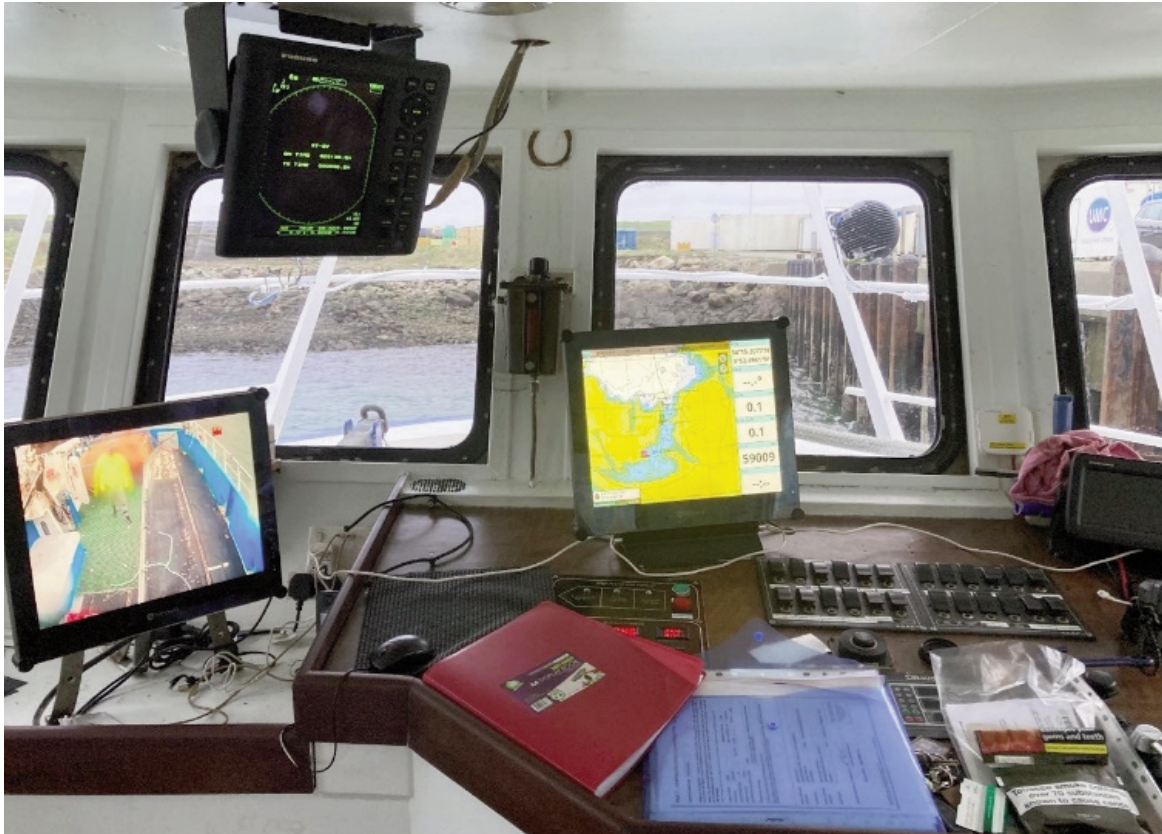
Photograph No.3: View from the wheelhouse showing the monitor on the port side (left) used to watch the operation on deck from the helm position.

rope wrapped around it. It should be noted that Crewmember A observed the incident unfold via the wheelhouse monitor. His observation has not been independently verified. The monitor in the wheelhouse only displays a real-time image of the deck, it is not recorded. Crewmember B who was watching the operation did not provide this description.

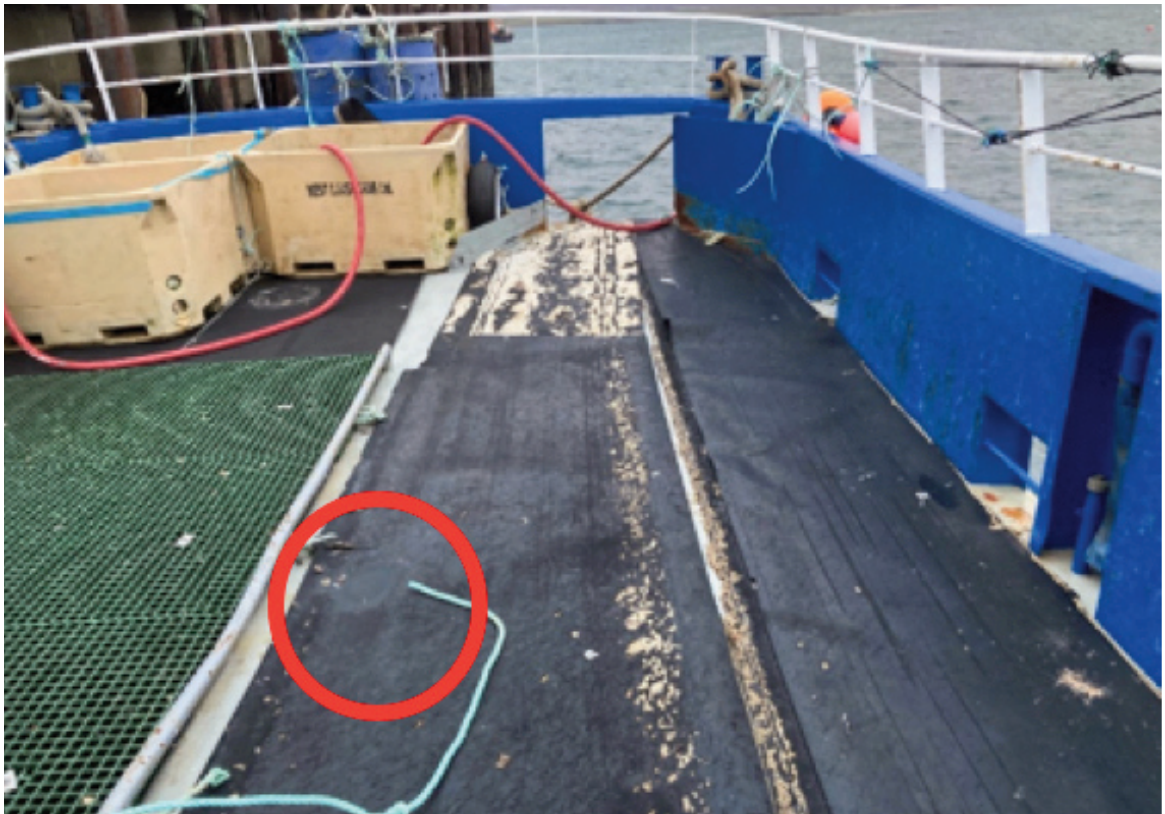
- 3.3.8 As Crewmember E was manoeuvring the block into position to go into the water he got caught up in the line and was hauled over the side of the vessel with the block and line through the stern door opening in the bulwark (see Photograph No.4). Crewmember A (the Skipper) says he saw Crewmember E wrapping the line attached to the block around his hand presumably to help him manoeuvre it into position. Once weight came on the line his hand was then trapped by the

Photograph No.4: View aft along the deck from the wheelhouse door showing the stern door opening in the after deck bulwark. The red circle indicates the approximate location of Crewmember E.

- 4.1 Crewmember A (the Skipper) says he saw Crewmember E wrapping the line attached to the block around his hand, presumably to help him manoeuvre it into position. Once weight came on the line his hand was then trapped by the rope wrapped around it. This is what caused him to be dragged overboard. This system of work was unsafe and was a causative factor in this incident.

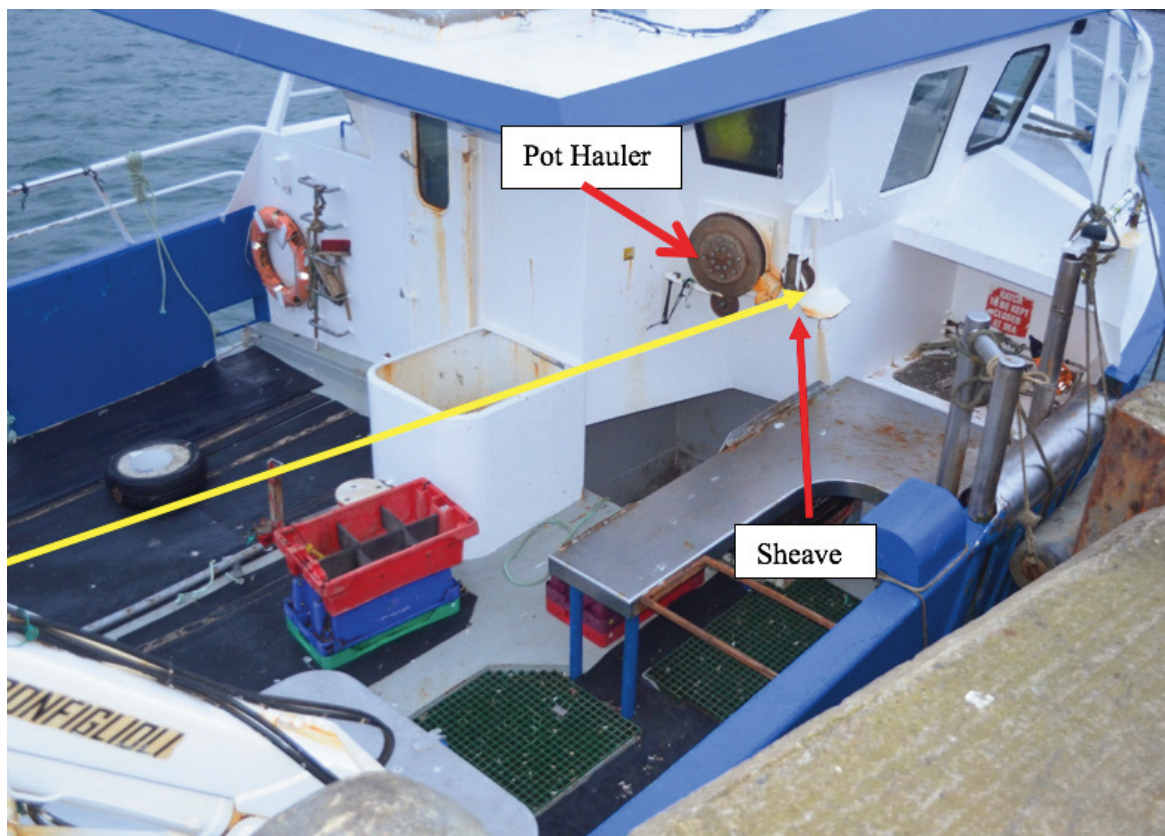
- 3.4.1 The Skipper and Crewmember B immediately noticed the man overboard, stopped the vessel and attempted to recover Crewmember E by hauling on the leader attached to the block which had just gone overboard. The alarm was raised onboard and the remaining two crewmembers (C and D) came on deck to assist. By this time Crewmember B had taken the leader and attempted to haul the line in using the pot hauler.
- 3.4.2 The pot hauling system onboard FV Seími was not designed to haul the leader back through the open door in the bulwark, it was not a fair lead. The weight of the block and the motion of the vessel in the swell caused the leader to chafe through and snap where it passed over the deck (see Photograph No.5). When the leader snapped contact with the MOB was lost completely. He was not wearing a PFD.

Photograph No.5: Yellow arrow indicates the direction the leader was pulled through the sheave and into the pot hauler in an attempt to recover the Casualty from the water.

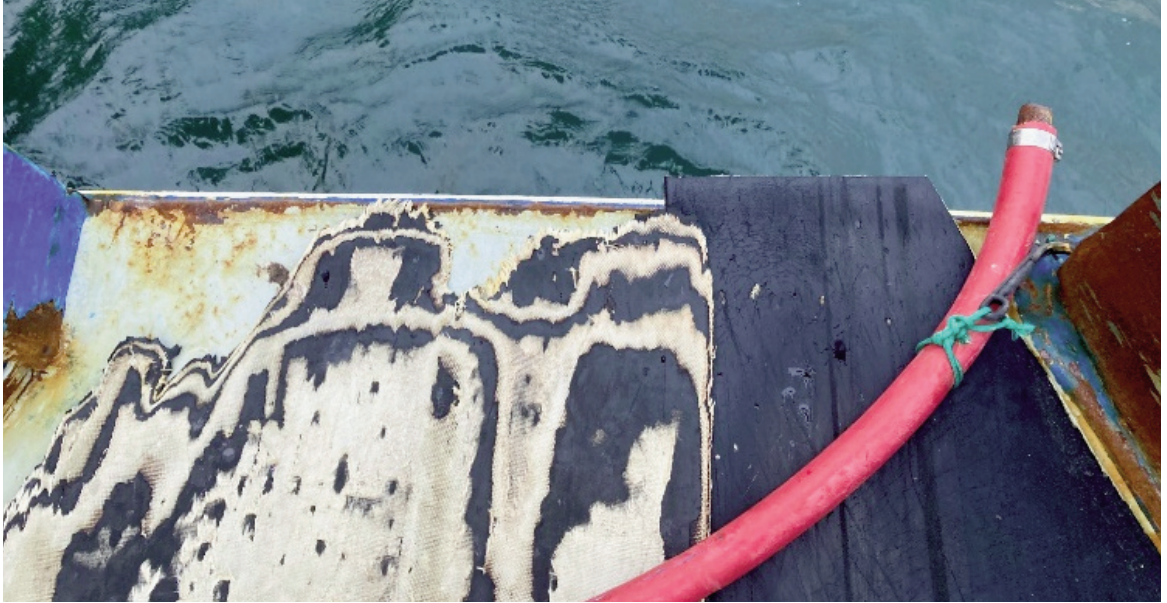
Photograph No.6: Deck edge at stern in way of stern door opening, the 90° edge chafed through the leader when the crew attempted to pull it back onboard.
