**REPORT OF AN INVESTIGATION  
INTO A MARINE CASUALTY  
INVOLVING A VESSEL  
IN OR AROUND  
BRUCKLESS PIER,  
DARNEY, CO. DONEGAL  
28 SEPTEMBER 2023**

**REPORT NO. MCIB/332  
(No.8 OF 2024)**

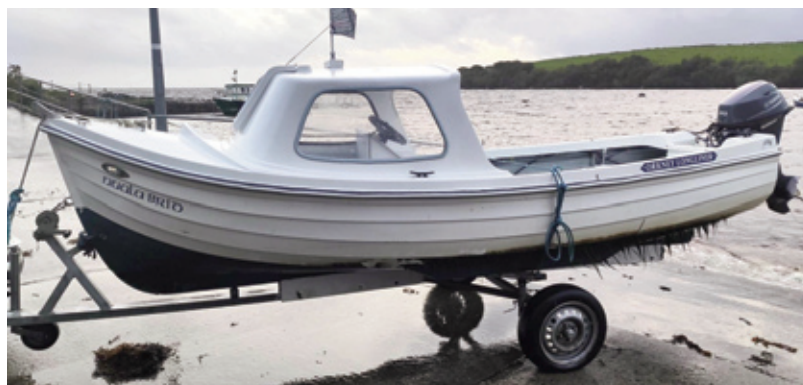
Figure 1: The Casualty's vessel, after being removed from the water on the evening of this marine casualty. Source: An Garda Síochána.

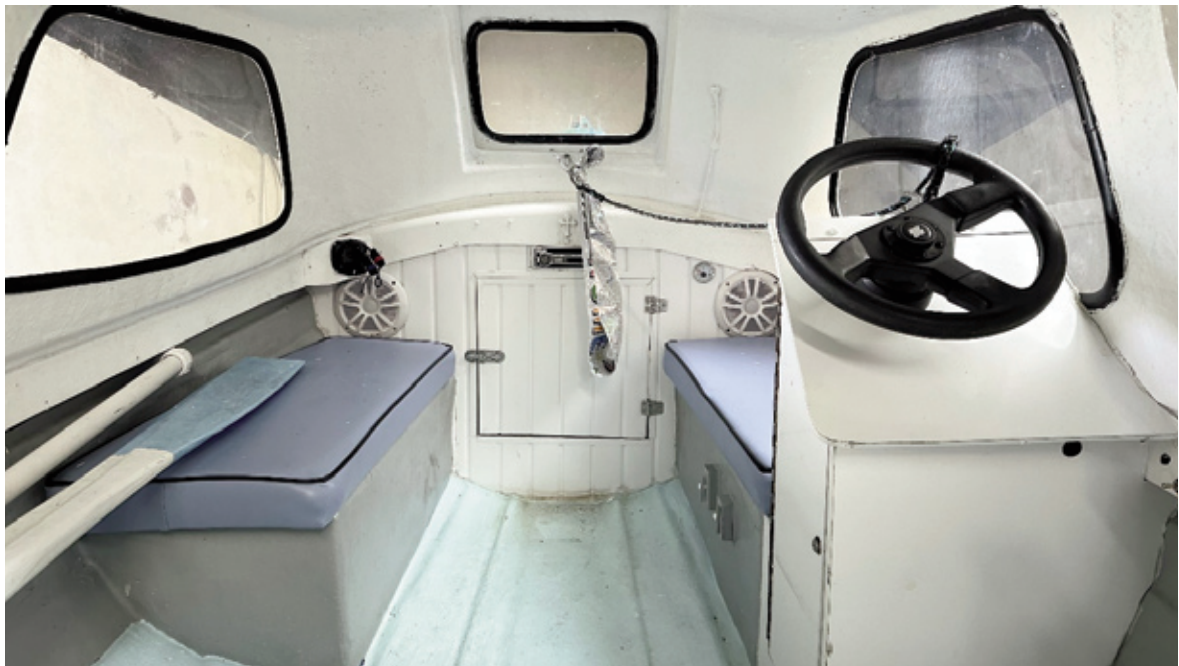
Figure 2: The interior of the Casualty's vessel, showing the forward cabin, foredeck compartment, and steering console.

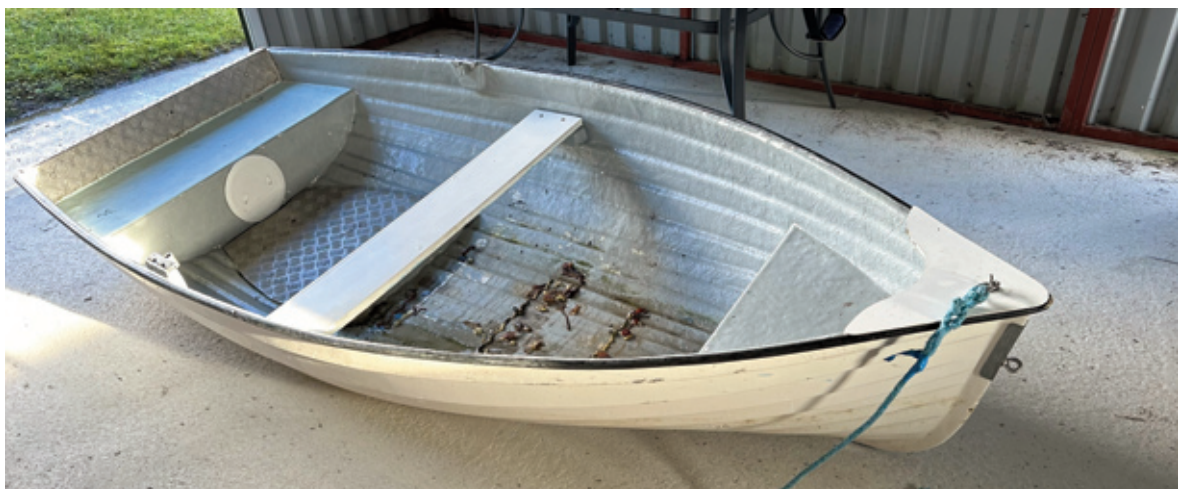
Figure 3: The dinghy tender that the Casualty had used to access the casualty vessel. Note: not shown is the battery-operated engine that was secured to the transom but was lost overboard in this incident.

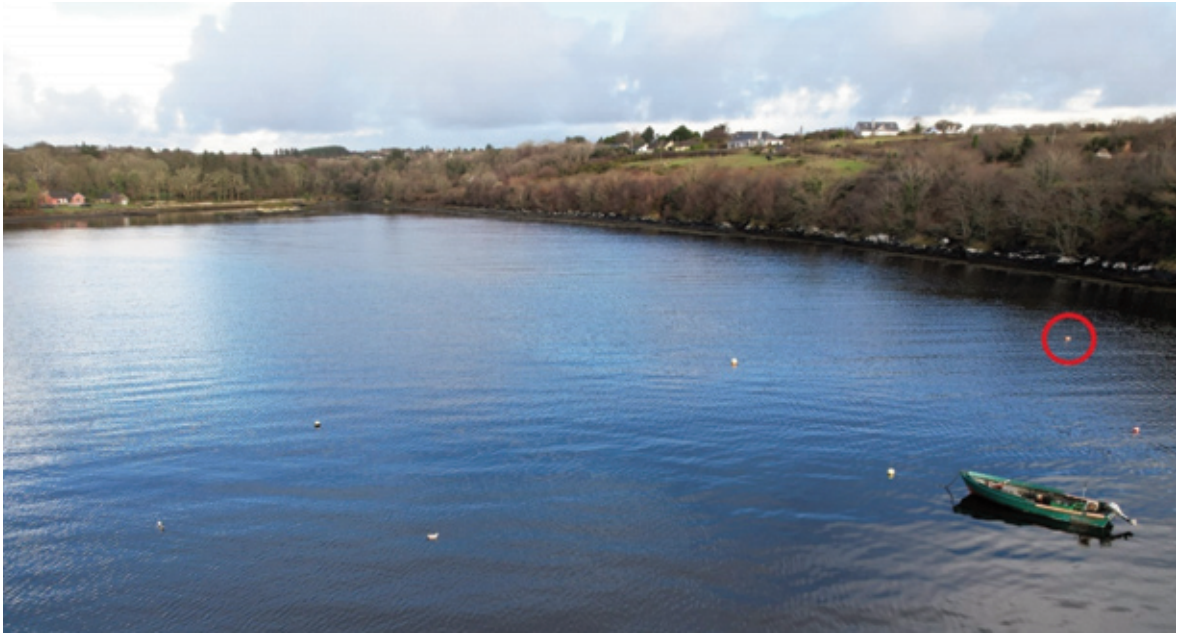
Figure 6: Bruckless Harbour, looking north, highlighting the position at which the Casualty's vessel was moored.

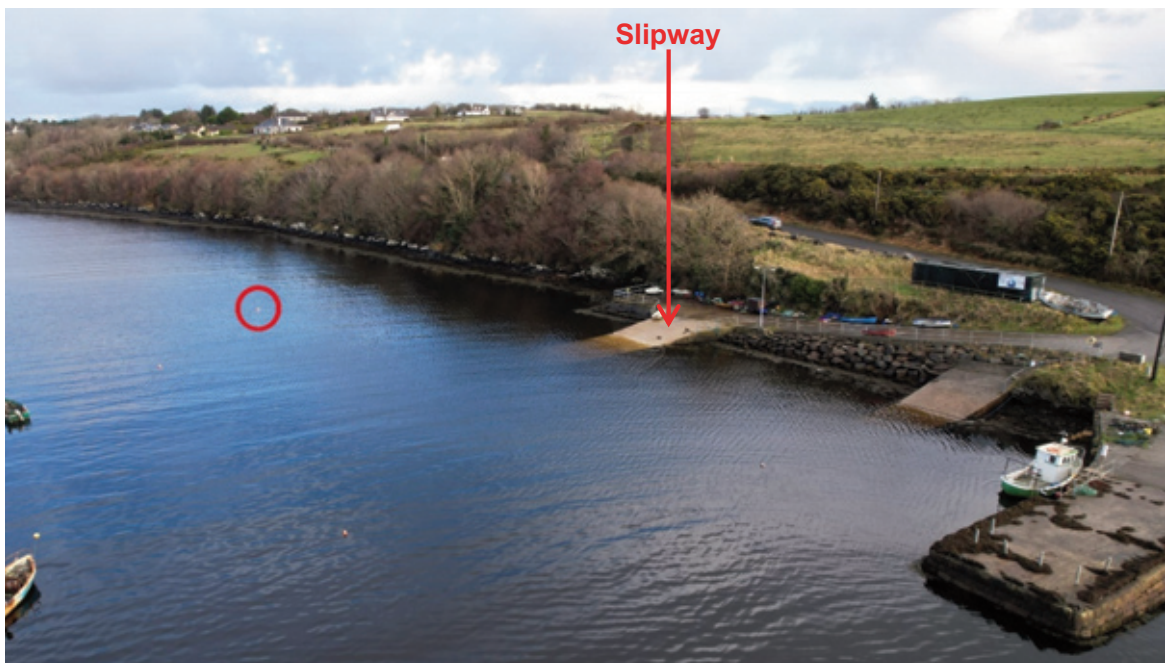
Figure 7: Bruckless Harbour, looking east, highlighting the position at which the Casualty's vessel was moored, and the slipway from which the Casualty had launched when going afloat.

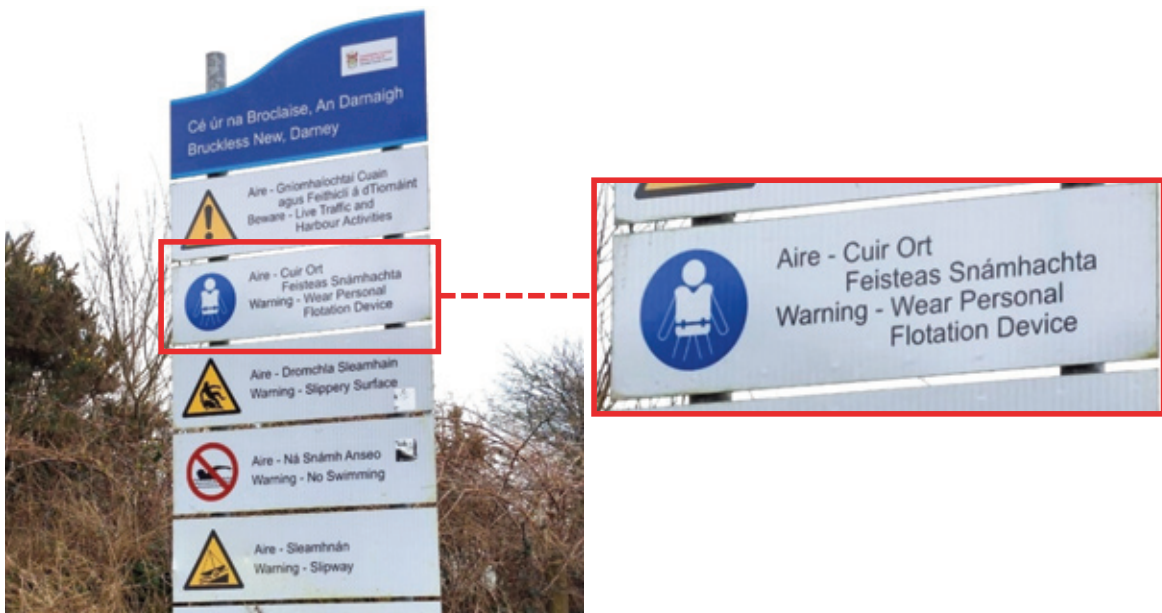
- 2.2.2 There was signage at the entrance to the pier from the public road, which was erected by Donegal County Council prior to this marine casualty (see Figure 9). The warnings on this signage included:

Figure 9: Signage at the entrance to Bruckless Pier.

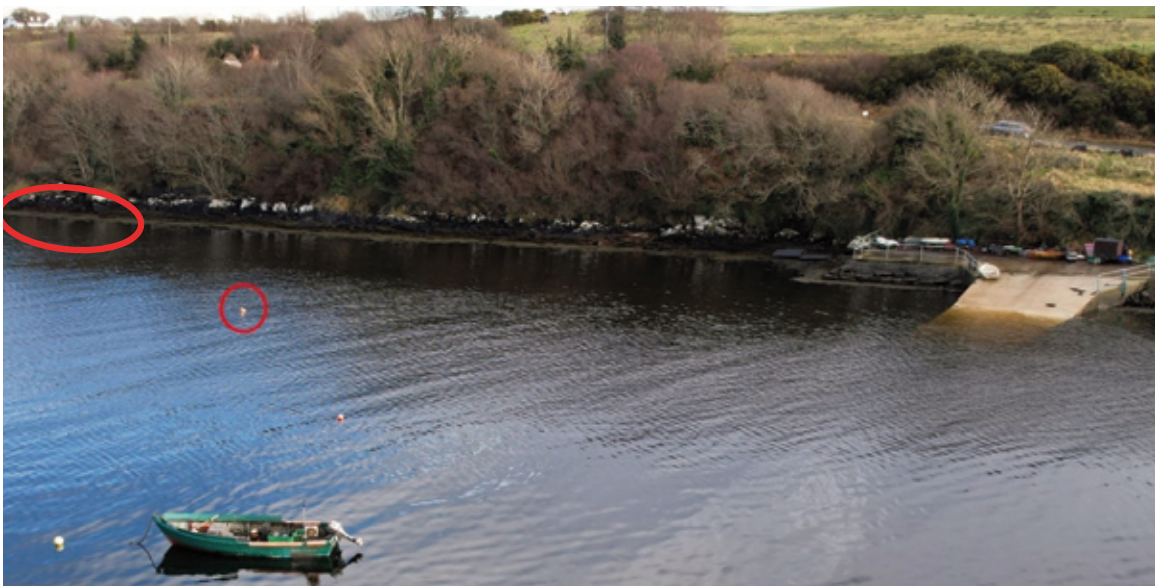
- 3.3.9 He untied the Casualty's motor boat from the mooring and then drove the motor boat to the shore to take onboard a person who had come to the pier to help. Together, they motored over to the Casualty's body in the water and retrieved him into the boat (see Figure 12). This was at approximately 17.00 hrs.

Figure 12: Bruckless Harbour, highlighting the approximate positions where the Casualty's vessel was moored and the Casualty was recovered from the water.

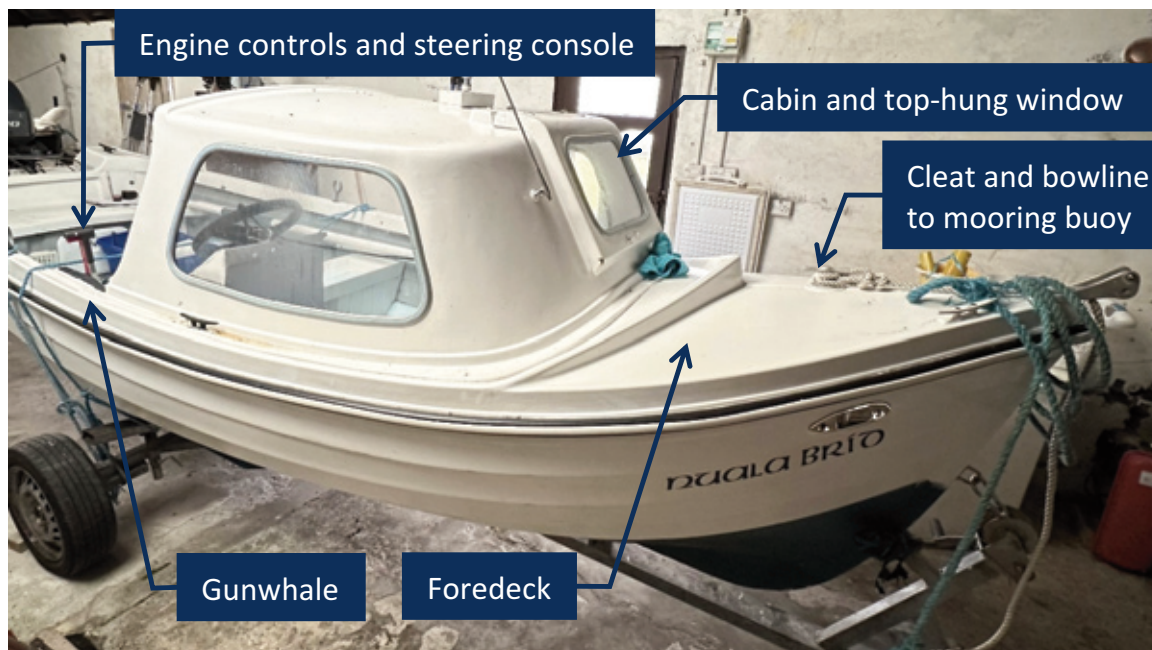
- 4.1.5 In its open-deck arrangement (without a forward cabin in place) there is unencumbered, direct access to the bowline from within this type of vessel. With the forward cabin in place on this vessel, access to the bowline first requires opening of the top-hung window, to reach for the bowline attached to a cleat out on the foredeck (see Figure 13). However, after this incident, the top-hung window was found to be locked, which indicates that the Casualty had not attempted to access the bowline in this standard manner. Alternatively, the Casualty may have attempted to use the vessel's boat hook to retrieve the bowline, which is likely to have required him to stand up and reach over the gunwhale to try and hook and then pull the bowline inboard.

- 4.1.6 Accessing the bowline through the top-hung window would have had less of an effect on the stability of either the vessel or the Casualty, than the somewhat awkward actions involved in standing up alongside the gunwhale and reaching over to hook and pull on the bowline, while taking account of wind and swell.

Figure 13: Overview of the main forward parts of the Casualty's vessel.

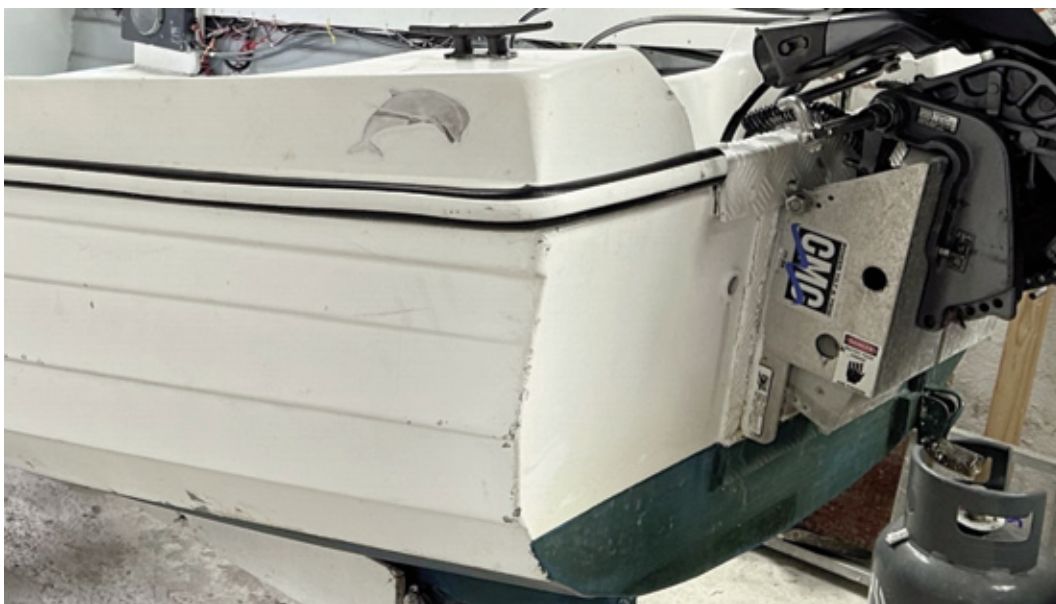
- 4.8.6 There were positions available on the transom of the Casualty's vessel and off the quarters that could have potentially facilitated the voluntary retrofitting of a fixed reboarding ladder (see Figure 14). Alternatively, there are multiple types of deployable emergency overboard ladders available commercially<sup>27</sup> that can be considered for retrofitting to a recreational vessel (see Figures 15 - 16).

Figure 14: Aft of the Casualty's motor boat, with space available for the potential retrofitting of a reboarding ladder or an emergency overboard ladder.

4.8.7 The MCIB's analysis indicates that the absence of a means of reboarding the vessel was a causal factor in this marine casualty event.
