**REPORT OF AN  
INVESTIGATION INTO  
A MARINE CASUALTY  
INVOLVING THE FISHING VESSEL  
ELLIE ADHAMH  
ON OR ABOUT THE  
26-28 MARCH 2021  
OFF THE COAST OF  
CO. CORK**

**REPORT NO. MCIB/308  
(No.9 OF 2024)**

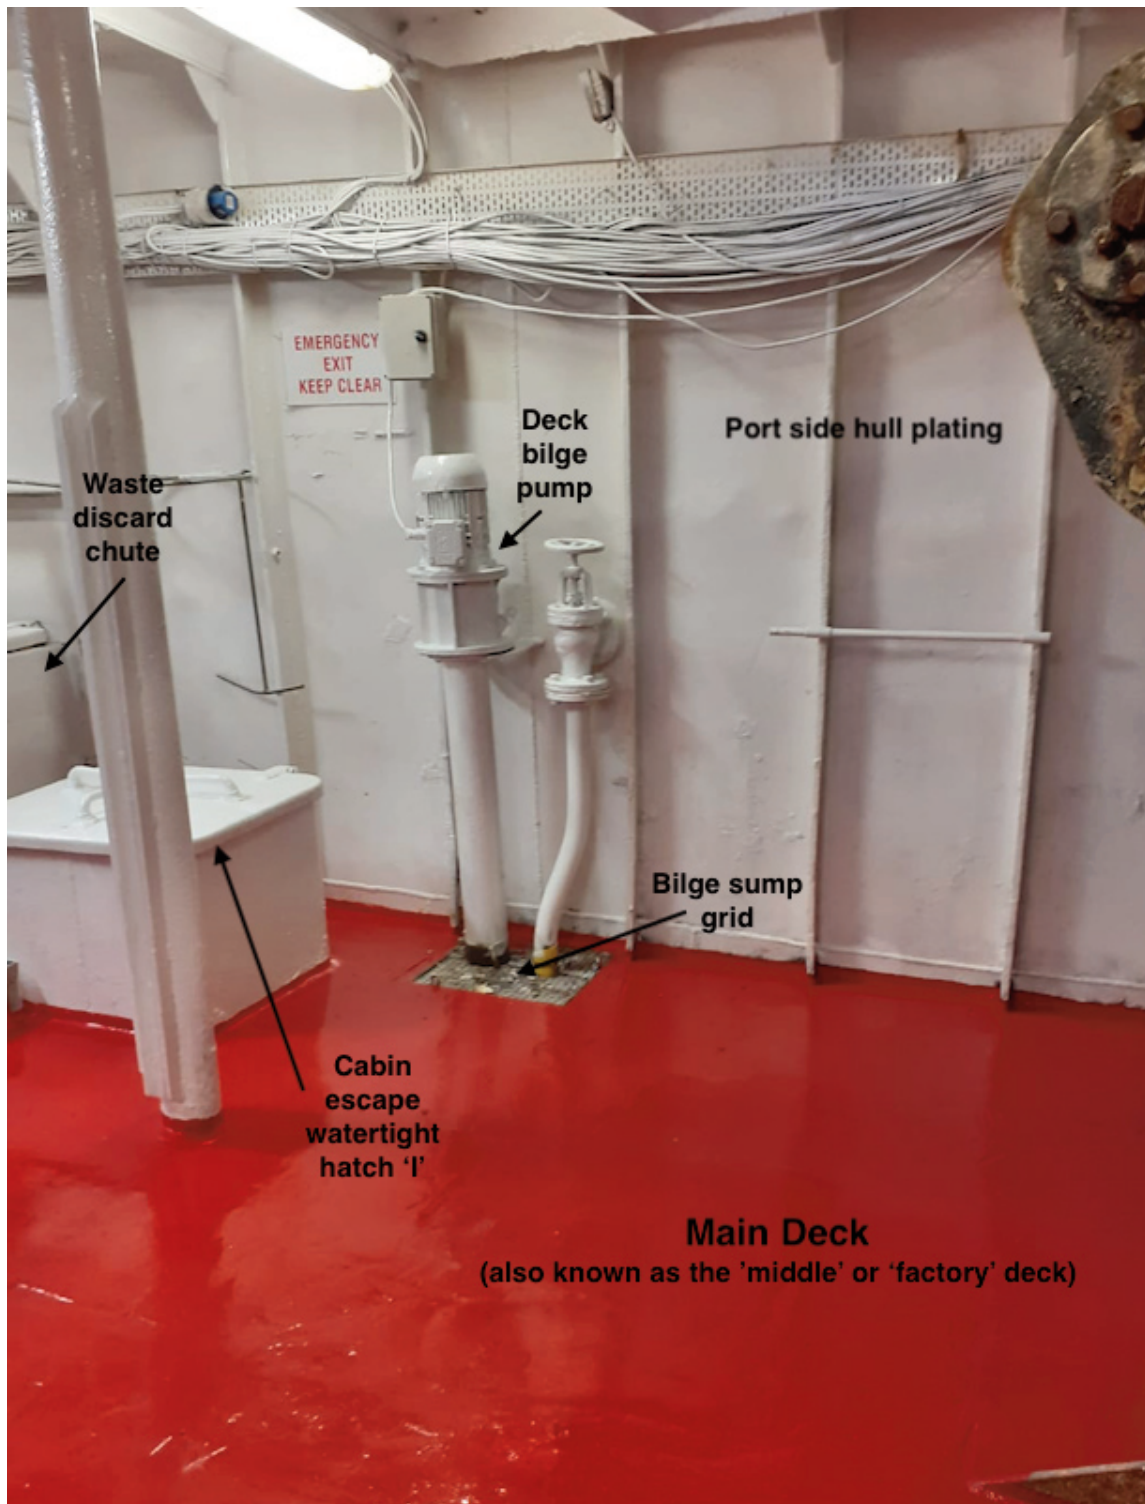
Appendix 7.5 Main Deck Cabin Escape Hatch Marked "I". Port Aft Deck Bilge Pump and Overboard Waste Discharge Chute (Photograph provided by Owner)

- 2.4.7 It was accepted by the Skipper and Owner that starting at some time during the trip there was a defect with the overboard waste discharge chute which proved to be a source of some of the water that ultimately flooded the vessel. The Skipper states that he only observed the water entering the factory deck via the missing bushing for the first time on Saturday 27 March 2021. The Owner stated

that the Skipper was not concerned by this level of ingress as it was of an insufficient amount. The flap on the outboard end of the chute was displaced as the bushing was missing. The Skipper stated that the leakage was similar to a garden hose. This missing bush meant that the flap was not positioned to provide any damping on the surging forces, induced by the vessel roll, on the secured waste chute cover so that the cover would experience higher loads than normal.
