**REPORT OF  
INVESTIGATION INTO  
THE LOSS OF A MAN  
OVERBOARD FROM  
THE YACHT “ALANA”  
AND HIS SUBSEQUENT DEATH  
OFF BRAY HEAD,  
CO. WICKLOW  
ON 14th SEPTEMBER 2008**

**REPORT No. MCIB/162**

Report MCIB/162 published by The Marine Casualty Investigation Board  
on 9th December 2009.

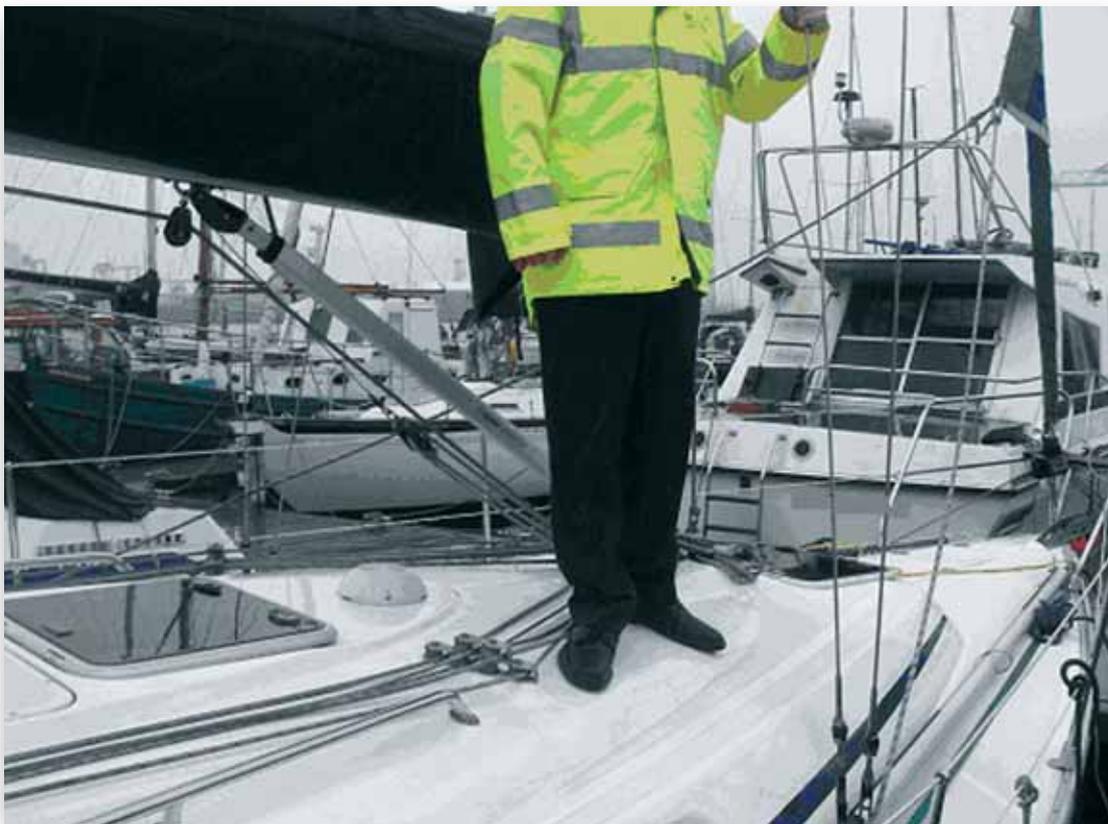
Figure 1 Approx. position of casualty prior to incident from starboard side.

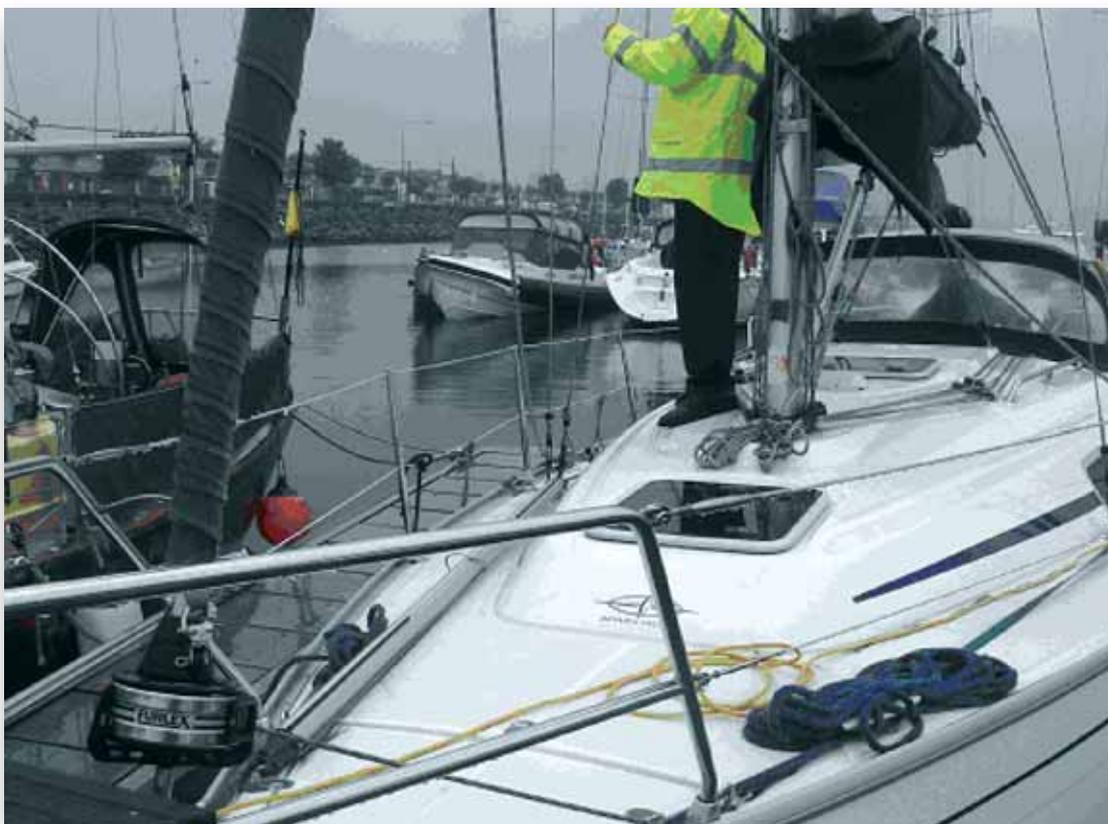
Figure 2 Approx. position of casualty prior to incident from port side.

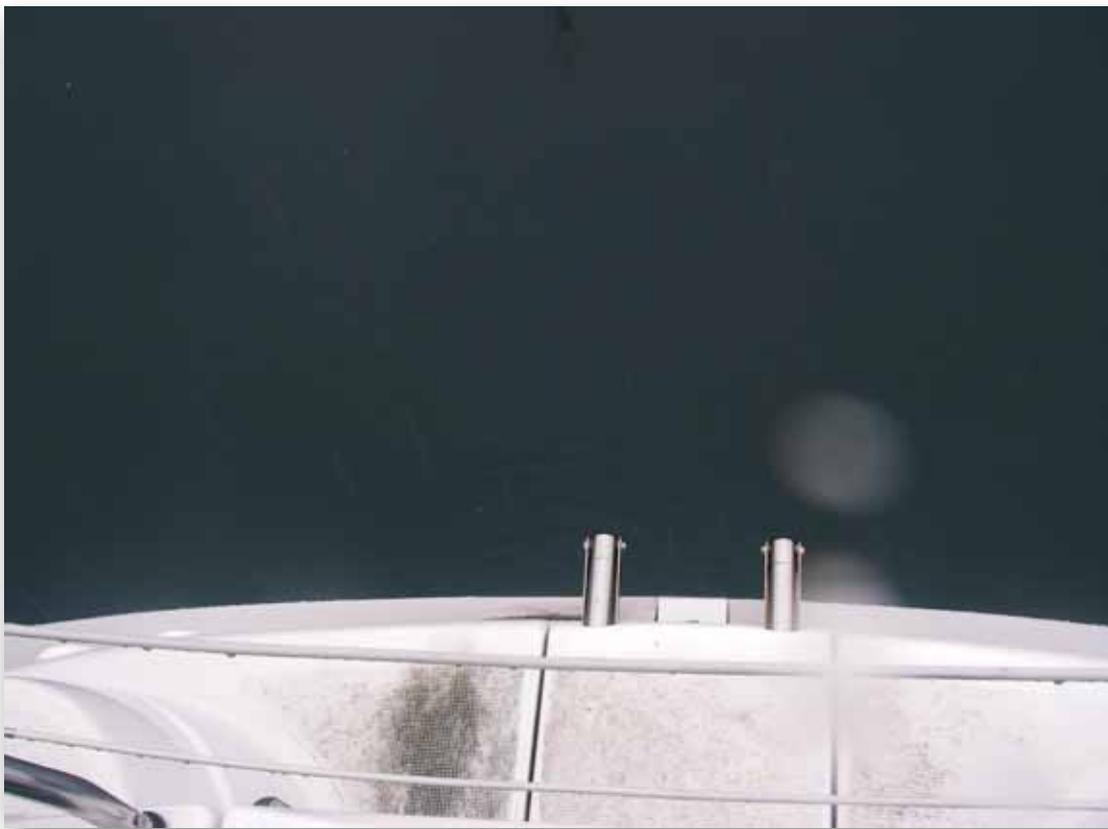
Figure 5 Extendible ladder on stern.

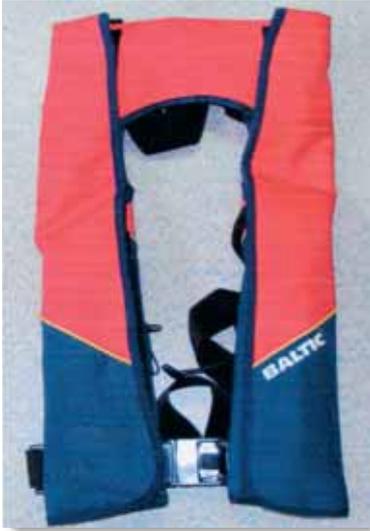
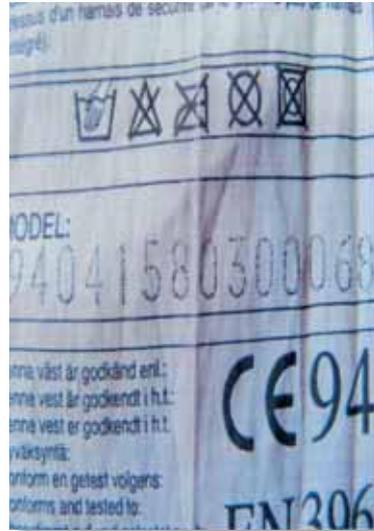
The serial number (Photos 1+2) indicate that it was manufactured in April 1994. There are no marking or other indication on the jacket to show that service had been carried out on the lifejacket since its manufacture. The manufacturer recommends that this type of jacket is serviced annually.

FROM MY RECOLLECTIONS, THE JACKET  
MR JONES WAS WEARING WAS MOSTLY  
BLUE, AND NOT MOSTLY RED AS  
SHOWN IN PHOTO 1.

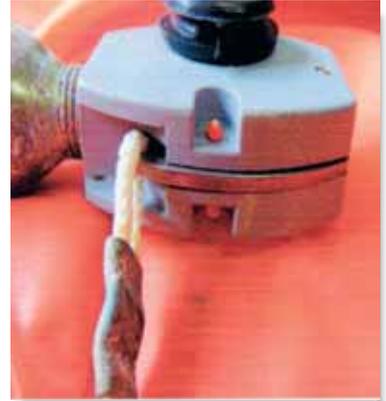
Photo 3

1. The cap was securely in place on the oral inflation tube.
2. The securing pin was in place for the manual inflation toggle (Photo 3) indicating that the toggle had not been operated.
3. The seal on the Co2 bottle was intact (Photo 4) indicating that it was unused. The bottle was badly corroded (Photo 5 + 6). However, it still weighted approx 134gms, which would be sufficient to inflate the lifejacket to a useable level.
4. The gaskets fitted in the unit were very badly worn due to age (e.g. lower gasket Photo 7).
5. The securing belt for the jacket had been cut.

The lifejacket was fitted with a new toggle clip and otherwise returned to its original condition.

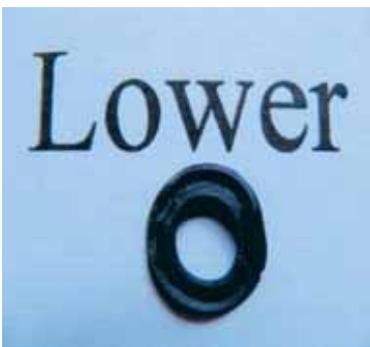
Photo 7

It is possible that the performance of the lifejacket would have been reduced due to possible Co2 leaks through badly worn gaskets and less than maximum Co2 volume being available in the bottle due to its corrosion.
