**REPORT OF AN
INVESTIGATION INTO
A MARINE CASUALTY
INVOLVING
THE FISHING VESSEL
BEN THOMAS
IN OR AROUND
DUNDALK BAY, CO. LOUTH
ON OR ABOUT THE
12 DECEMBER 2023**

**REPORT NO. MCIB/333
(No.7 OF 2025)**

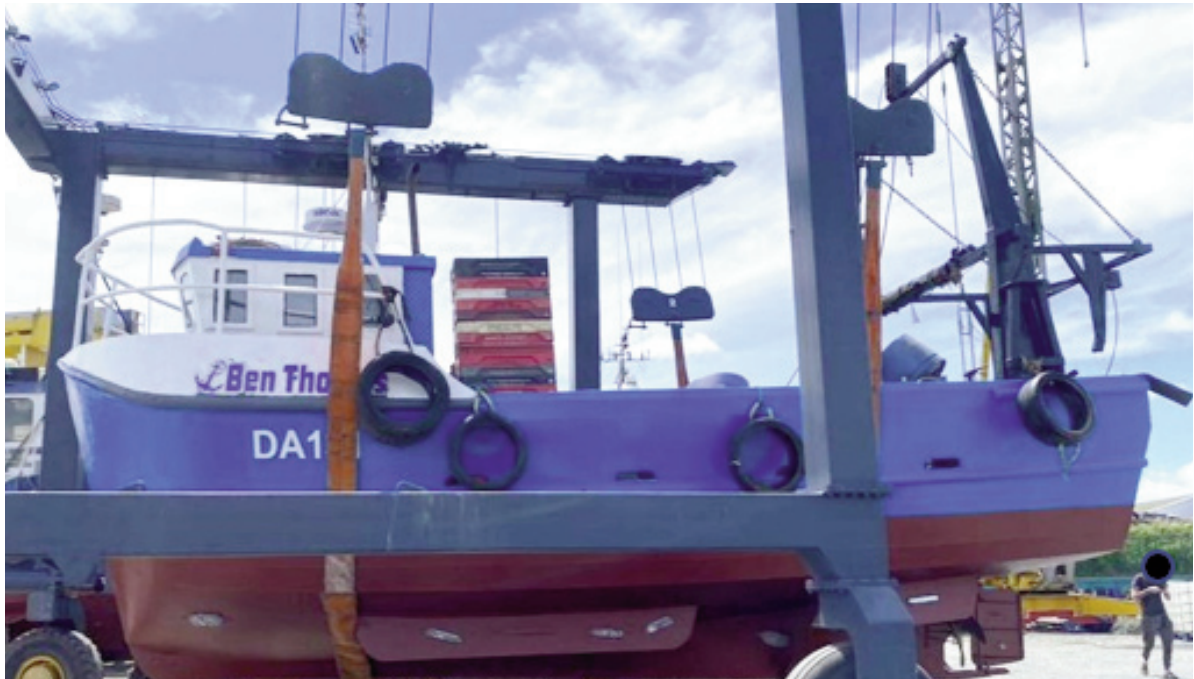
Figure 1: FV Ben Thomas (image supplied by the vessel's owner).

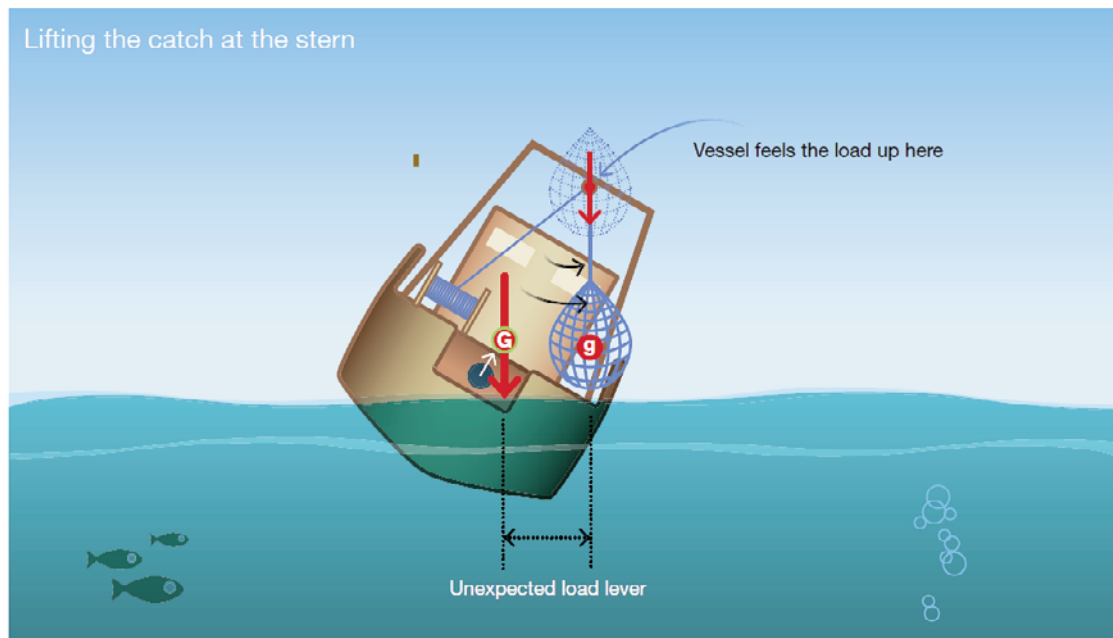
The weight of the catch at the height of the deck has a big enough impact, but when it is lifted by blocks the centre of gravity of the catch shifts, partly or fully up to that height.

Figure 7: The effects on a vessel's stability of a load lifted at a height.²⁴

- 4.1.4 When a load is being lifted, its centre of gravity is at the point of suspension, not at the load itself. This creates a hazard for a vessel, as the height and magnitude of the suspended load will affect the vessel's centre of gravity. A load that can swing is an additional hazard. When a vessel heels, the suspended load can swing outwards in the direction of the heel and then pull the vessel further over to that side. Other external forces can add to the risk of capsize, such as unsecured onboard load or liquids onboard as they transfer towards the lower side of the vessel. As a result, the stability of a small fishing vessel is constantly changing during a voyage, because of the dynamic nature of the vessel's movement, changes in weather, changes in the vessel's loading, and changes in the operations onboard.

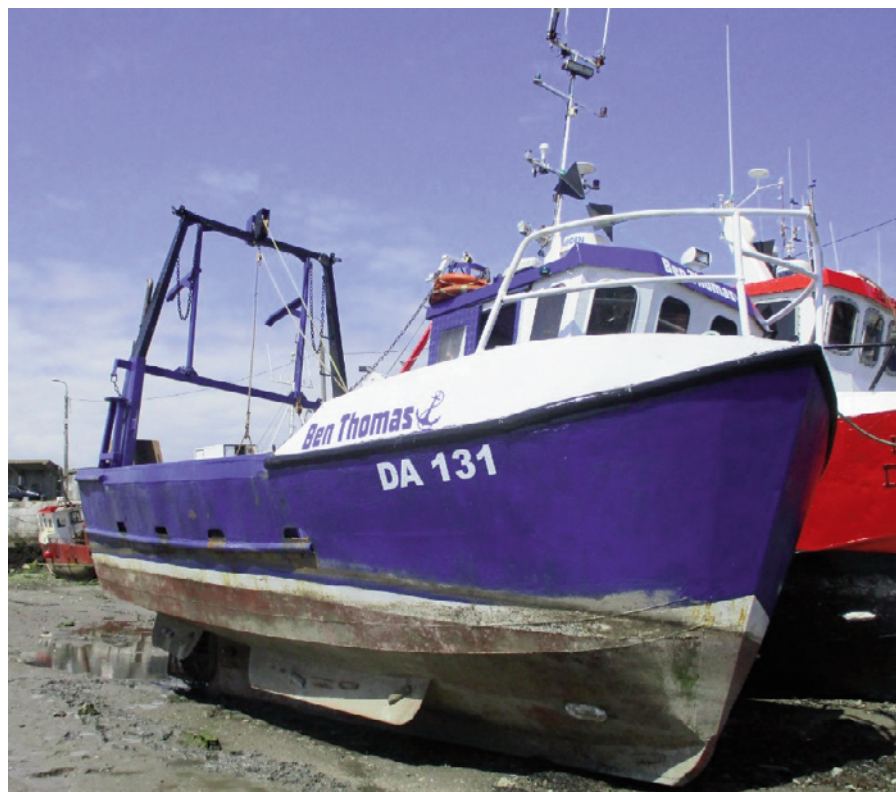
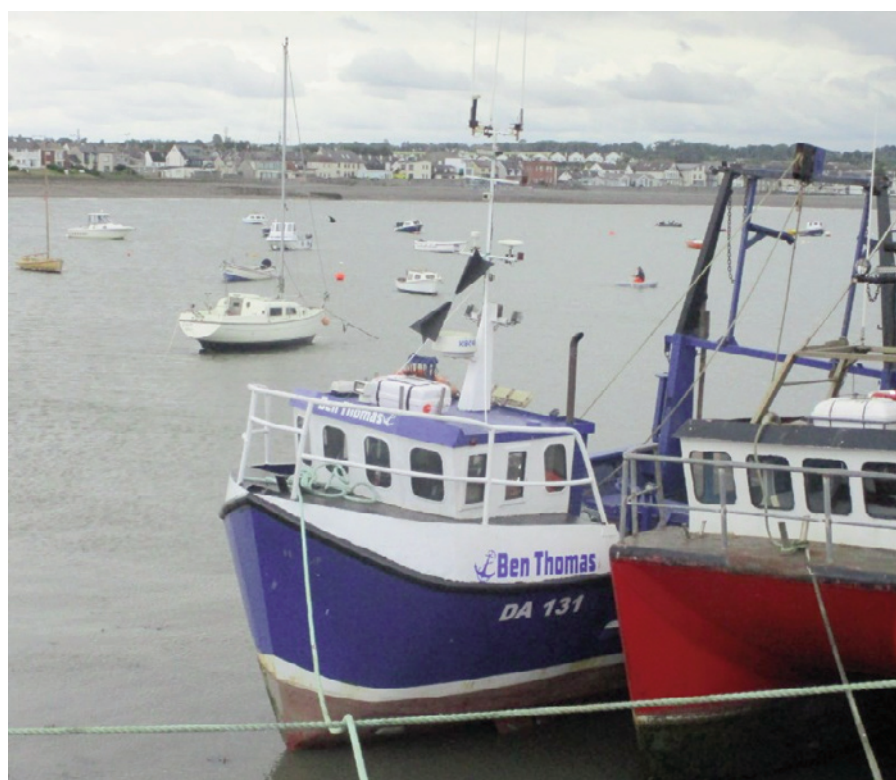
Appendix 7.2 Vessel Code of Practice Survey - Addendum

Note: The vessel is not afloat. The stern, where the dredge cage would be, cannot be seen.

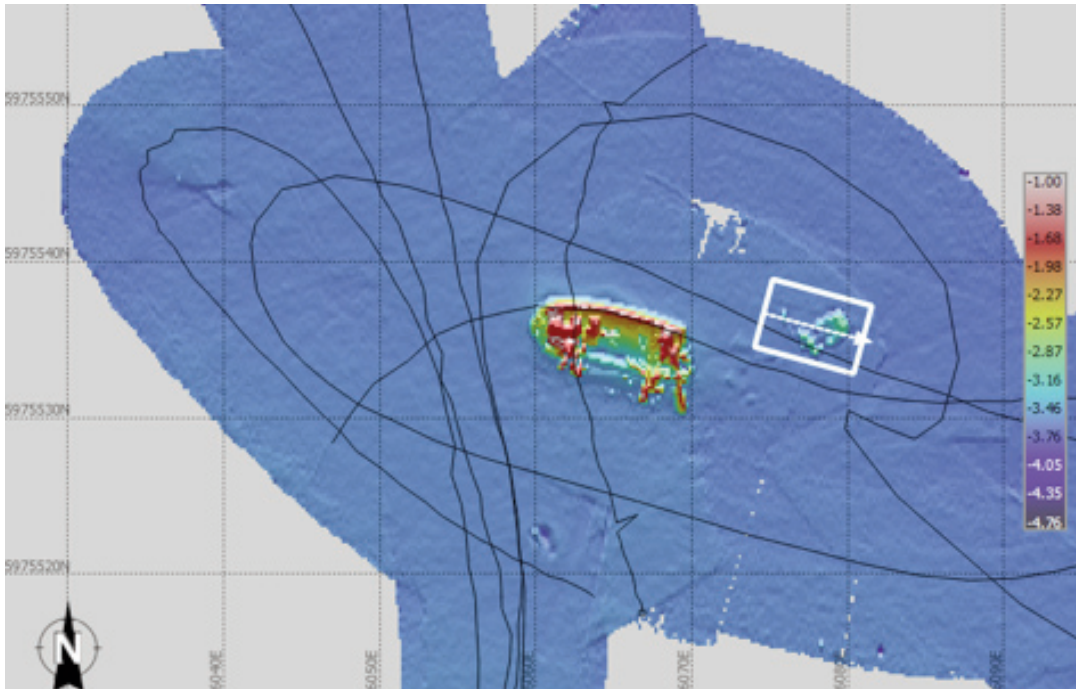
A frame that holds dredging equipment is still intact and appears in good condition. Dredge cage was found approx. 6-8 metres astern of vessel and still connected via towing wire.

Location of the vessel and cage on 12 December 2023, showing the cage in close proximity to the vessel. Image supplied by SEP Hydrographic.

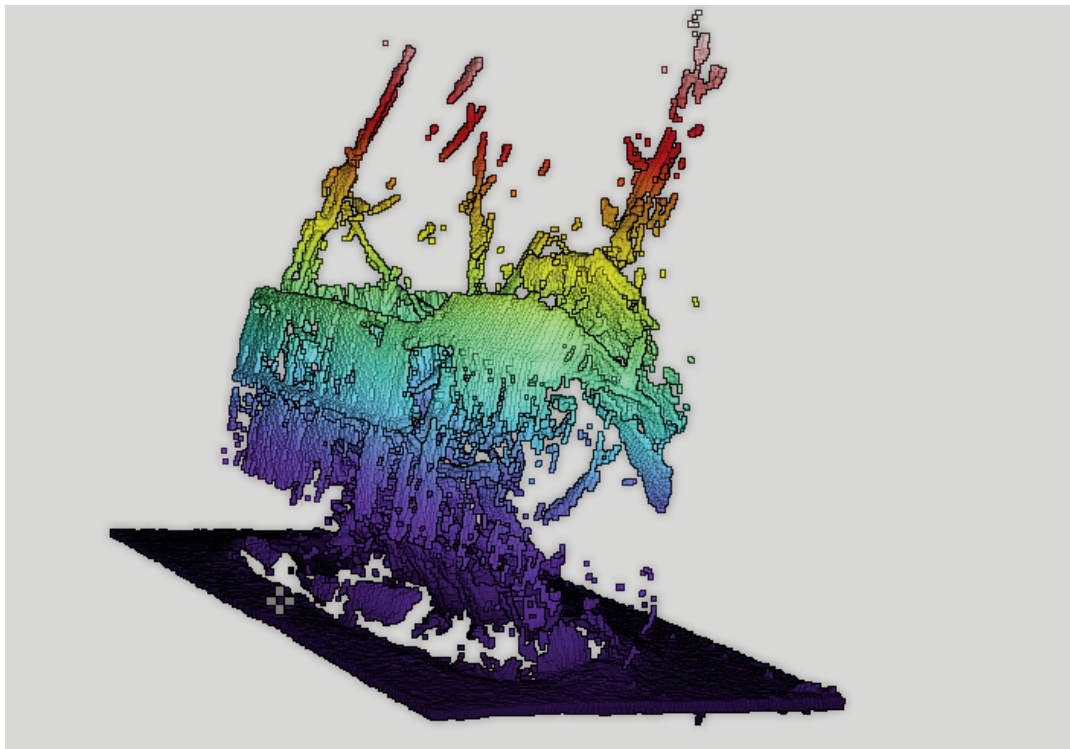
Diver conducted a full Hull survey of vessel. All Hull plating on visible sides are intact and in good condition with no signs of damage found. Port side of vessel was not visible as it is lying along the seabed.

Sonar side-scan of part of the FV Ben Thomas, showing the vessel upright on its port side. Image supplied by SEP Hydrographic.
