**REPORT OF INVESTIGATION
INTO COLLISION OF
“CAMLIN STAR” WITH
CARRICK CRAFT JETTY
AT BANAGHER, CO. OFFALY
ON 9th APRIL 2007**

REPORT No. MCIB/142

Report MCIB/142 published by The Marine Casualty Investigation Board
5th November 2009

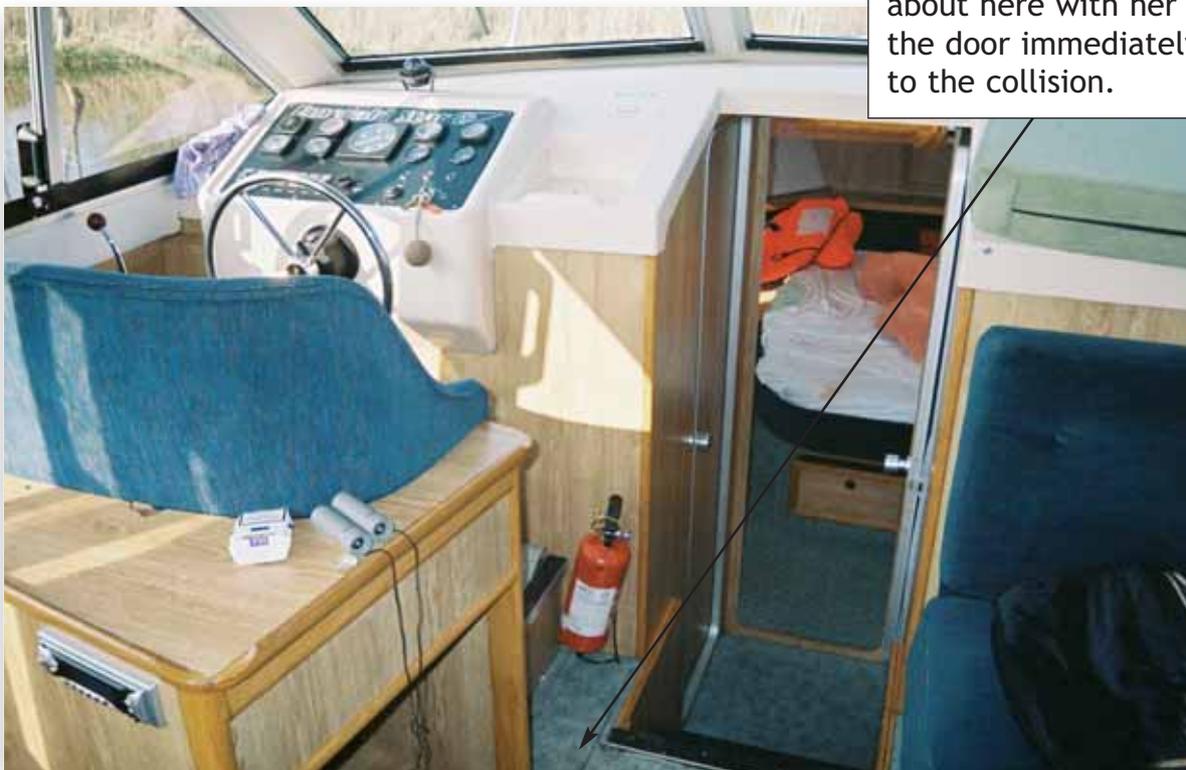
- 3.7 At the moment of impact Ms. Ciara O'Donnell was standing at the top of the steps, facing aft in the cabin and was thrown backwards, landing on her back having fallen into the forward cabin. (see photo indicating approximate position of Ms. O'Donnell at the time of the incident).

Ms. O'Donnell was standing about here with her back to the door immediately prior to the collision.

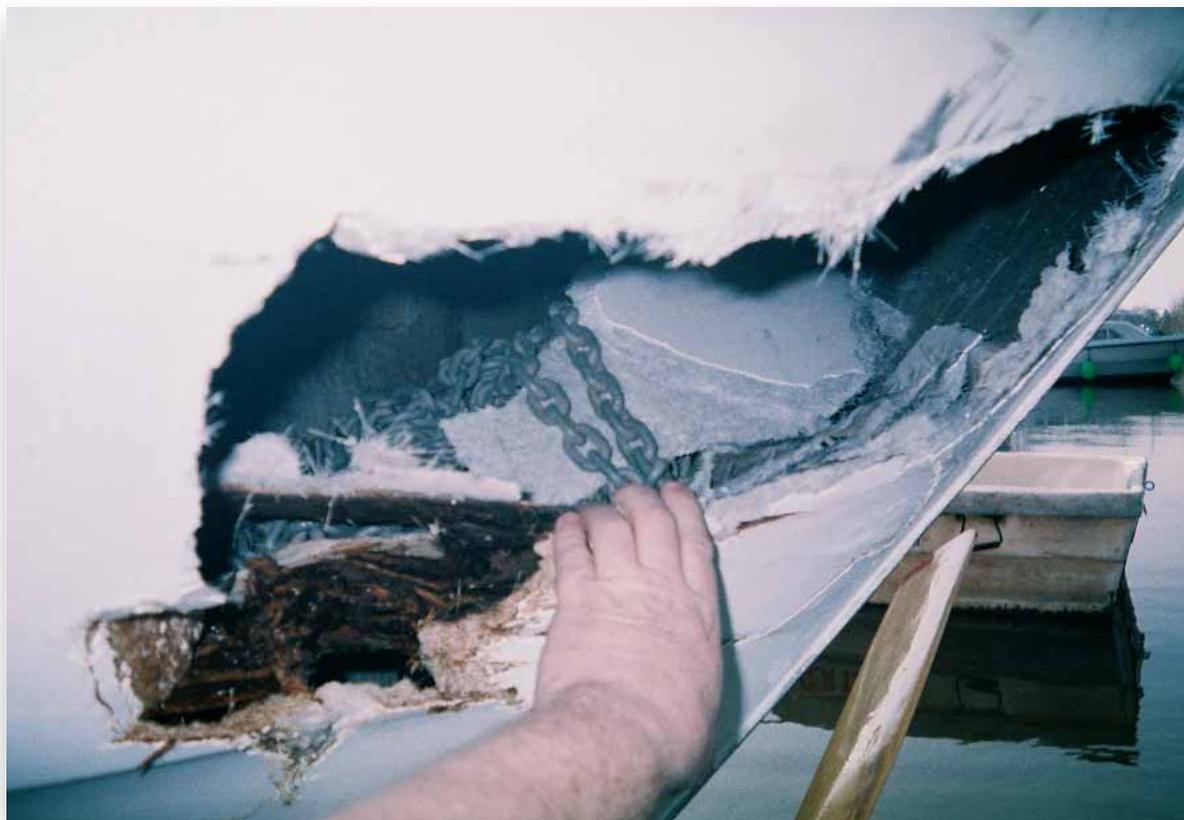
- 3.8 The vessel was holed on the starboard bow above the waterline (see photo) but did not take on much water and no pollution was caused.

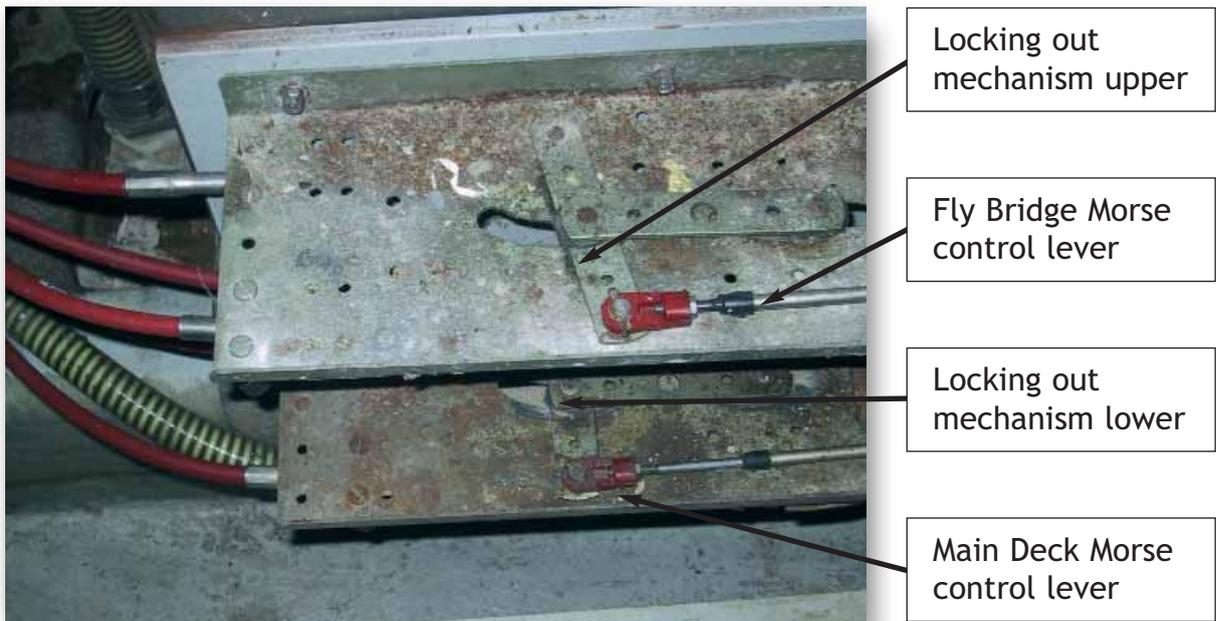
Figure 1 Change-Over Mechanism

Change-Over Mechanism from upper deck to lower deck, which is situated below lower deck level was visually tested under operation. All linkages were suitably lubricated and in good working order.

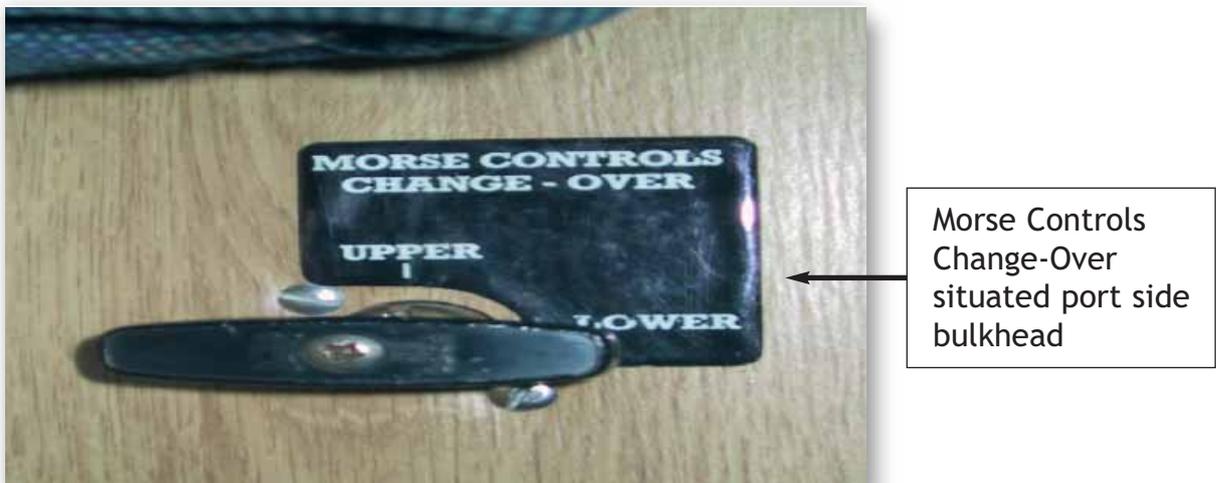
Figure 2 Morse Controls Change-Over

The Morse Controls Change-Over, which is situated under the main deck consol seat, outboard side was tested and operated satisfactorily. The selector switch was tested and operated satisfactorily.

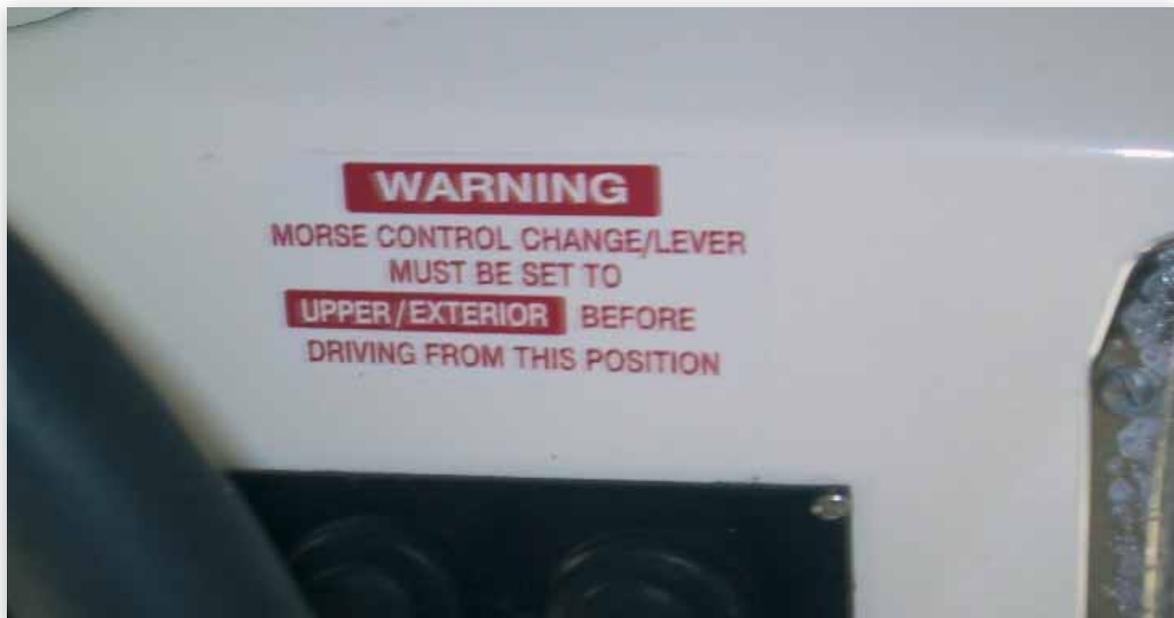
Figure 3 Upper Deck Helm Warning

Explicit instruction situated forward of the steering helm with respect to change-over control.

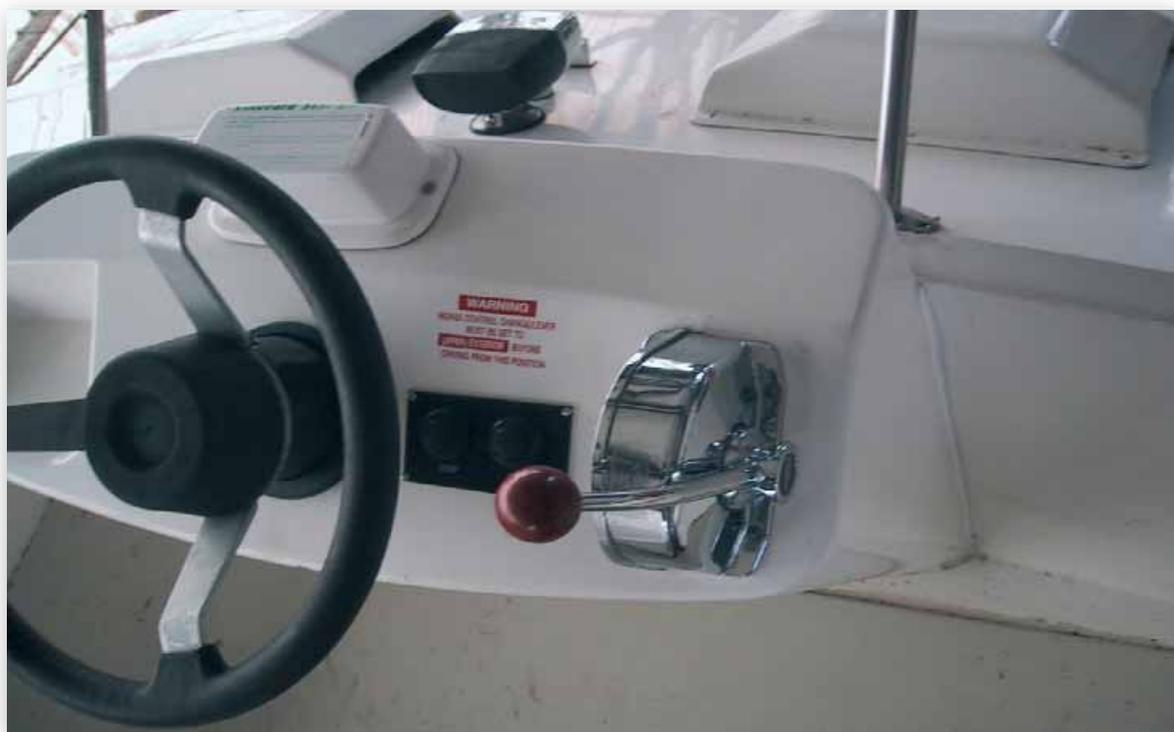
Figure 4 Upper Deck Helm Controls

Upper Deck Helm position showing the size of sign in context with the surrounding instrumentation and control systems.

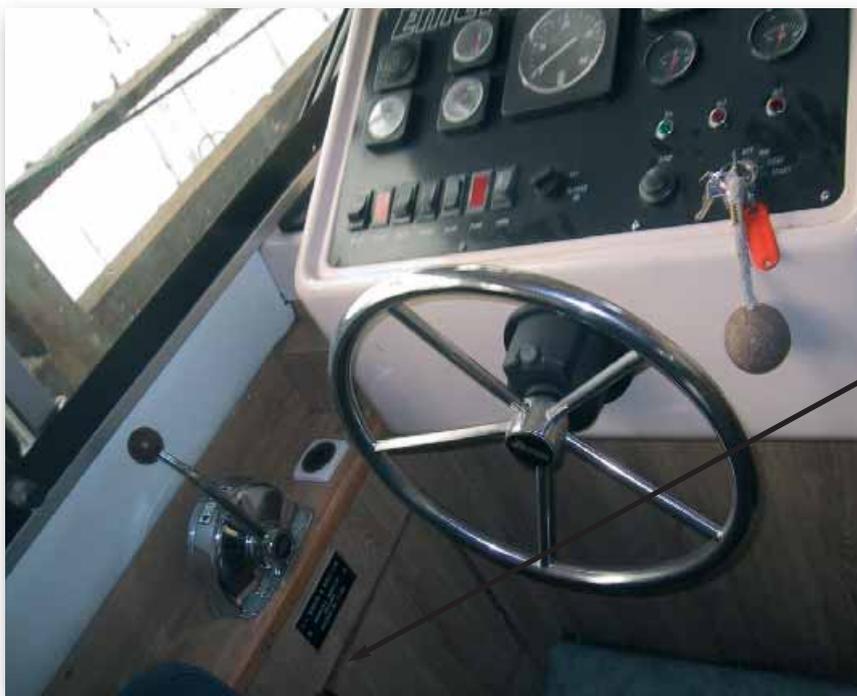
Figure 5 Main Deck Helm Controls

Location of change-over control at the main deck helm console.
