**REPORT OF AN
INVESTIGATION INTO A
MARINE CASUALTY INVOLVING
A VESSEL IN OR AROUND
CARRICK-ON-SHANNON MARINA,
CO. LEITRIM
ON OR ABOUT
7 AUGUST 2023**

**REPORT NO. MCIB/331
(No.3 OF 2025)**

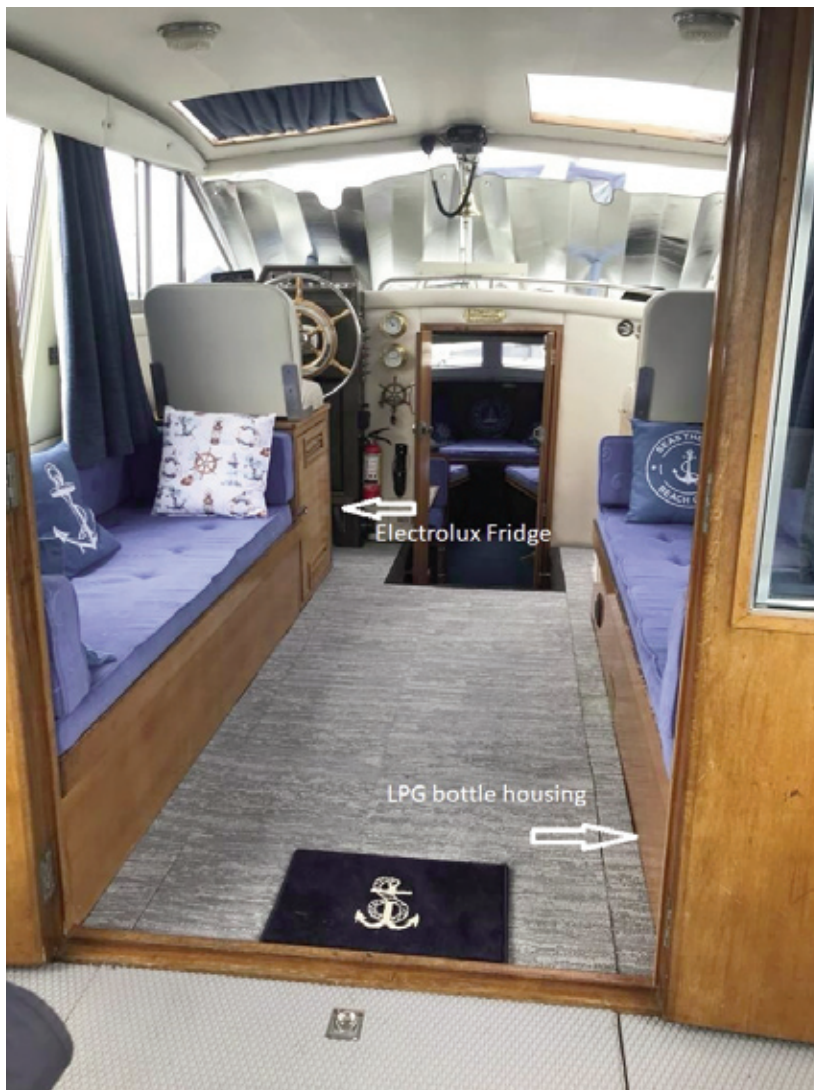
Photograph No.1: The interior of DollFinn looking forward showing the position of the fridge and the storage location of the LPG cylinders.

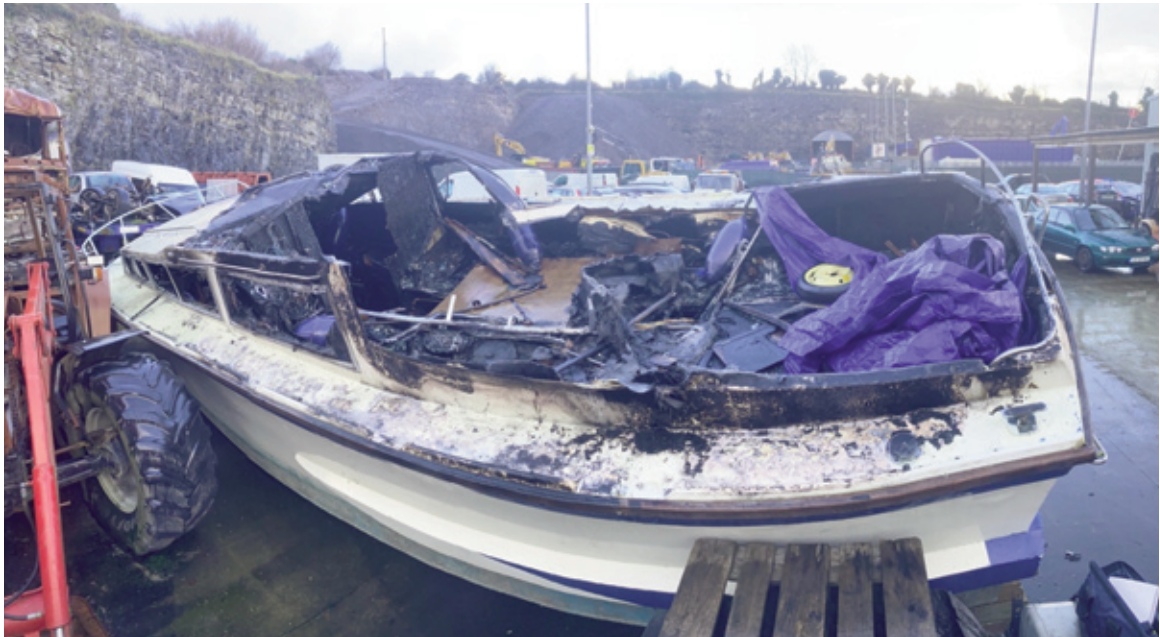
Photograph No.3: The remains of DollFinn clearly showing the extensive fire damage to the after section of the vessel.

- 5.2 The MCIB inspection of the vessel concurs with the conclusion that the fire started in the after section of the vessel and spread forward to the main accommodation and sleeping area. This is consistent with the burn pattern and smoke damage observed on the vessel.

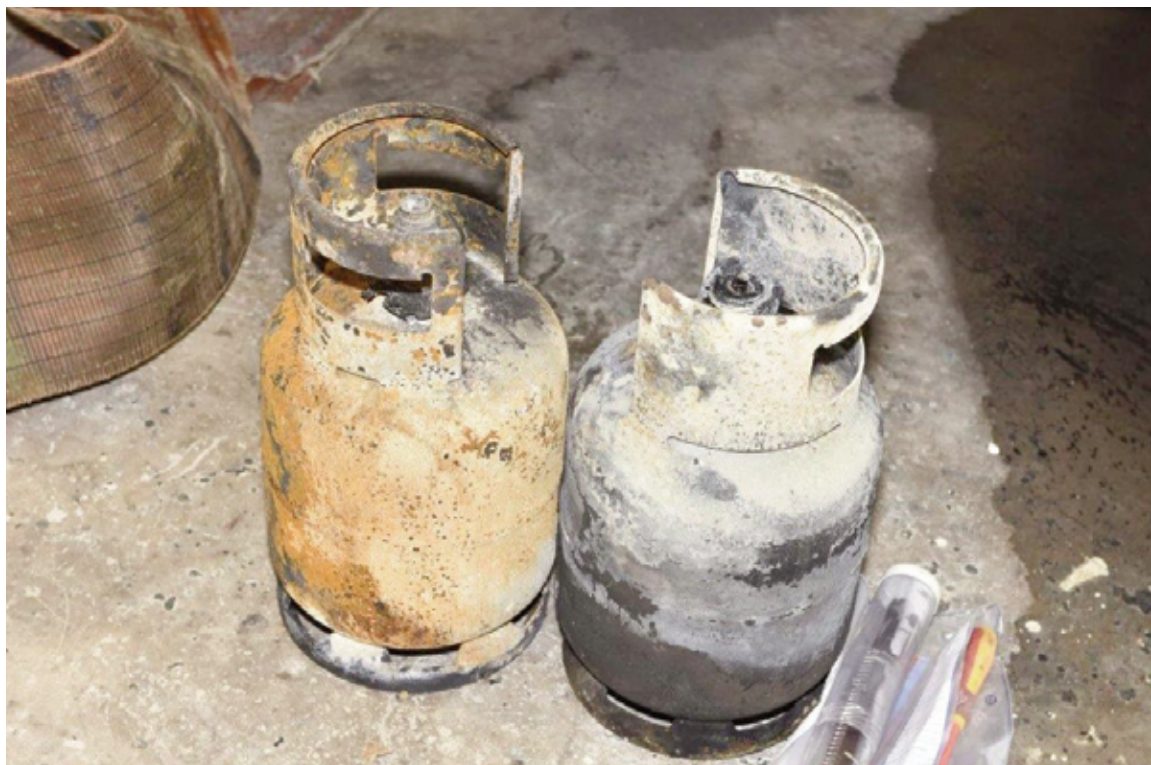
I believe was batteries used for domestic use". The MCIB investigation of the vessel after the fire, noted a number of intact LPG cylinders in the boat. The MCIB investigator believes that given the evidence presented that the LPG cylinders onboard DollFinn were not the source of the "larger" explosion heard and agrees with the witness's assessment that it may have been the batteries. As can be seen in Photograph No.4, the LPG cylinders were found intact by AGS.

Photograph No.4: The LPG cylinders from DollFinn.

- 4.11.6 A statement made by a sub-officer of the Carrick-on-Shannon Fire Station to the AGS confirmed that the fire fighters removed the intact LPG cylinders from the vessel when fighting the fire.

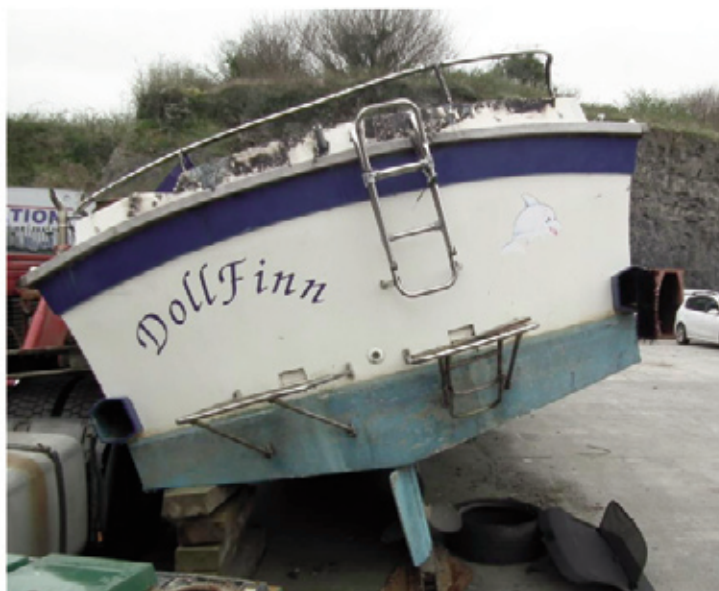
Photo 1 showing a view of the vessel from the stern.

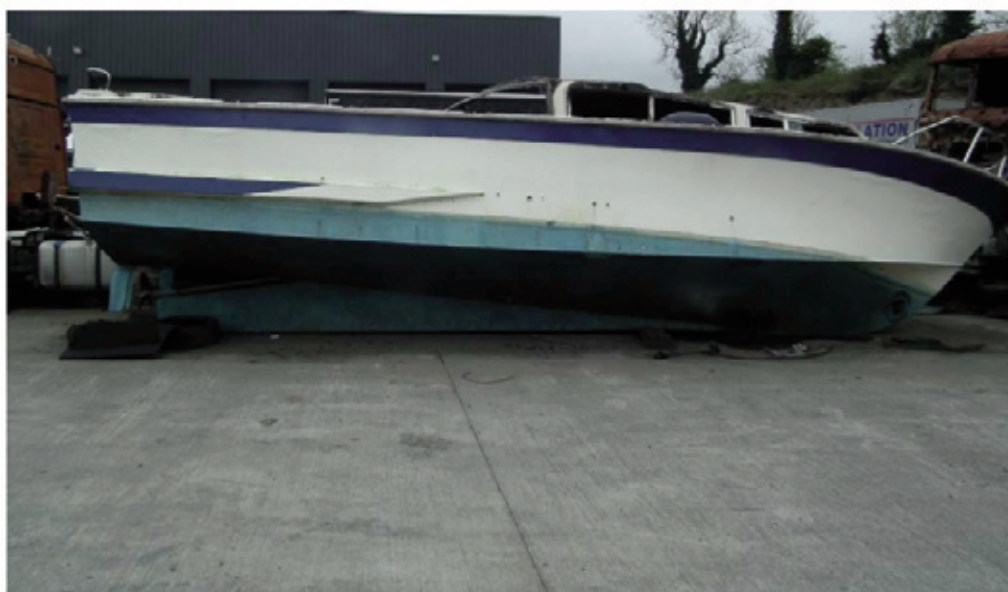
Photo 2 showing a view from starboard of the vessel.

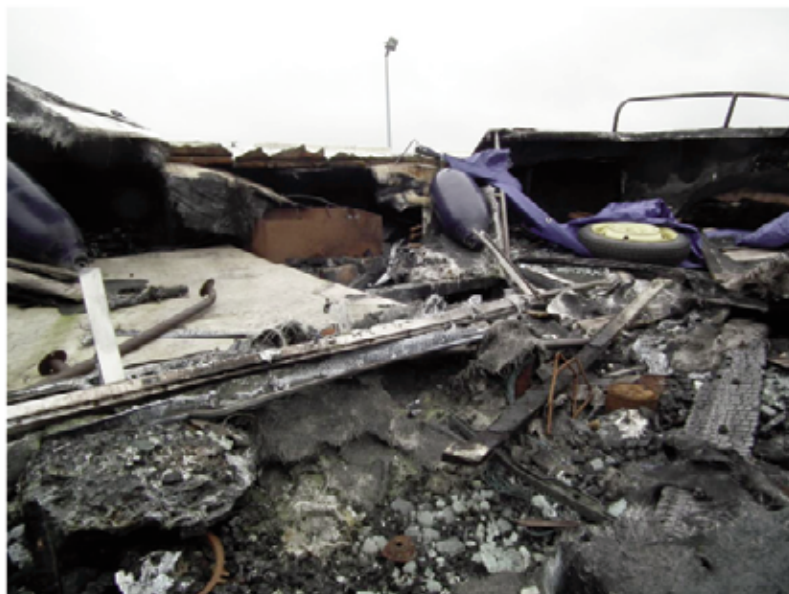
- The source of the fire located close to the deck;
- The fire consumed the timber and plastic materials which were part of the after deck of the boat;
- A fire in a confined area such as the well of the boat along the after deck would not be able to access sufficient oxygen to completely burn either the timber or, more particularly, the plastic;

Photo 3 showing a view of the well of the boat looking sternwards.

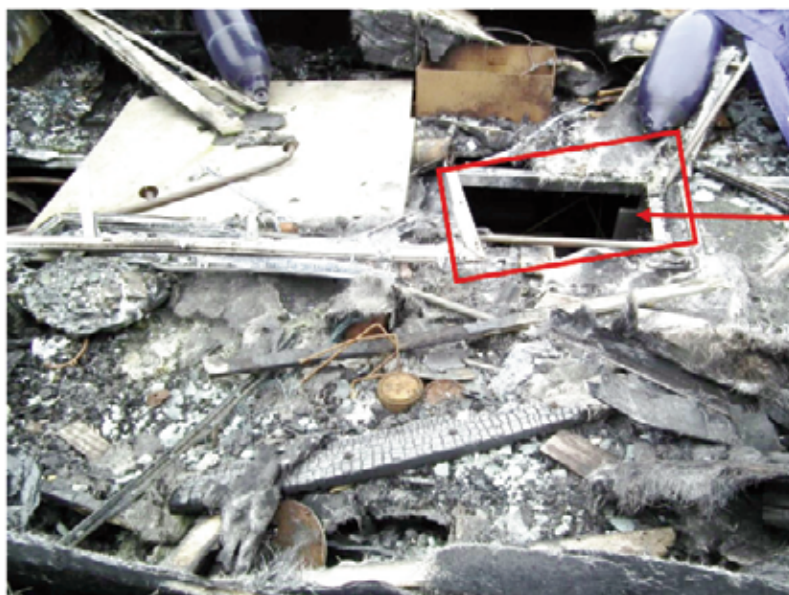
Hatch to
engine
compartment.

Photo 4 showing the hatch to the engine compartment.

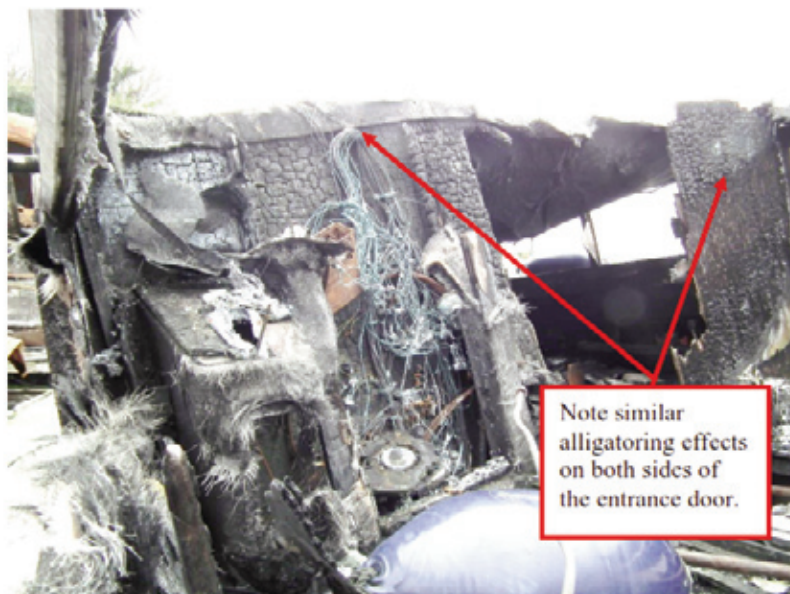
- The fire attacked the refrigerator from the left-hand side (or stern of the boat);
- As the fire progressed, it would attack the upright timber walls of the cabin, resulting in both walls exhibiting the same pattern of damage;

Photo 5 showing a view of the outside of the upright timber walls of the cabin.

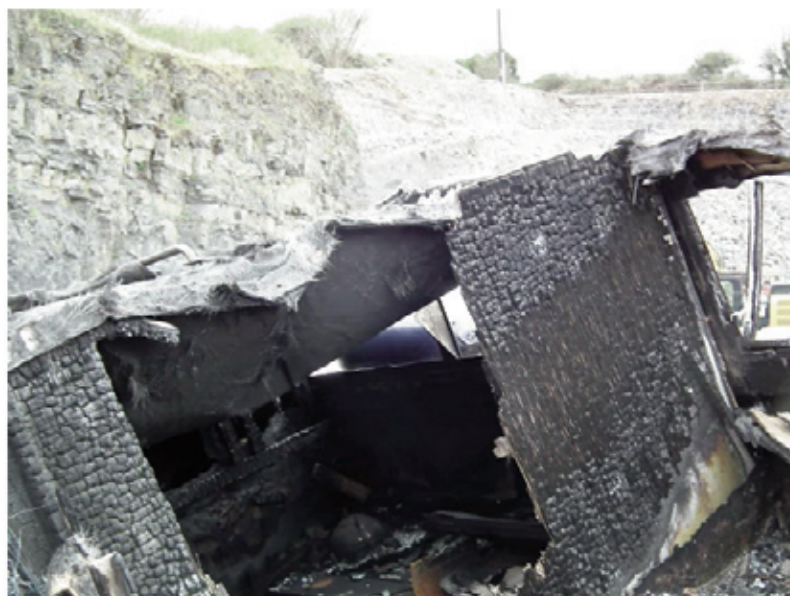
Photo 6 showing an alternative view of the outside of the walls of the cabin.

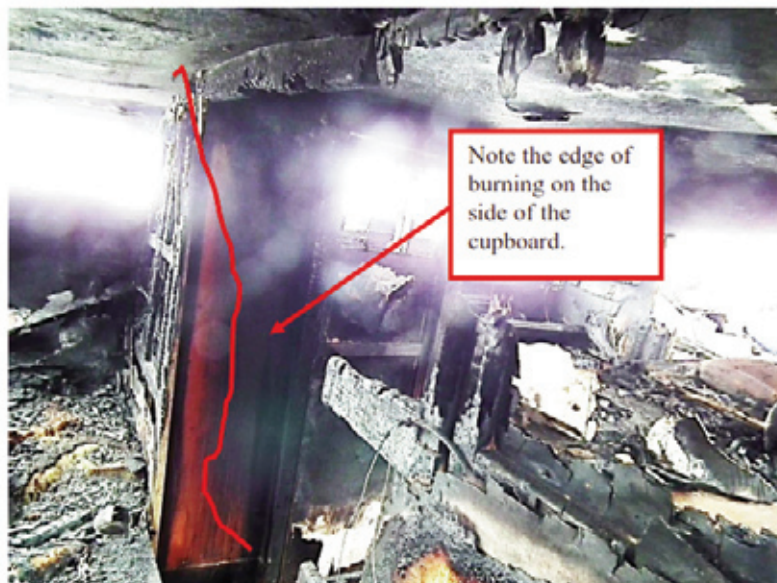
Photo 7 showing a view inside the accommodation cabin looking sternward.

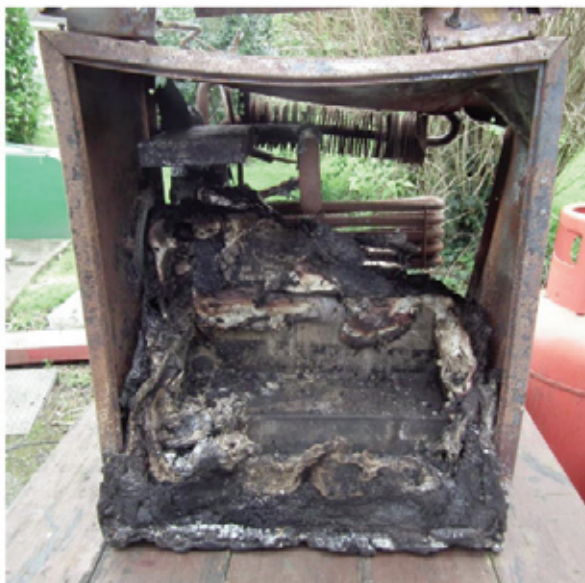
Photo 8 showing a view into the refrigerator.

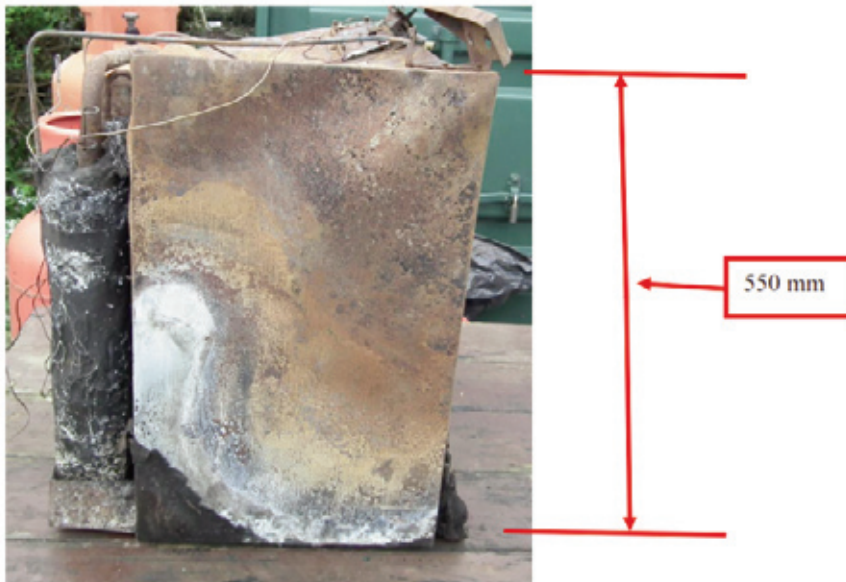
- 5.3 The AGS forensic engineers report states that the fire pattern on the side of the refrigerator indicated that the fire had reached the refrigerator from the deck level and from the rear of the boat. This is consistent with the damage observed by the MCIB investigator.

Photo 9 showing a view of the refrigerator looking towards where the bow was.

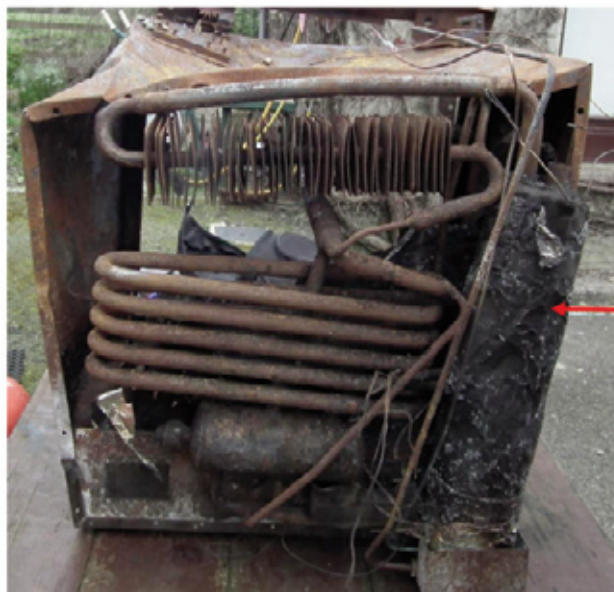
- 5.4 Although the refrigerator was not available for the MCIB investigator to inspect, the AGS forensic engineers report notes that the insulation of the exhaust pipe from the burner was intact, though exhibiting a covering of black carbon, thereby further indicating that the fire was not seated at the rear of the refrigerator.

Note that the insulation of the exhaust pipe, though blackened, is still intact.

Photo 10 of the fridge looking towards the starboard.

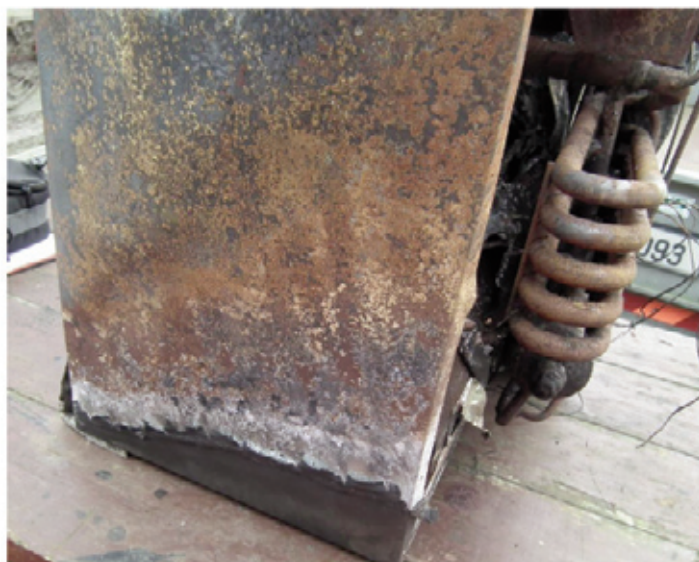
Photo 11 of refrigerator looking towards the stern.

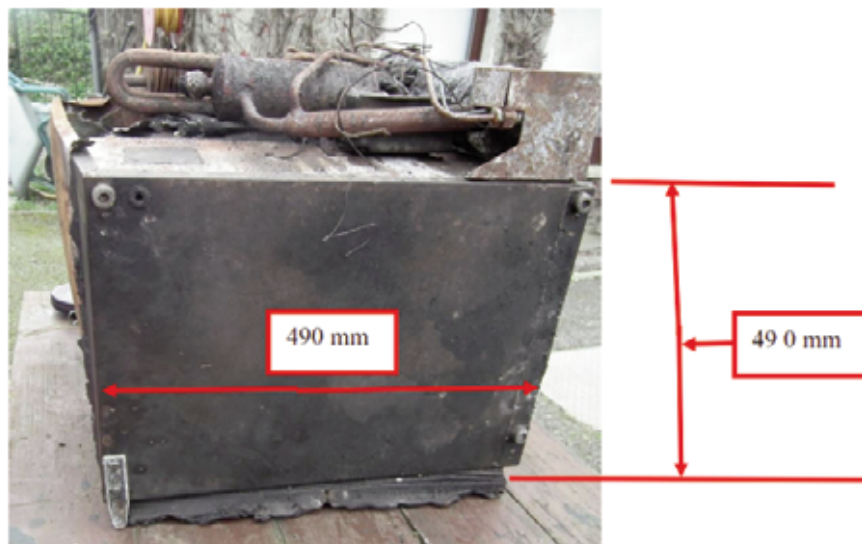
Photo 12 showing the base of the fridge.

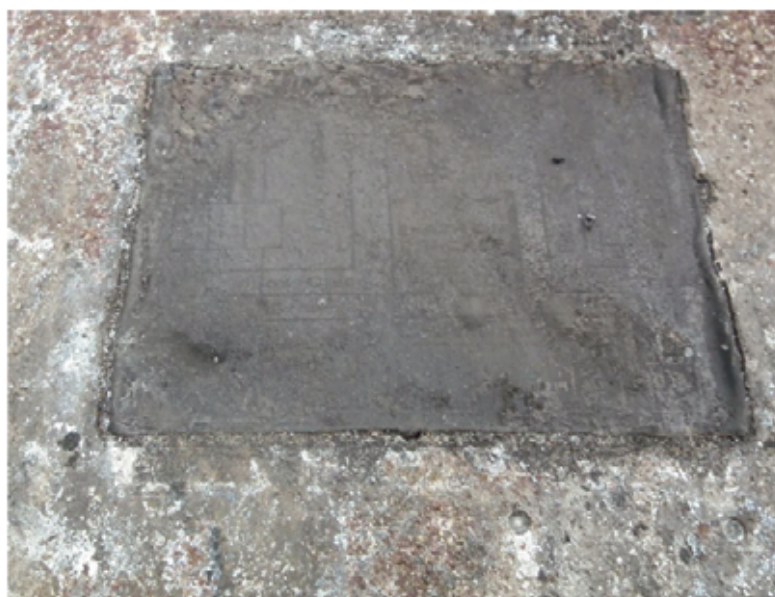
Photo 13 showing a view of the locus of the name plate.

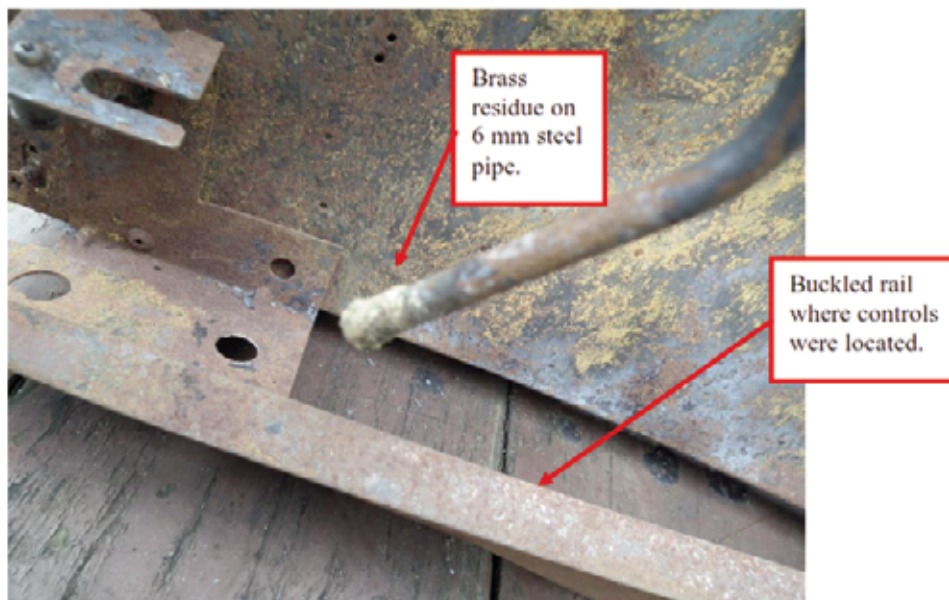
"The pipe supplying LPG gas to the gas -fired refrigerator failed, thereby releasing LPG gas onto the after deck of the boat."

Photo 14 showing the connection end of the gas supply piping to the burner.

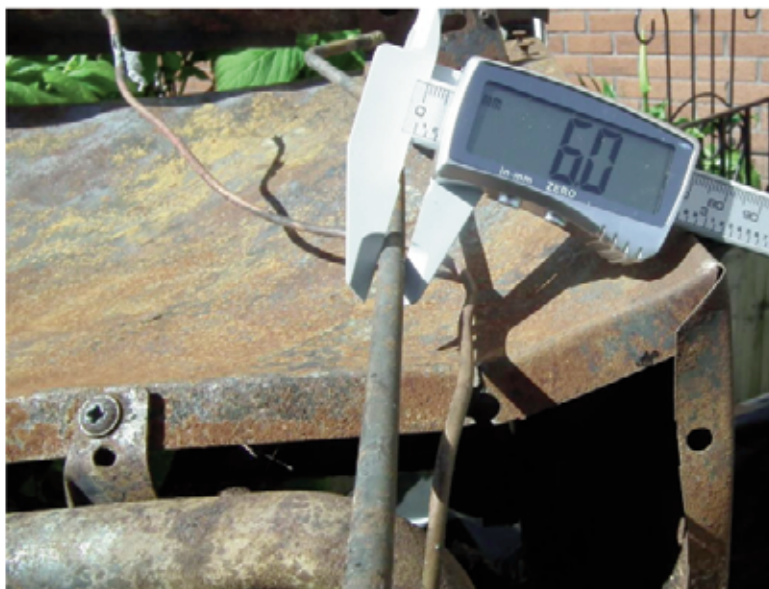
Photo 15 showing a view of the measured outside diameter of the gas supply pipe to the burner.

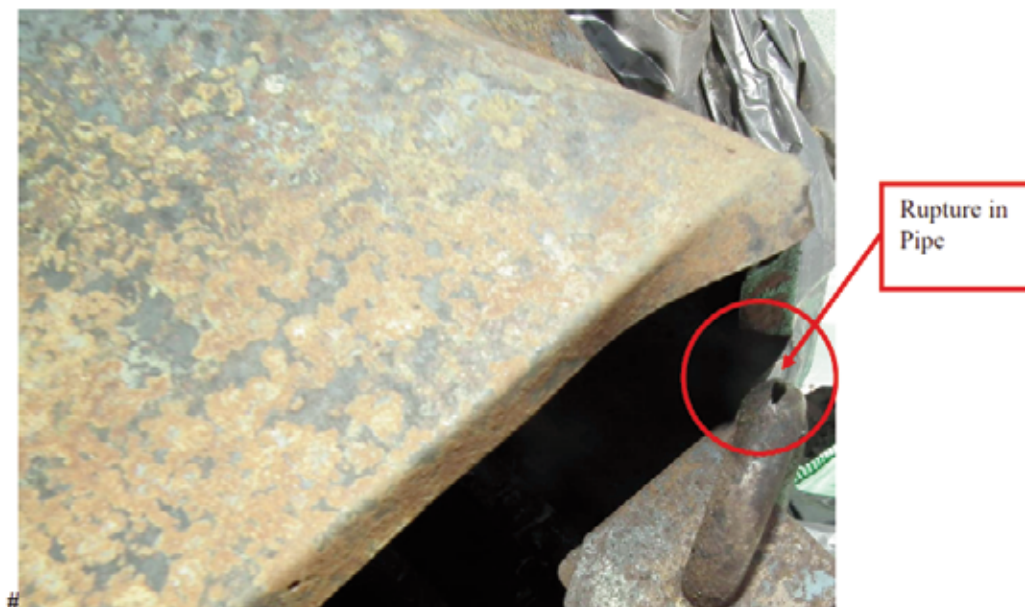
Photo 16 showing a view of a rupture in the ammonia circulation system.

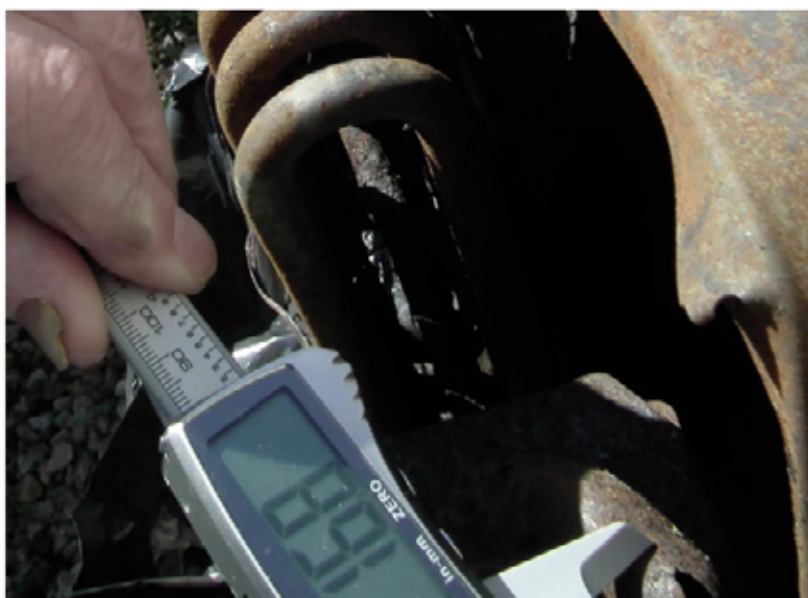
Photo 17 showing the length of the rupture as 16.8 mm.

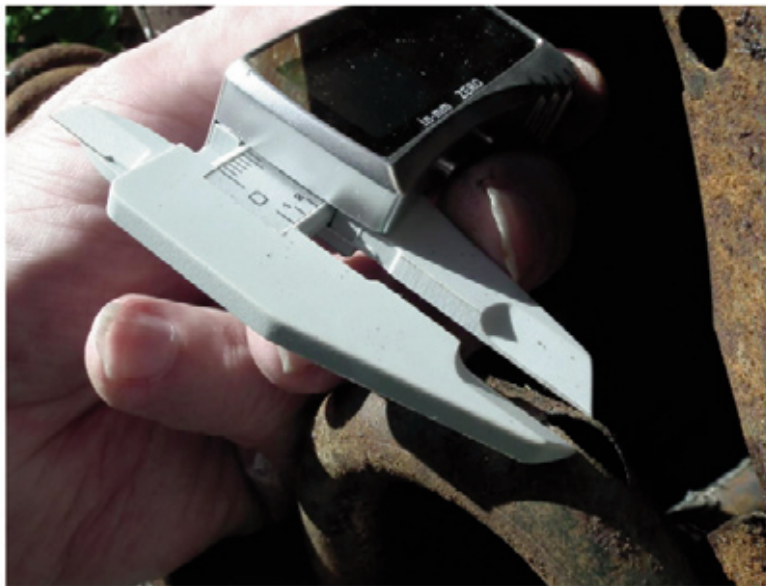
Photo 18 showing the width of the rupture.
