**REPORT OF AN
INVESTIGATION INTO
A MARINE CASUALTY INVOLVING
FV EXCEL AND MV PETREL PACIFIC
IN OR AROUND
THE NORTH ATLANTIC OCEAN
ON OR ABOUT
6 AUGUST 2023**

**REPORT NO. MCIB/336
(No.10 OF 2024)**

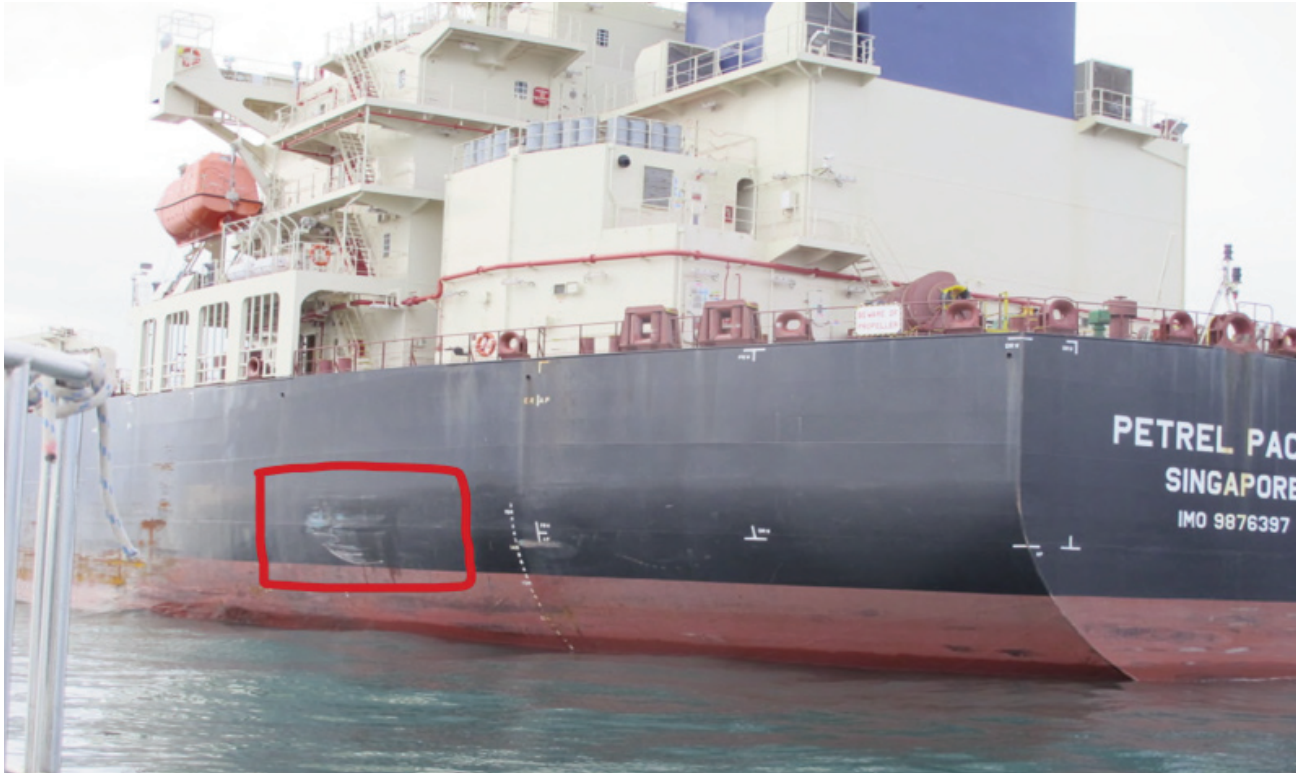
- 2.7.1 MV Petrel Pacific was inspected by an ABS surveyor on 7 August 2023 whilst the vessel lay at anchor in Saint Brides Bay, UK. A further ABS survey was conducted while the vessel lay afloat at Montreal on 30 August 2023. Damage was noted in way of frame numbers 20 - 23, Engine Room 1st Deck and below 1st Deck (approximately 14480 mm) on port side shell. The collision had caused set-in and slight deformation of port side shell plating. Smooth indentation was observed of approximately 35 mm depth over an area of 1000 x 2000 m2. The affected area was considered cosmetic by the attending surveyor.

MV Petrel Pacific damage to port side shell plating.

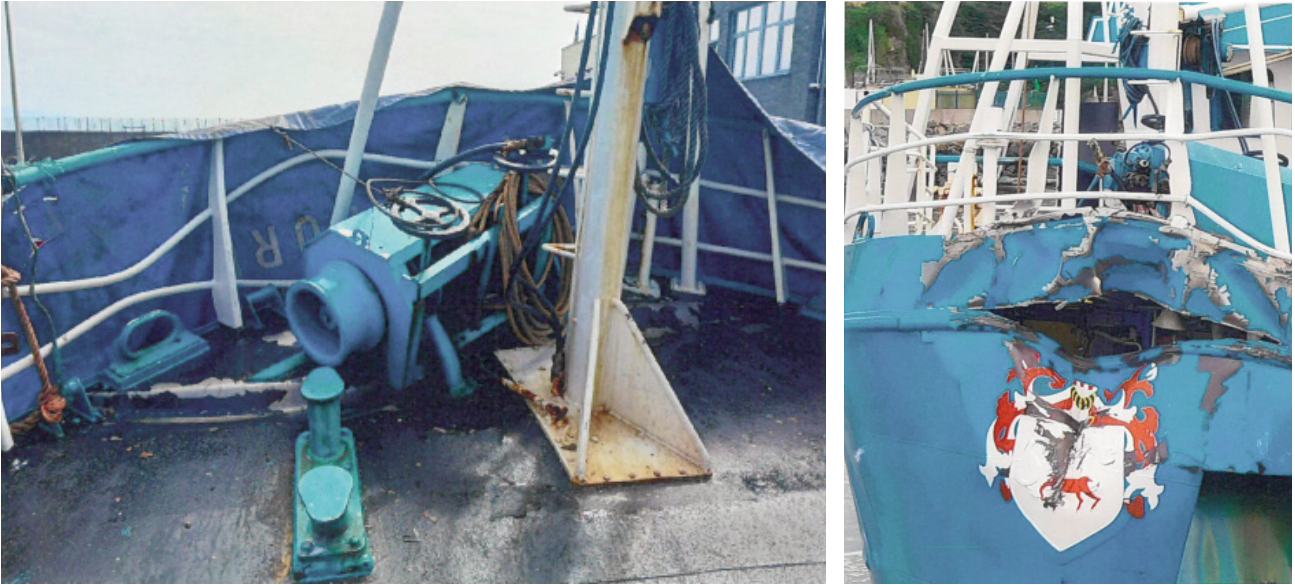
- 2.7.2 FV Excel was inspected by a surveyor of the Irish MSO on 8 August 2023 while alongside in Dunmore East. Damage was observed in the forward aluminium superstructure to a point approximately 0.5 m of the foremast. The anchor was forced upwards and aft, trapping the anchor chain and rendering the vessel unable to anchor. Extensive deformation of the aluminium superstructure had occurred, with aluminium separated from the steel hull at the bonding bar. Damage to the steel structure was minimal and limited to the forward facing structure above a wrap round stringer above the working deck.

Damage to the bow of FV Excel

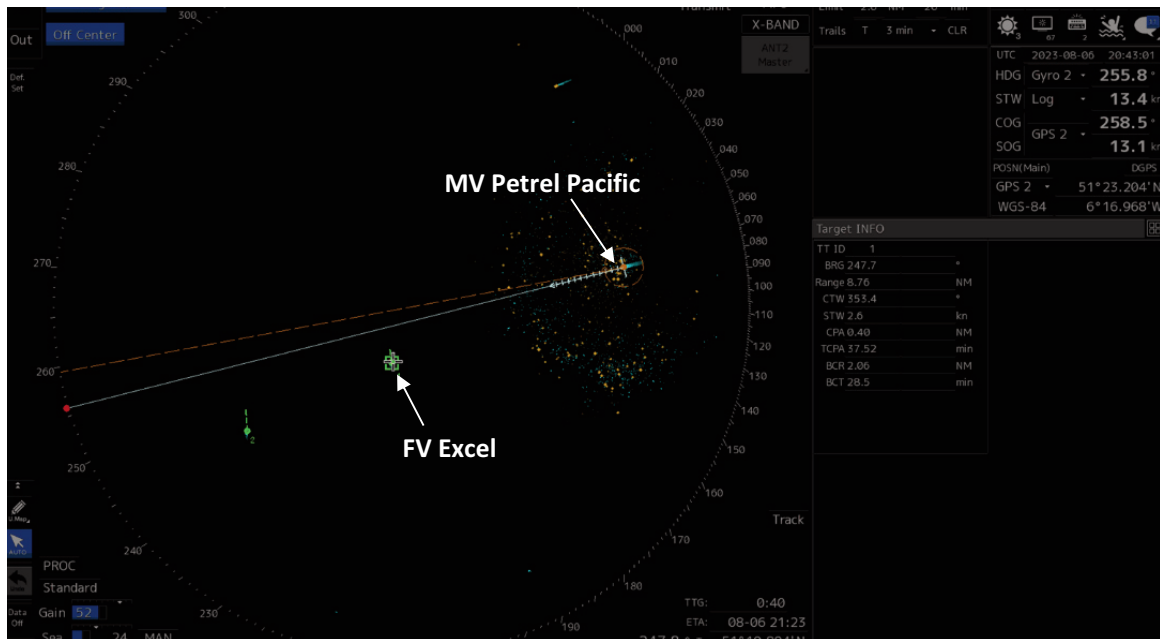
- 3.5 The AB arrived on the bridge and assumed look-out duties at around 20.00 hrs. At 21.43 hrs the radar target of FV Excel was acquired on the ARPA radar of MV Petrel Pacific.

ARPA Radar Display 21.43 hrs.

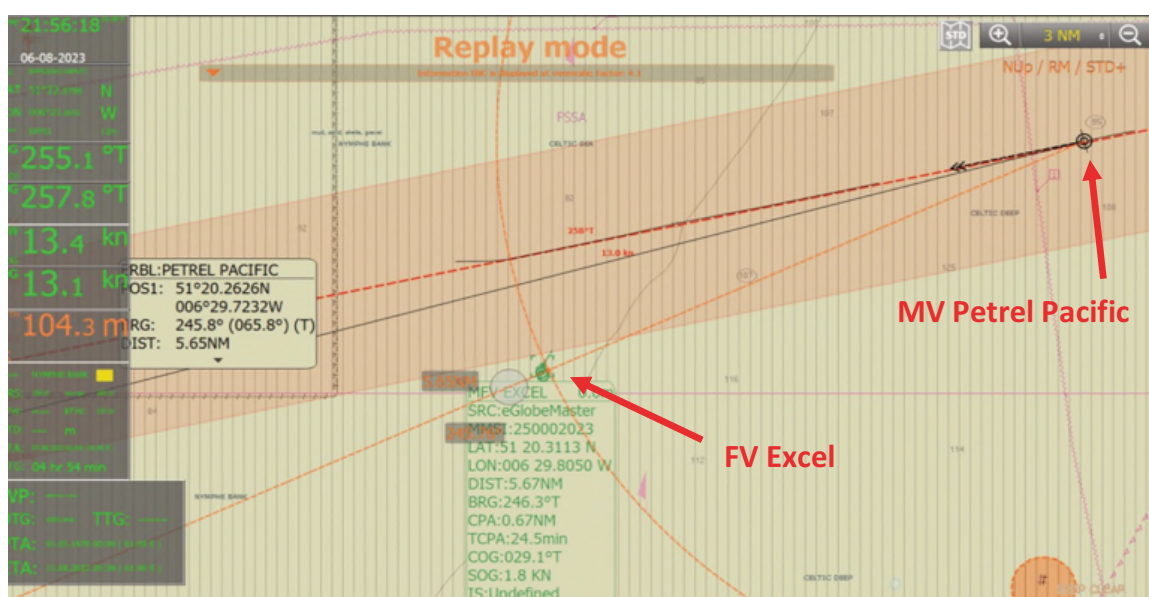
ECDIS Display MV Petrel Pacific 21.56 hrs.

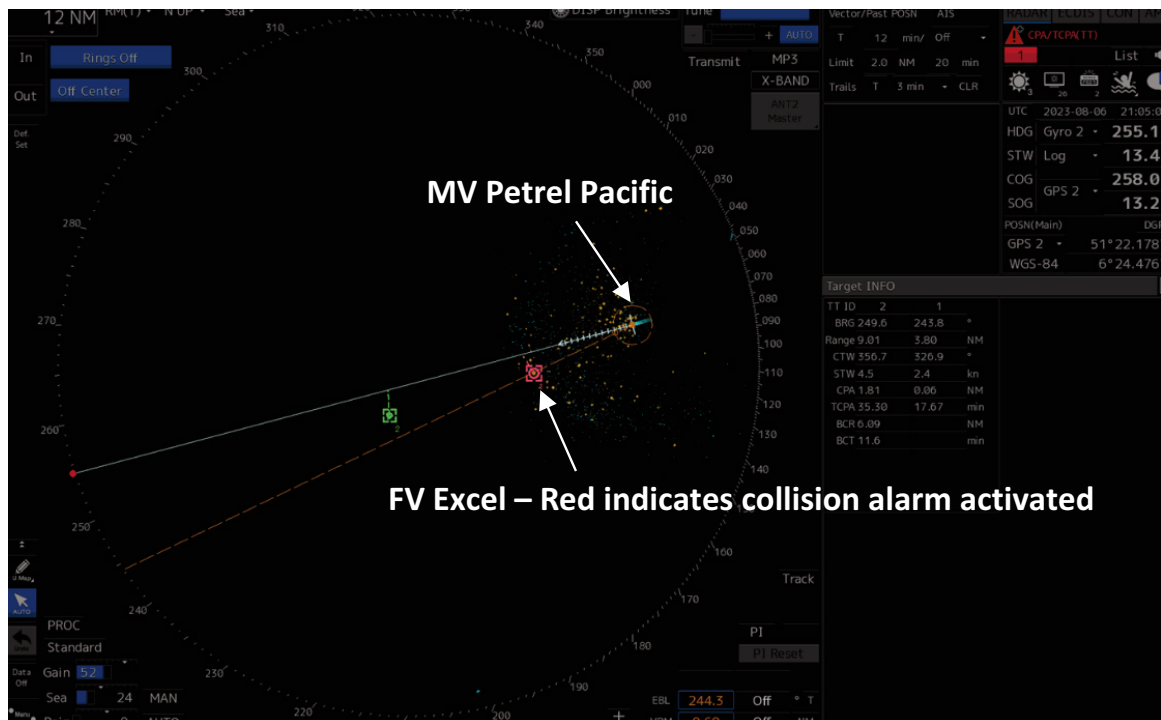
- 3.7 MV Petrel Pacific continued her course and speed. At 22.02 hrs, Collision minus 20 minutes (C-20), the collision alarm activated on the ARPA, showing a CPA of 0.42 NM with FV Excel. The witness evidence states that at approximately 22.05 hrs (C-17) the Master called the OOW to the Radio/Chart Room, which was located separately to the bridge, in order to attend to some paperwork. This conversation was not captured on the VDR, but rather the VDR does evidence that the bridge door was opened and closed at 22.05.13 hrs, supporting the witness evidence that the OOW left the bridge. In his witness evidence the OOW states he only left the bridge after satisfying himself that there was no risk of collision with FV Excel, however, at 22.05 hrs the CPA of FV Excel was 0.06 NM and the APRA collision alarm was activated (the CPA did then fluctuate, increasing and decreasing as the vessels converged). FV Excel had a STW of 2.4 kts and a CTW of 326.9° True; the two vessels were already converging in a close quarters situation as the OOW departed from the bridge.

ARPA display at 22.05 hrs CPA with FV Excel 0.06 NM.

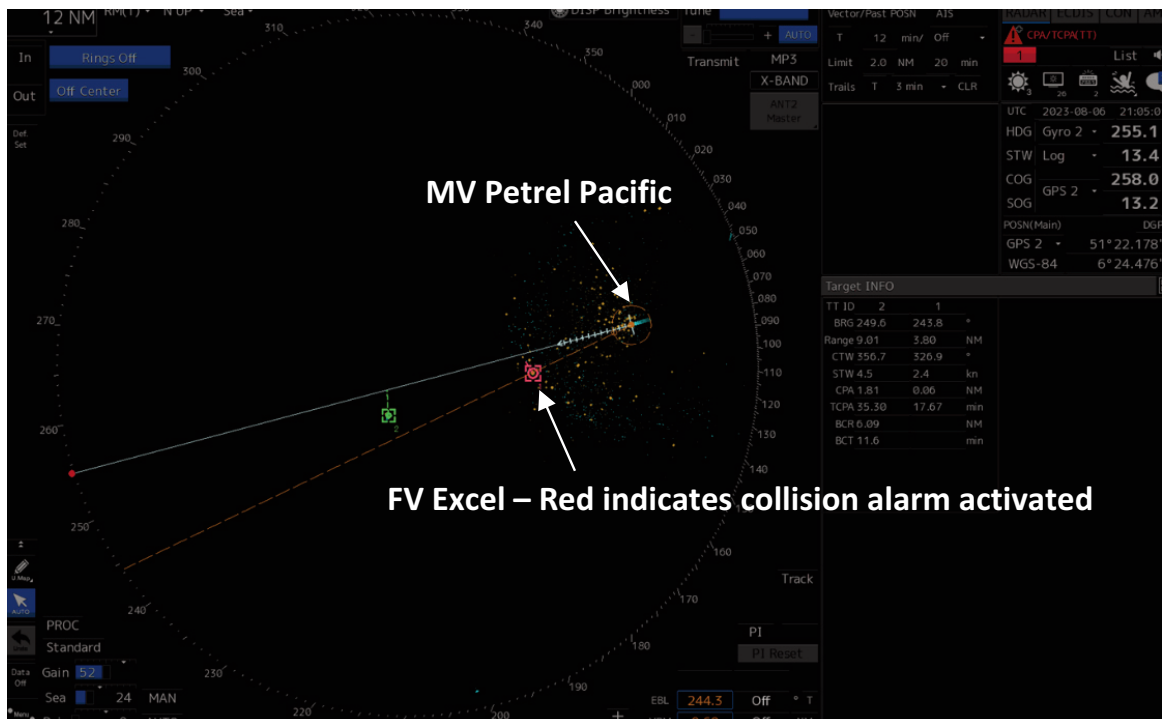
- 3.14 By around 22.19 hrs C-3, the STW of FV Excel had increased to 7.0 kts and the CPA had reduced to 0.00 NM i.e. a collision was imminent, with FV Excel advancing at speed toward the port side of MV Petrel Pacific. The Skipper's attention was focused on shooting gear and he was oblivious to the impending risk of collision.

Radar display MV Petrel Pacific approximately 21.18.46 hrs C-3.

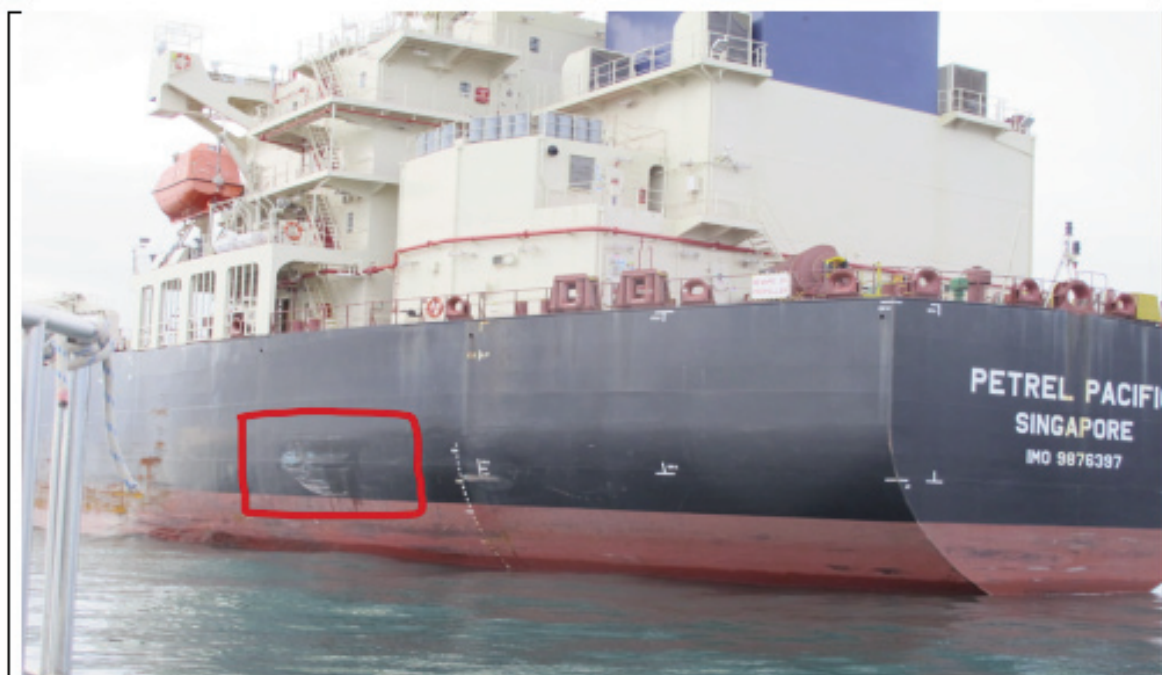
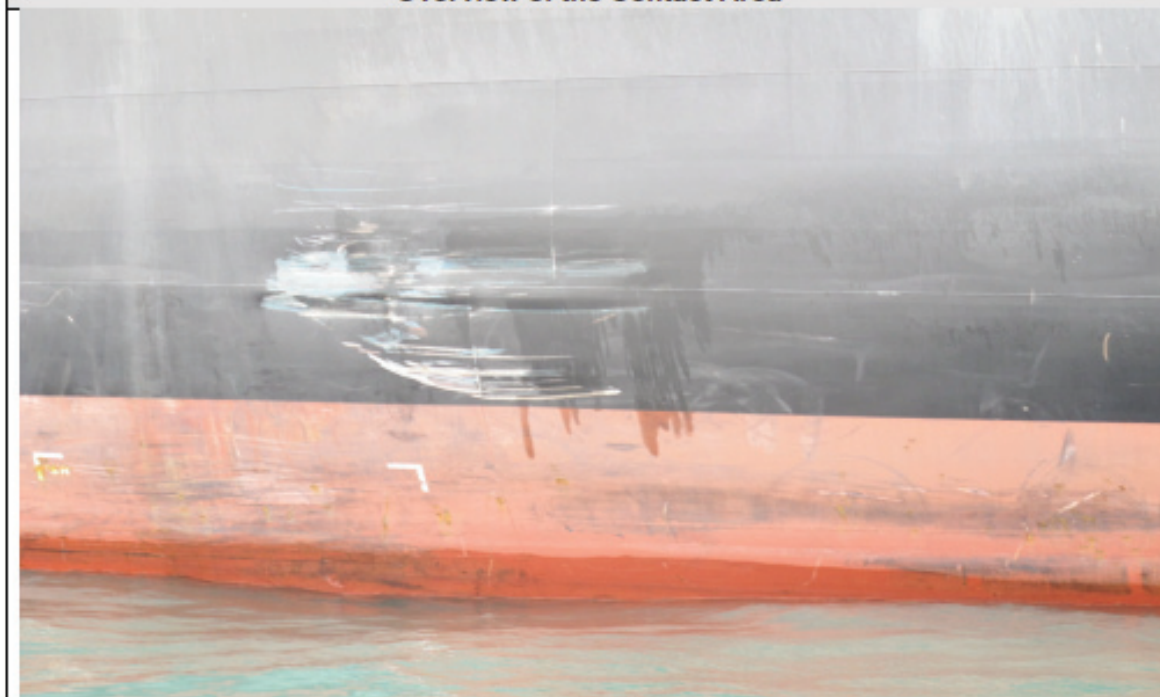
Smooth indentation has been observed of approx. 35mm depth over an area of 1000x2000m2.

Overview of the Contact Area

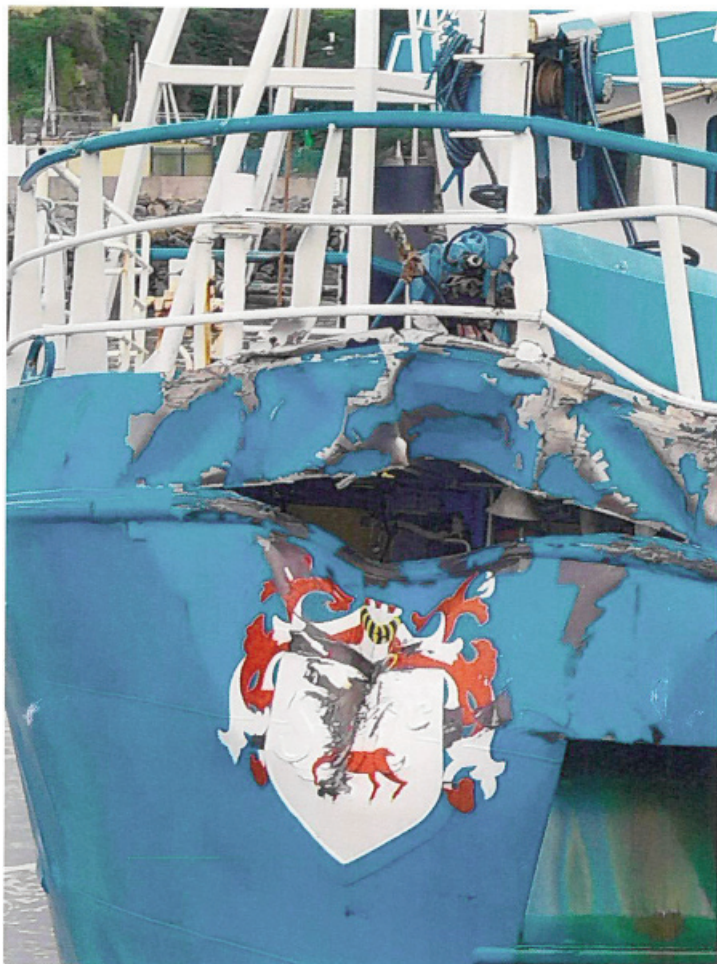
The damage was limited to the Forward Aluminium superstructure to a point approximately 0.5 Metre aft of the foremast. The Anchor winch was forced upwards and aft, trapping the anchor chain and rendering the vessel unable to anchor. There was extensive deformation of the aluminium superstructure (as can be seen in the attached photographs Fig 1 and 2) where the aluminium separated from the steel hull at the bonding bar. Damage to the Steel structure was minimal and limited to the forward facing structure above a wrap round stringer above the working deck. (Figure 3)

Damage to bow 1Fig

Repair work to include but not limited to:- replacement of deformed plating steel and aluminium. Refit anchor winch and mast after repair, rewiring mast repair to hydraulic hoses as necessary, replacement of filling and vent pipes from the forepeak tank. Replacement of fittings as required.

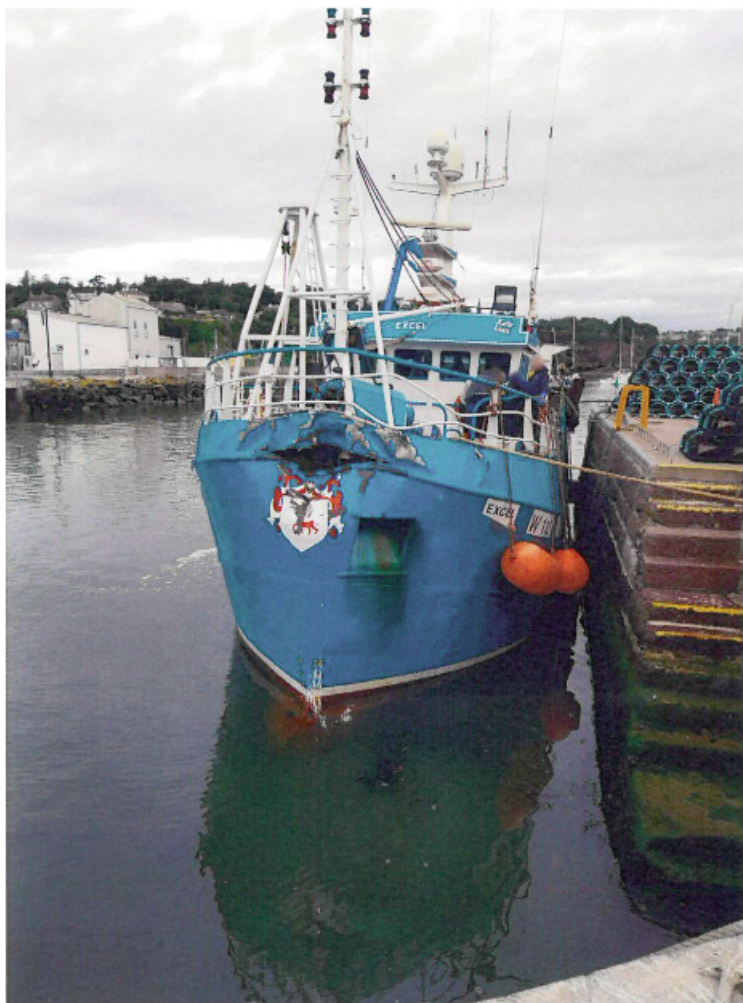
Damage to bow 2

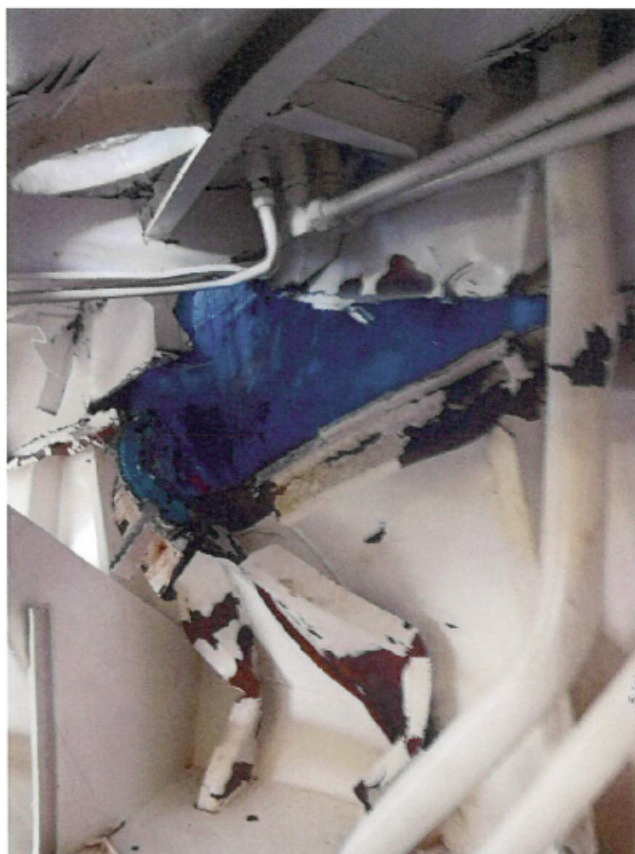
Damage to bow 3

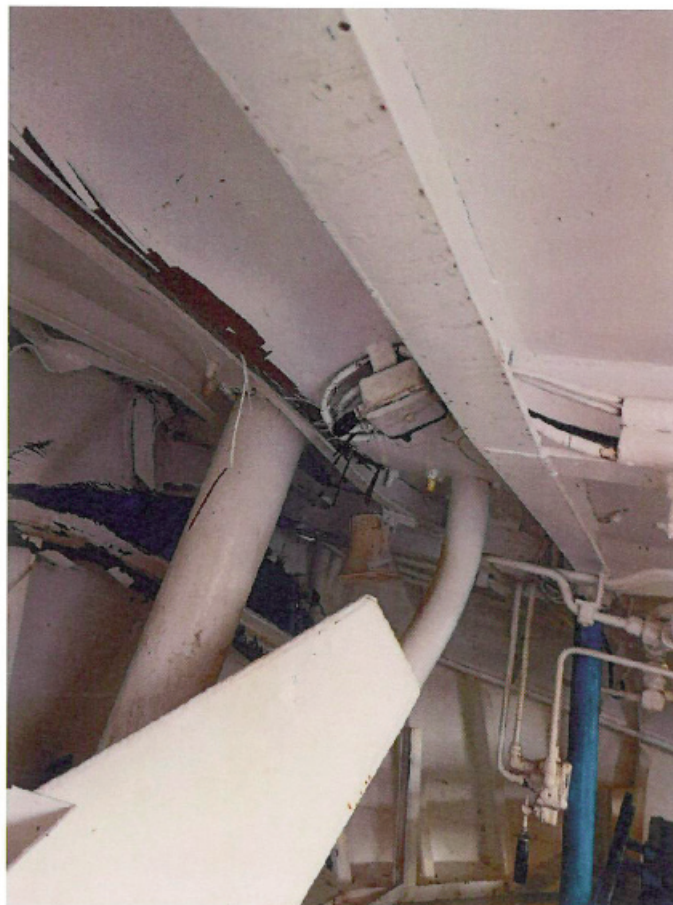
Damage to bow 4

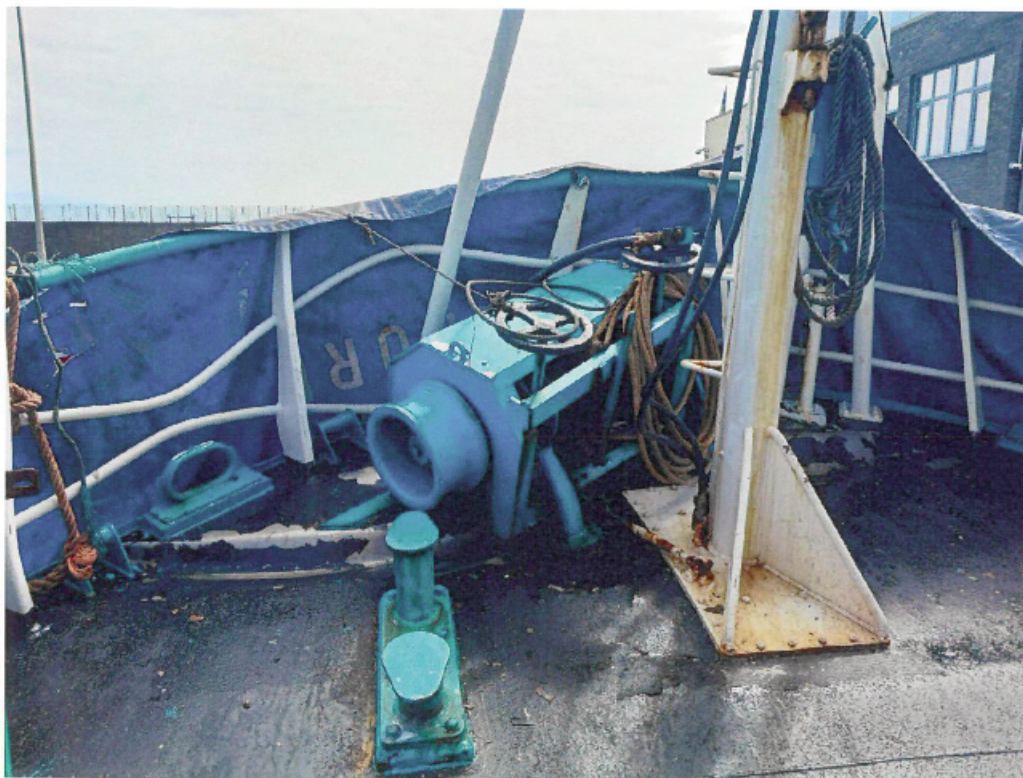
Damage to bow 5

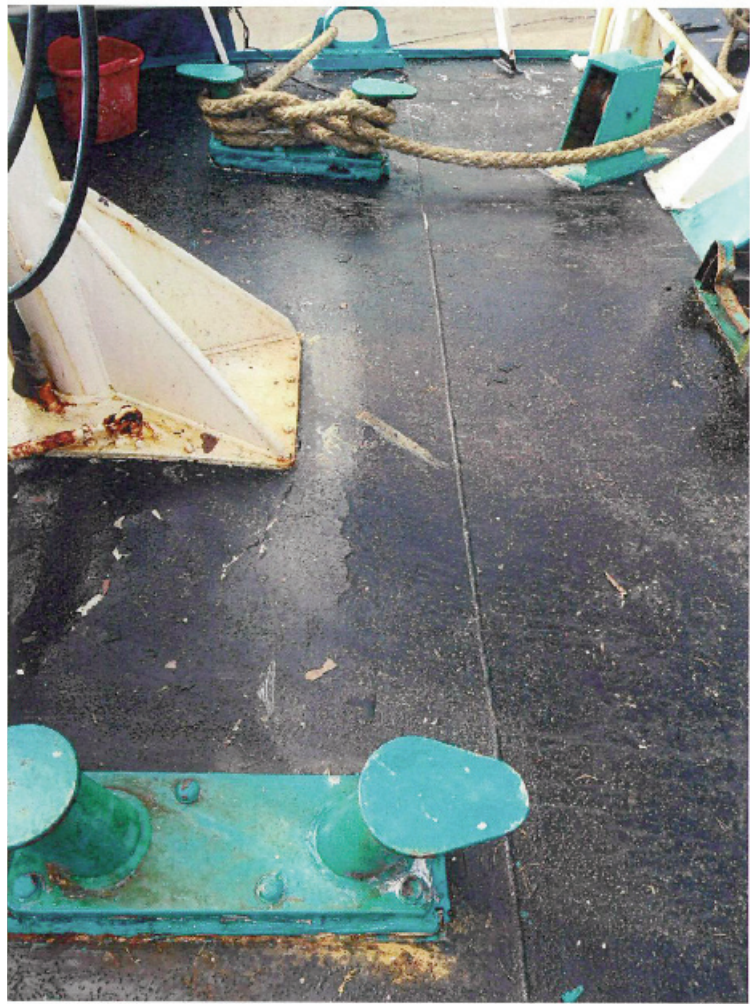
Damage to bow 6 Deformation in upper deck aft of Mast
