REPORT OF AN INVESTIGATION
INTO A MARINE CASUALTY
INVOLVING A VESSEL IN
OR AROUND
INISHBOFIN ISLAND,
CO. GALWAY
ON OR ABOUT
3 JULY 2024

REPORT NO. MCIB/338 (No.4 OF 2025) The Marine Casualty Investigation Board (MCIB) examines and investigates all types of marine casualties to, or onboard, Irish registered vessels worldwide and other vessels in Irish territorial waters and inland waterways.

REPORT NO. MCIB/338 (No.4 OF 2025)

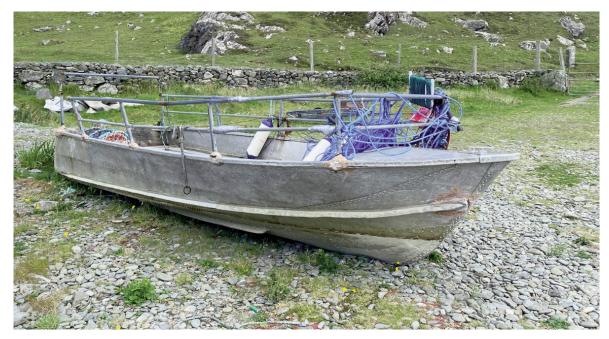
Photograph No. 1: The vessel ashore without the engine - photograph taken post incident.

- 2.1.1 The vessel was owned by the Casualty and was inspected by the Marine Casualty Investigation Board (MCIB) on 27 July 2024. According to witnesses interviewed over the course of the investigation, the Casualty had installed a new 15-hp Yamaha outboard engine approximately three months prior to the incident this engine replaced a previous 20-hp outboard engine. At the time of inspection of the vessel, the engine was not present, as it was removed shortly after the incident to facilitate a service. However, from witness statements, the engine was found with the gear engaged in the forward position. Witnesses involved in the recovery of the vessel reported that a kill cord was in place when the vessel was recovered.

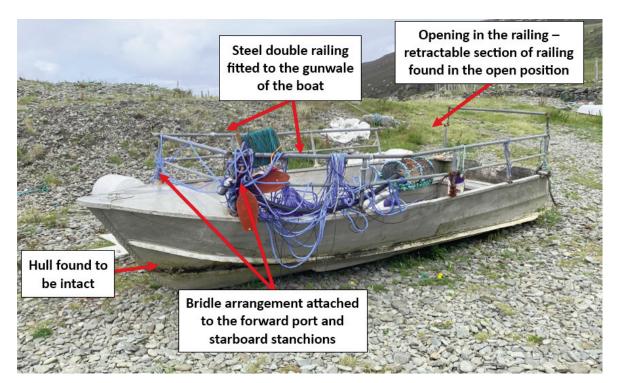
- 2.1.2 The vessel was constructed primarily from studded and welded aluminium, featuring minor fiberglass repairs to the hull. A steel double railing encircled the vessel, with a section designed to open for tending to pot buoys and other work. Witness statements indicated that the railing was installed by the Owner. The opening section of the railing could be secured using a retractable portion of the railing, which was found in the retracted position during the inspection. Attempts to close the retractable railing were unsuccessful due to the deformation of the starboard side railing. The damage was evident, with multiple stanchions bent outward. There was no means of getting back onboard in the event of a man overboard situation. It may have been possible to board the vessel via the transom, however there would be a risk of injury if the propellor was still turning.

Photograph No. 2: Railing around the vessel and bridle arrangement.

- 4.2.2 The exact date when the double steel railings were added to the vessel is unknown; however, it is clear they were installed to enhance operational functionality, such as containing livestock and supporting lobster pot operations. Positioned along the gunwale, these railings significantly impacted the vessel's stability. By raising the centre of gravity, they reduced the vessel's natural ability to resist rolling motions, making it more vulnerable to instability, particularly in challenging sea conditions.

- 4.2.4 The addition of railings, while functional for certain tasks, failed to account for their impact on the vessel's stability, particularly in adverse conditions.

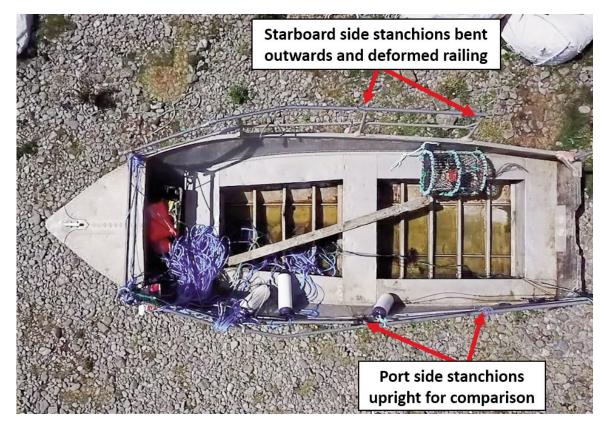
Photograph No. 3: Aerial photograph showing deformation to the railing and stanchions.

- 3.15 Witness statements advised that a steel double railing, which encircled the vessel, with a section designed to open for tending to pot buoys and other work (observed by the MCIB) was installed by the Casualty. The MCIB inspection noted damage on the starboard side railing with multiple stanchions bent outward. The retrofitted railings on the vessel would have contributed significantly to stability issues as this altered the vessel's centre of gravity and would have increased the rate of water ingress. With the vessel full of water and tethered to the seabed

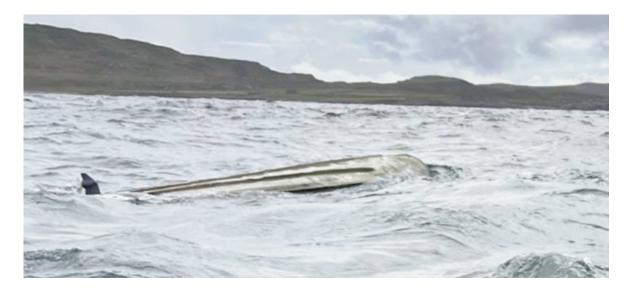
2.1.3 The vessel was located by rescue helicopter R118 during the search and rescue operation and was observed inverted and afloat. The vessel was subsequently found to be tethered to the seabed by a bridle arrangement that was connected to a pot riser.

Photograph No. 4: Photograph taken of the upturned vessel during the salvage. Credit salvage team.

- 3.13 If the Casualty had encountered a fouled pot he would have rigged a bridle from the bow of his vessel, attaching it to the pot rope or riser. As stated by witnesses, this method of freeing pots is a common practice in this area. This proposition is confirmed by the fact that the vessel was subsequently found to have been tethered to the seabed by a bridle arrangement that was connected to a pot riser.

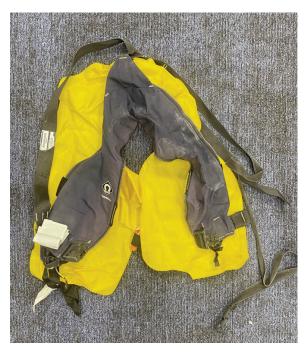
- 2.11.4 During the MCIB inspection of the PFD on 27 July 2024, it was found to be in generally reasonable condition. All straps were intact, and the inflation chambers were in good working order, though scuff marks and signs of general wear and tear were noted. The PFD had been overdue for its scheduled inspection, which was due in March 2024. Additionally, part of the automatic inflation device was missing, and scuff marks were observed around the fitting where the device would have been mounted. The green indication tag for manual inflation was still in place which means that given it was not used for manual inflation, the PFD was automatically inflated by the automatic inflation device. It follows that the damage noted to part of the automatic inflation device occurred after inflation, which is consistent with the noted scuff marks around that part of the PFD, presumably caused when the Casualty's body came to rest on the beach area.

Photograph No. 7: The Casualty's PFD observed in reasonable condition at the time of inspection.

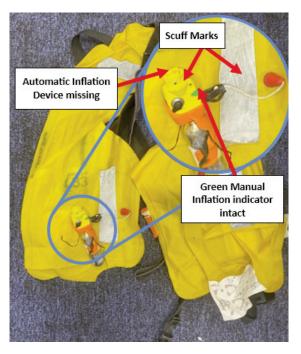
Photograph No. 8: Close up of the manual inflation indicator which remained intact suggesting automatic inflation.

- 3.18 It is known that the Casualty's lifejacket activated its automatic inflation device on immersion, causing the lifejacket to inflate as subsequently, the Casualty was found on the shore with his PFD inflated.
