**REPORT OF AN INVESTIGATION  
INTO A MARINE CASUALTY  
INVOLVING THE  
PASSENGER VESSEL  
SEA BREEZE III  
IN OR AROUND  
THE SKELLIG ISLANDS,  
CO. KERRY  
ON OR ABOUT  
7 JULY 2024**

**REPORT NO. MCIB/339  
(No.6 OF 2025)**

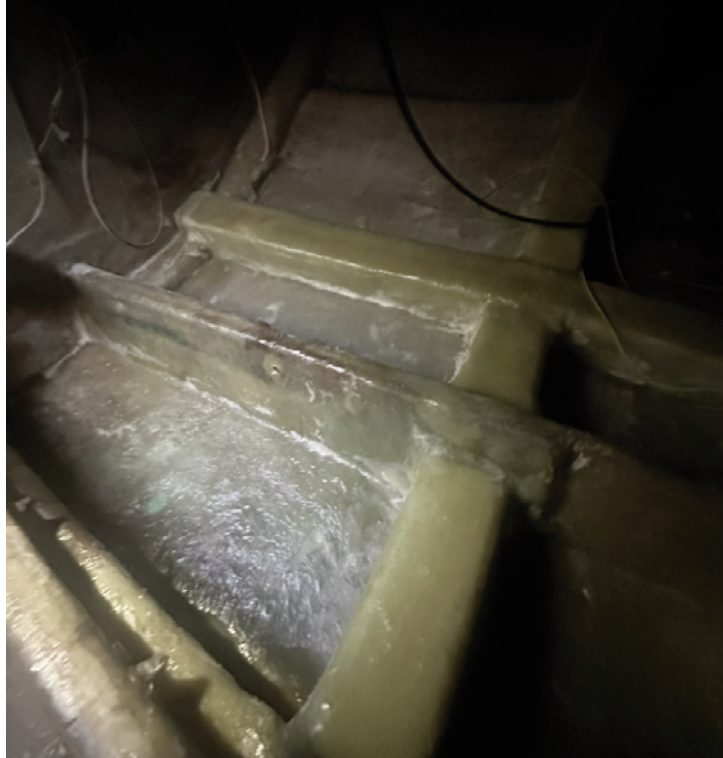
*13.5 The cracking in the hull under the wheelhouse should be cleaned back to sound material and reinforced. The stiffeners should be cut out and rebuilt where cracked. The crack noted externally in that area should be cleaned back and repaired. The hull has been repaired and extra stiffeners have now been fitted (Fig. 9, 10)”.*

Figure 8: Fibreglass repairs to the hull with extra stiffeners added.

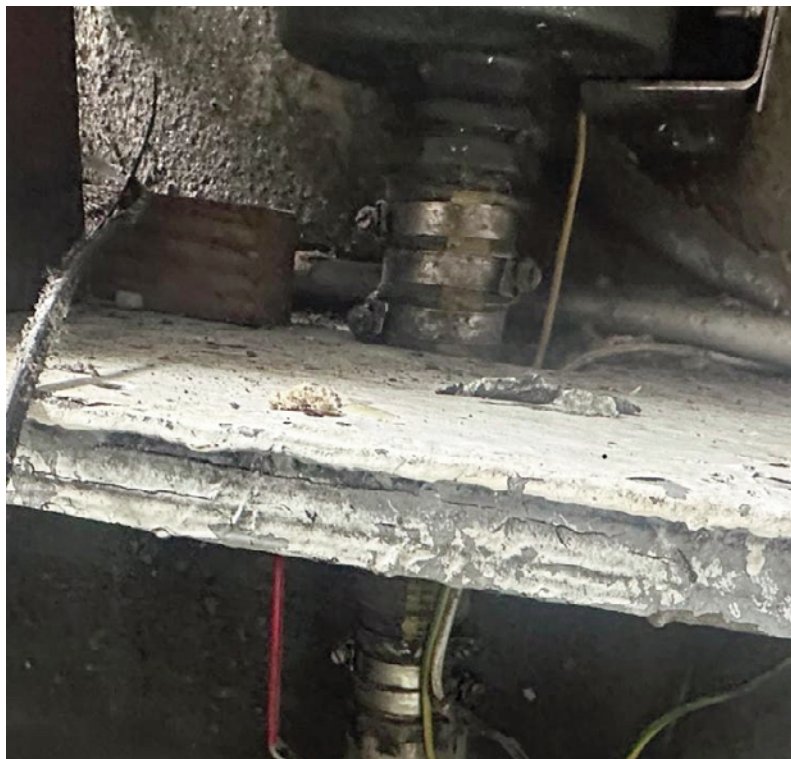
*13.3 Ensure all through hull fittings are secure with freely operating valves. The fire pump intake pipe, seacock and through hull fitting should be replaced. The toilet seacocks should be replaced. All seacocks serviced/replaced and all tested and working.*

Figure 9: Replacement sea cock.
