REPORT OF THE INVESTIGATION INTO THE SINKING OF THE IRISH FISHING VESSEL "TAMARISK" OFF DURSEY ISLAND, CO. CORK ON 29 APRIL 2000.

The Marine Casualty Investigation Board was established on the 5<sup>th</sup>, June 2002 under The Merchant Shipping (Investigation of Marine Casualties) Act 2000

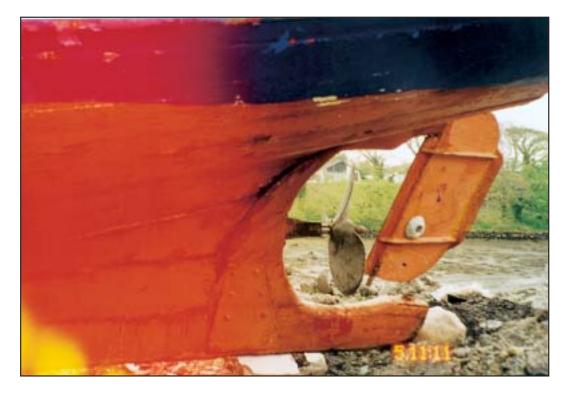
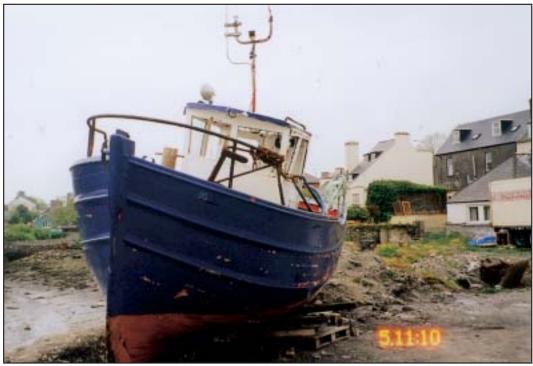
8.3 Photographs showing damage sustained by "Tamarisk"

- 6.1 The "Tamarisk" was badly damaged. It was holed on both sides of the bottom in the midship area. See photographs in Appendix 3.
- 6.2 The rudder was dislodged and bent. There was general flooding damage.
- 6.3 Mr. Murphy stated that the wind was light from the SE and from his experience this would tend to push the vessel towards the shore. Also he stated that the tide, which was low, was also tending to set the vessel onto the shore.
- 6.4 All aids to navigation in the vicinity were functioning correctly at the time of the incident.
- 6.5 There were two lifejackets on board the vessel at the time of the grounding. This is in compliance with the Merchant Shipping (Life Saving Appliances) (Amendment) Rules, 1999, which came into operation on the 1st April 2000. It is clear that neither crewmember would have survived this incident had they not been wearing lifejackets.
