**REPORT OF THE  
INVESTIGATION INTO  
THE GROUNDING OF  
M.V. "WHITHAVEN"  
ON THE RIVER BARROW  
ON 9TH MARCH, 2002**

**The Marine Casualty Investigation Board was established on the 5<sup>th</sup>, June 2002 under The Merchant Shipping (Investigation of Marine Casualties) Act 2000**

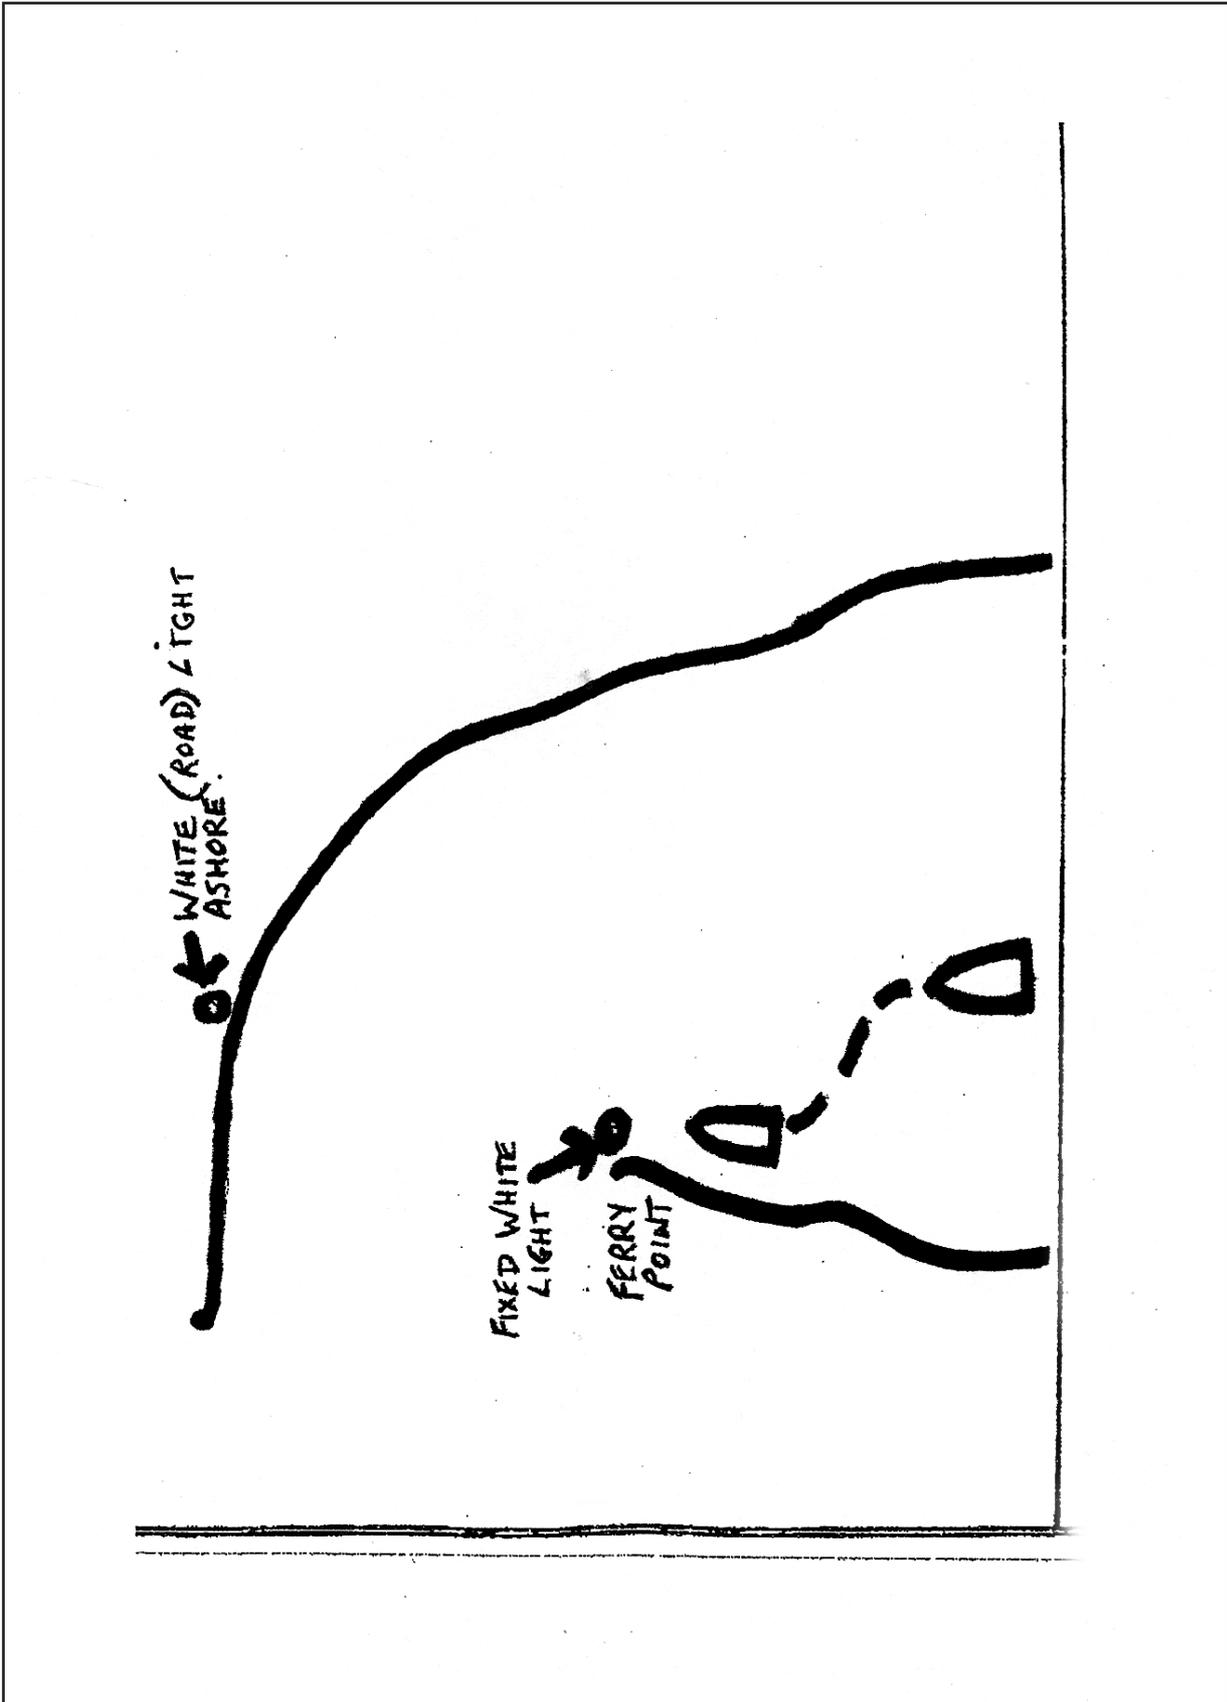
8.4 Sketch of occurrence from Master of "Whithaven".

- 4.1 The Pilot states that on approaching the corner at Ferry Point the light of the middle red buoy was obscured and the white floodlight on the Fish Trap was mistaken for the white floodlight at Ferry Point. The white floodlight at Ferry Point was mistaken for the white road light at Ballinlaw. Port helm was applied when the actual Fish Trap floodlight (then taken to be the Ferry Point floodlight) was bearing approximately 4 points (45 degrees) on the port bow. In the meantime the Master could see the white shore light on a road (Ballinlaw) almost ahead and the white floodlight at Ferry Point to port. He was then aware of a helm movement beside him and then saw the two white lights move across to the starboard bow. The Master called to the Pilot and said that the ship must come to starboard. As he said this more port wheel was being applied. However the Pilot immediately applied starboard wheel bringing the rudder back from port through 'midships and across to starboard. The bow stopped swinging to port and started to turn to starboard. (See appendix 8.4)

- 4.2 The Pilot stated that on becoming aware that he was not in the channel the helm was immediately put hard to starboard and the vessel travelled a short distance parallel to the shore before grounding port side to the shoreline between the floodlight on the Fish Trap and the floodlight on Ferry Point. The Pilot stated that the engine was immediately stopped. The vessel came to rest approximately 20 to 30 metres from Ferry Point floodlight and parallel to the shore. The grounding was recorded as occurring at 01.33 hours on Saturday morning 9th March 2002.

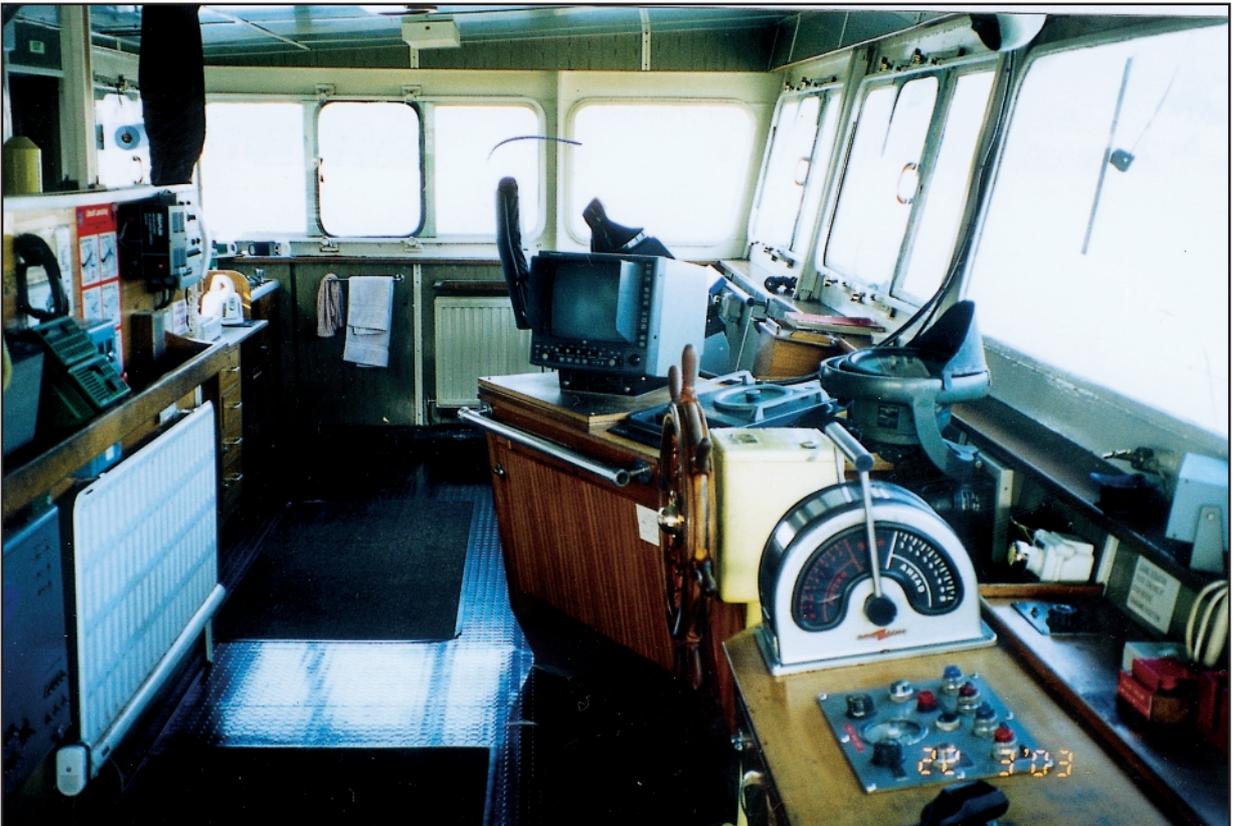
8.9 Photograph of bridge components of "Whithaven".

- 6.4 The Pilot was not standing in a position to effectively utilise the radar to assist in picking up all navigation buoys and then visually identify those navigation marks.
