Leeson Lane, Dublin 2.
Telephone: 01-6782460.
Fax: 01-6783129.
email: info@mcib.ie
www.mcib.ie

**REPORT OF THE
INVESTIGATION INTO THE LOSS
OF THE MFV "MAGGIE B"
ON 29th MARCH 2006**

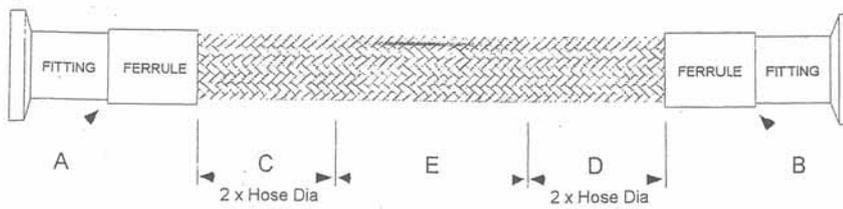
ITEM	ASSEMBLY PART NO.	CUSTOMER CODE	SERIAL NO.	TEST PRESSURE	TEST SERIAL NO.	TEST REPORT NO.
01	Hose presented for testing by	N/A	N/A	1900 PSI	N/A	041961

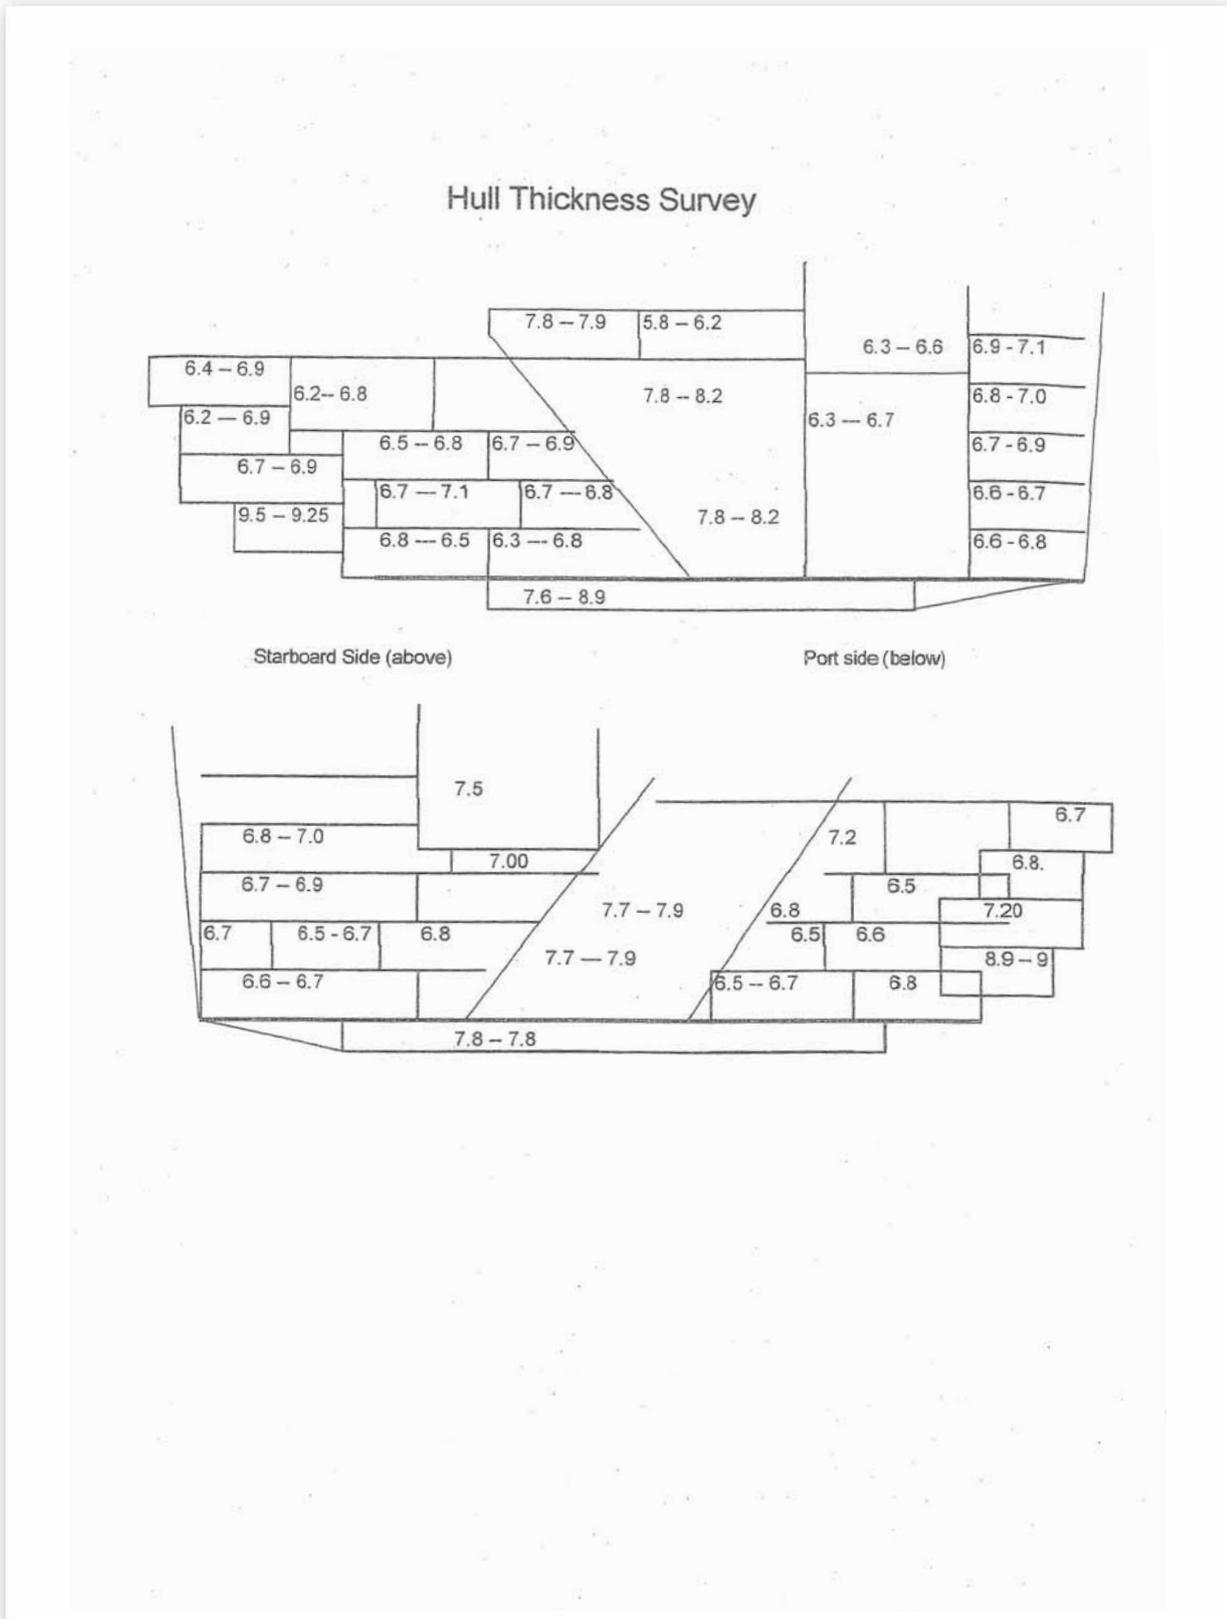
Appendix 8.6 Condition and value survey report by Promara.

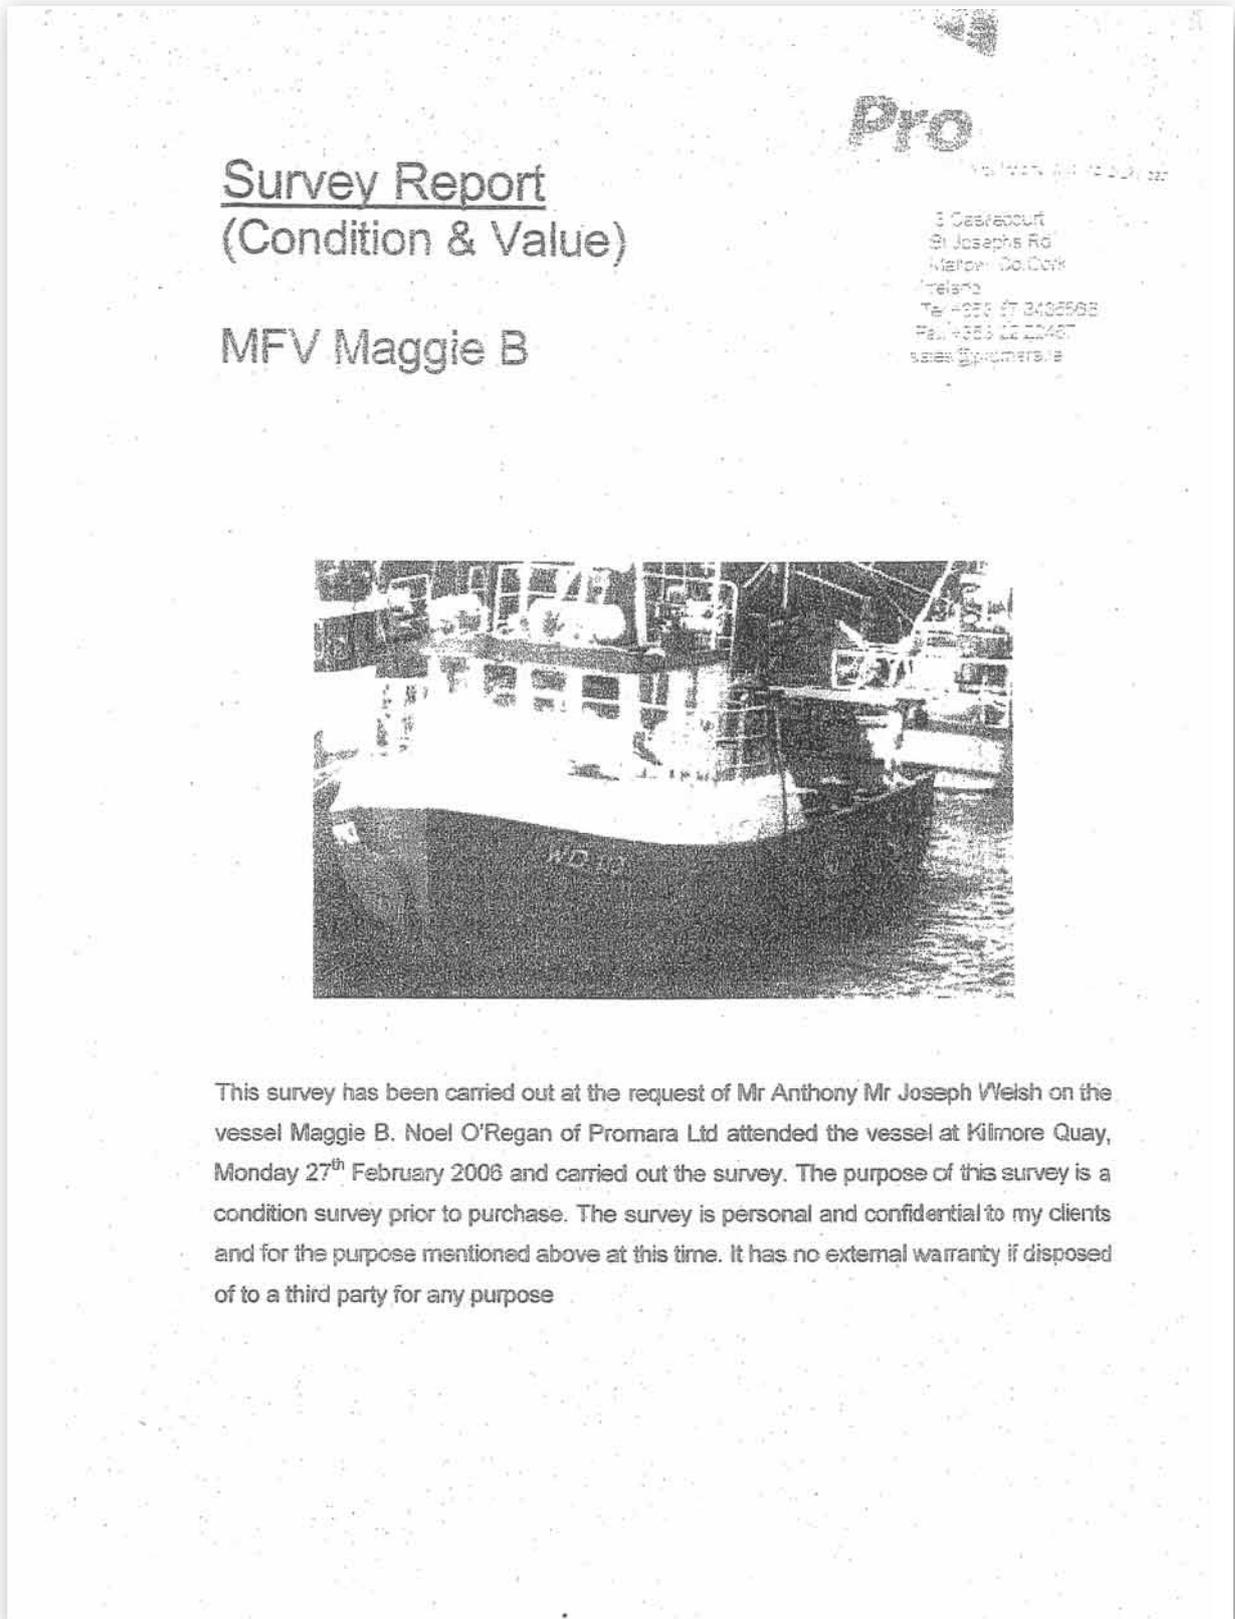
Survey Report
 (Condition & Value)

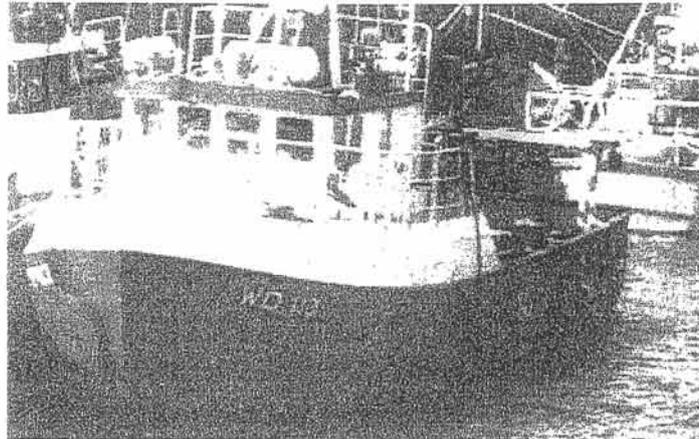
This survey has been carried out at the request of Mr Anthony and Mr Joseph Welsh on the vessel Maggie B. Noel O'Regan of Promara Ltd attended the vessel at Killmore Quay, Monday 27th February 2008 and carried out the survey. The purpose of this survey is a condition survey prior to purchase. The survey is personal and confidential to my clients and for the purpose mentioned above at this time. It has no external warranty if disposed of to a third party for any purpose

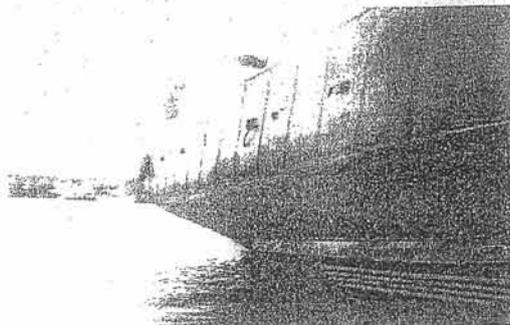
Hull side showing keel cooler

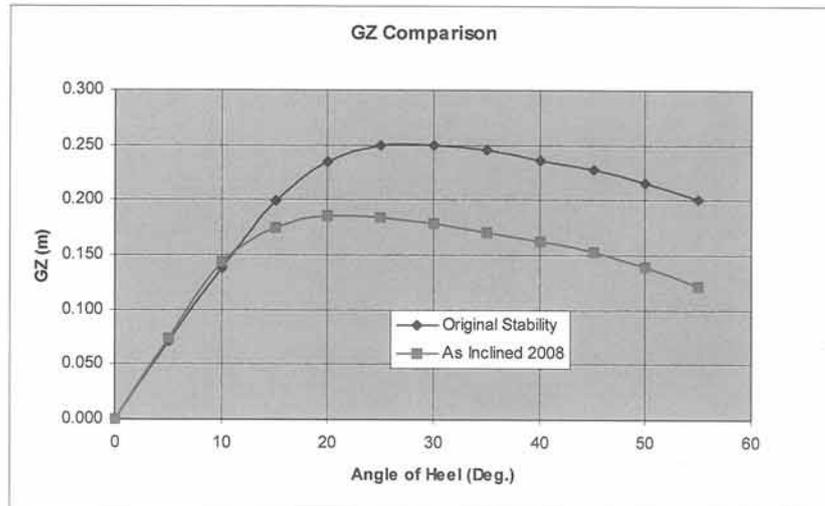
The difference between the two graphs represents the loss of stability due to the change in the lightship. As a comment on this graph two conclusions may be drawn. Firstly at small angles of heel, up to ten degrees, the stability profile appears to be marginally improved for the vessel as inclined, this can be attributed to the slightly lower vertical centre of gravity.

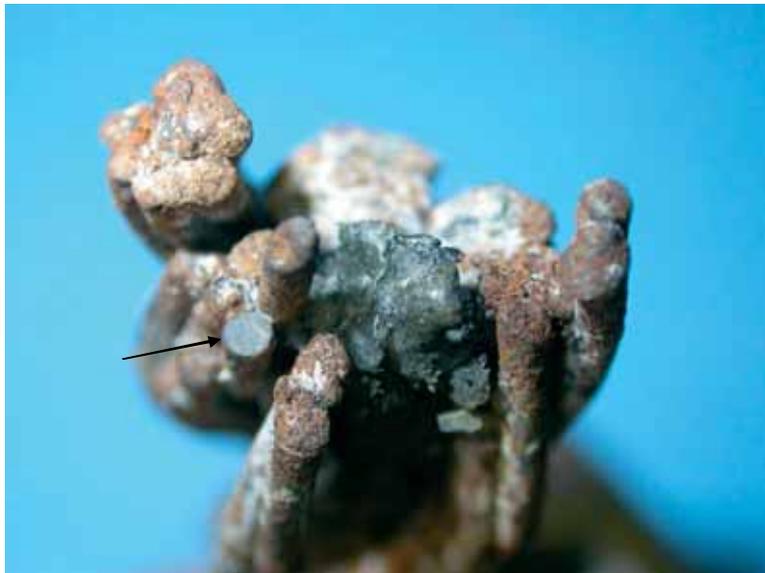
Figure 20: As above and viewed from a different camera angle to show a transverse fatigue like wire fracture (arrowed).

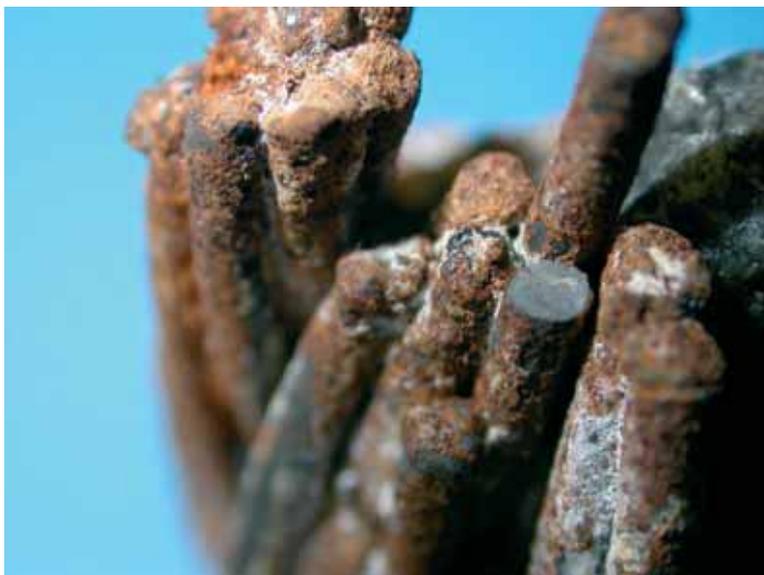
Figure 21: Detail of figure 20, showing fatigue like wire fracture (wire exhibiting unmelted relatively clean grey fracture surface).

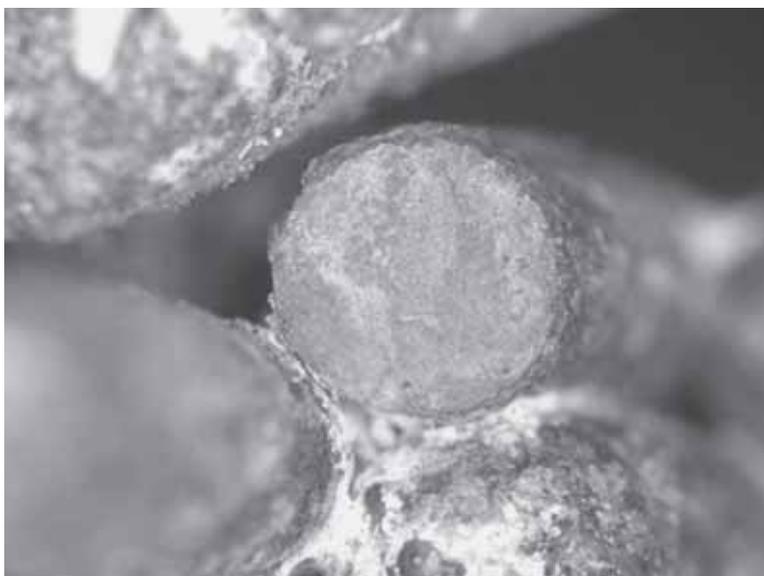
Figure 22: Detail of above.

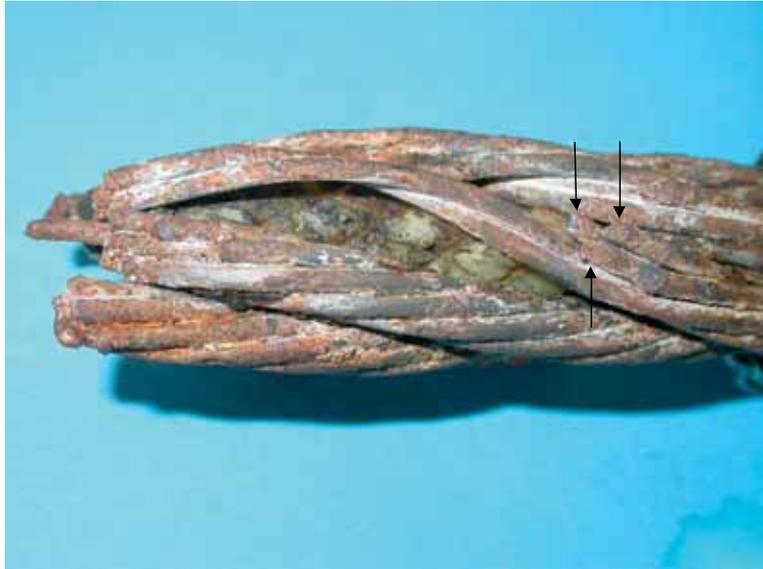
Figure 31: Port Side Winch End sample, showing a site of transverse fatigue like fractures of individual wires.

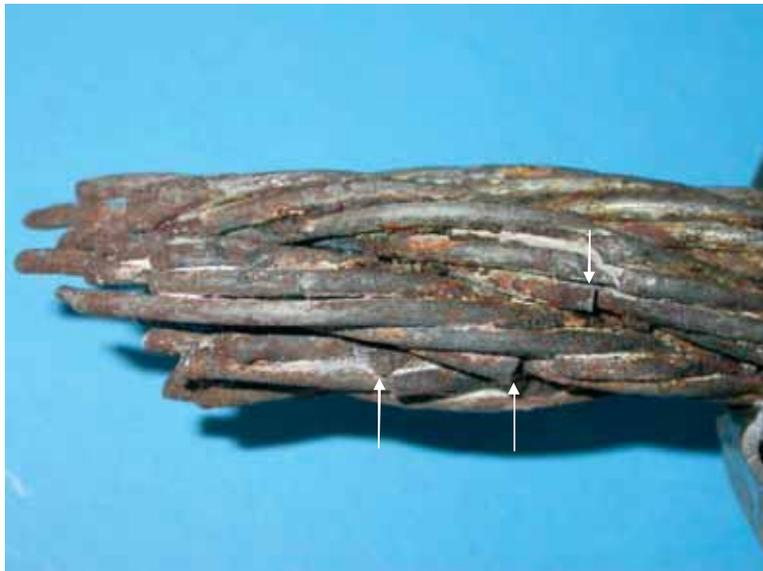
Figure 32: Port Side Fixed End sample, showing sites of transverse fatigue like fractures of individual wires.

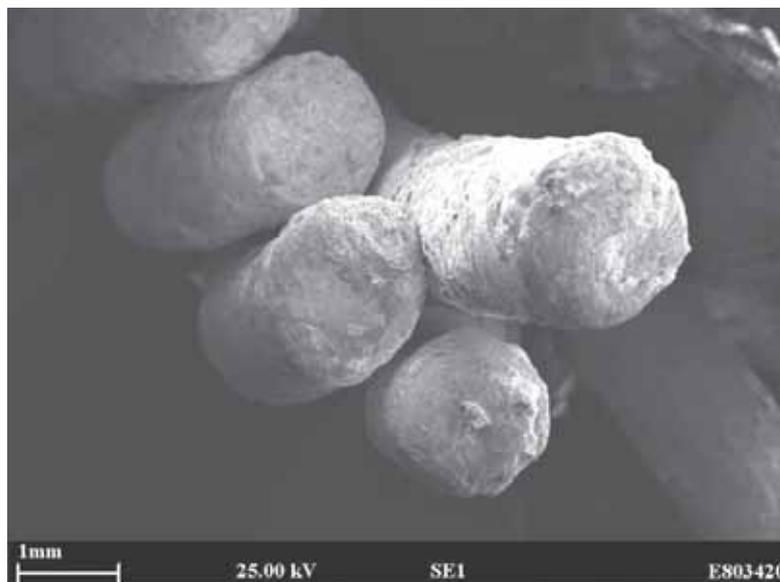
Figure 33: SEM fractograph, showing a group of wires exhibiting transverse fractures (Starboard Side Fixed End sample).

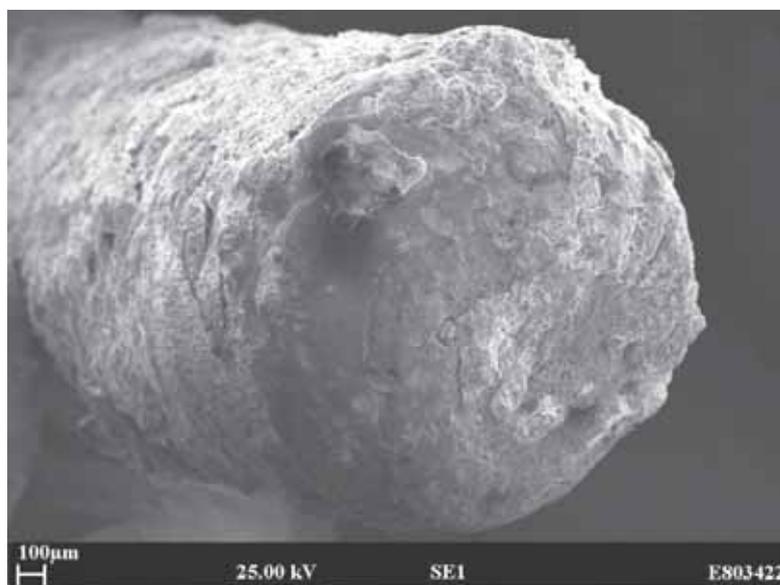
Figure 34: SEM fractograph, showing clear evidence of melting damage in one of the wires shown in figure 33.

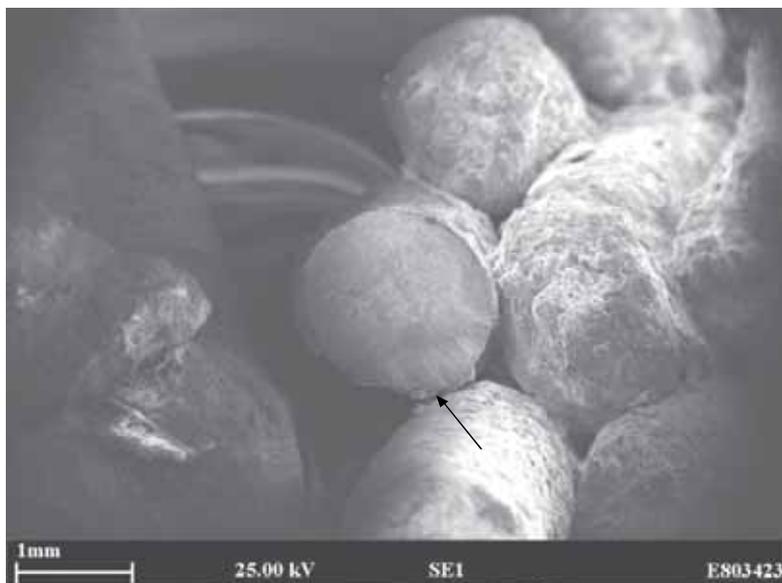
Figure 36: SEM fractograph, showing a transverse wire fracture (arrowed) exhibiting no apparent melting damage (Winch End Port Side sample).

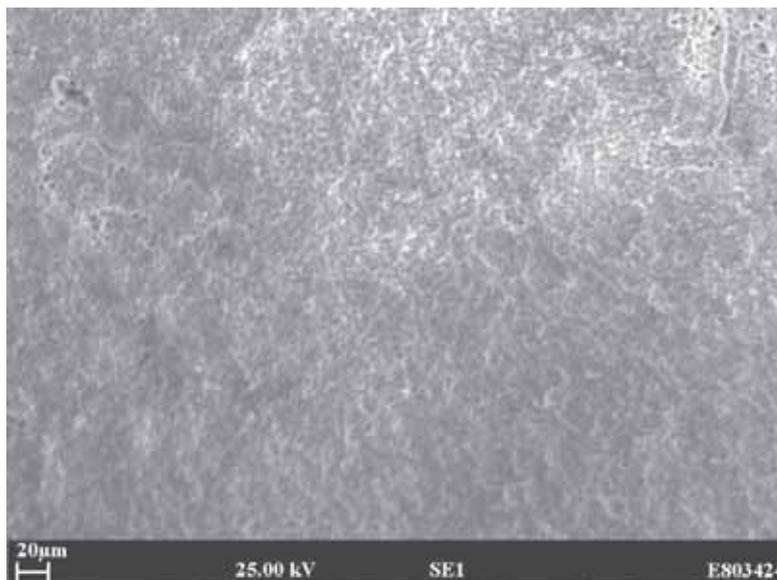
Figure 37: SEM fractograph, showing detail of figure 36 and deeply scaled indeterminate nature of the wires fracture surface in particular.

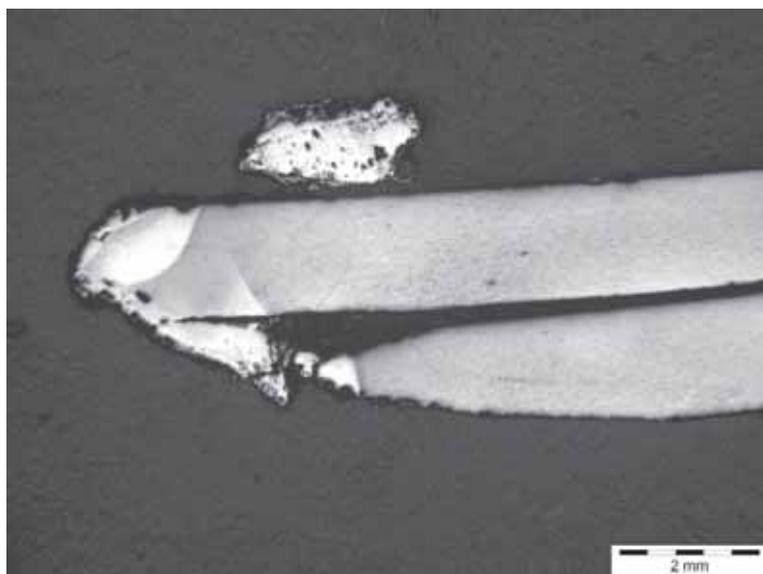
Figure 38: Macrograph (image captured at X12.5) specimen etched in Nital. Strand from the Starboard Fixed End sample showing melting and HAZ damage.

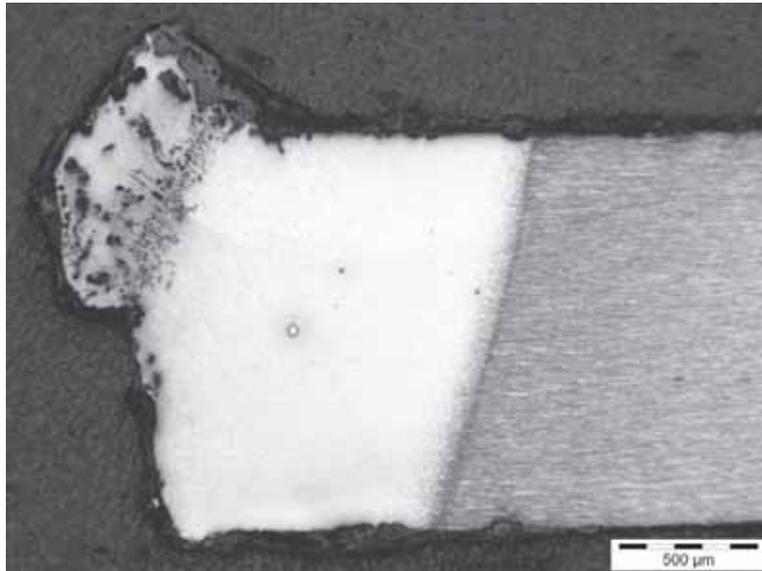
Figure 39: Micrograph (image captured at X50) specimen etched in Nital. Port Side Winch End sample, showing melting and HAZ damage.

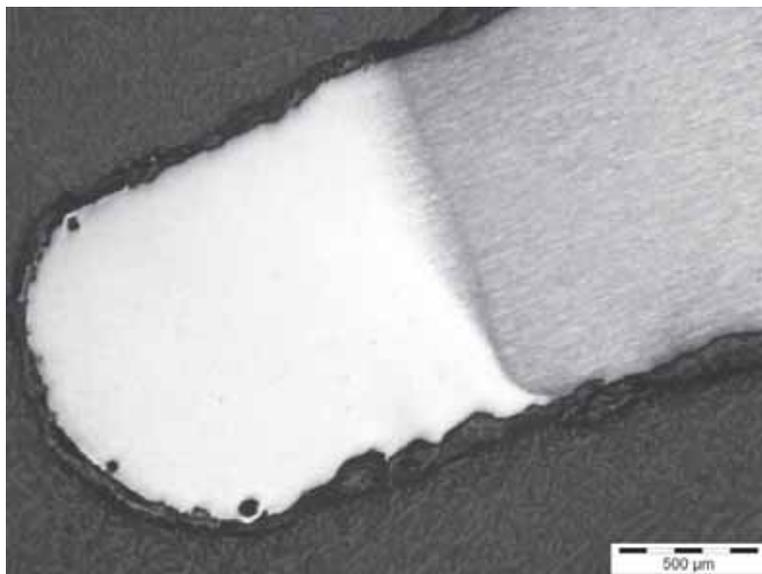
Figure 40: Micrograph (image captured at X50) specimen etched in Nital. Port Side Winch End sample, showing deep HAZ and thermally rounded wire end.

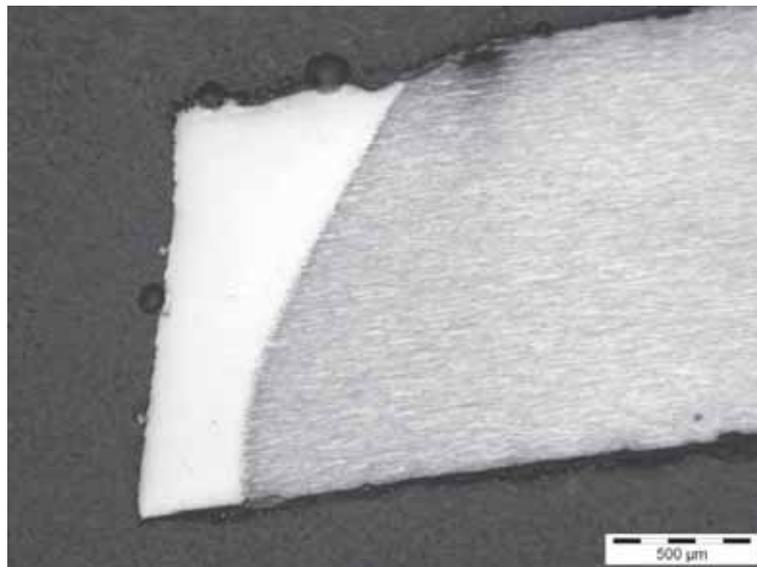
Figure 41: Micrograph (image captured at X50) specimen etched in Nital. Port Side Fixed End sample, showing a relatively shallow HAZ superimposed on what was thought to be an earlier fatigue fracture site.

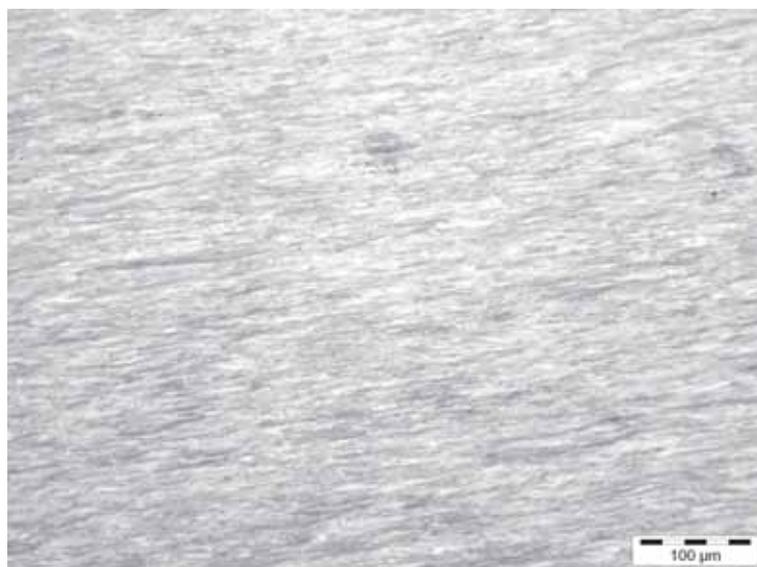
Figure 42: Micrograph (image captured at X200) specimen etched in Nital. Starboard Fixed End sample, showing an anomaly free microstructure typical of the patenting process.
