**REPORT OF INVESTIGATION
INTO A FATAL INCIDENT ON THE
RIVER SHANNON AT
CASTLECONNELL,
CO. LIMERICK
ON
4th FEBRUARY 2016**

**REPORT NO. MCIB/253
(No.6 OF 2016)**

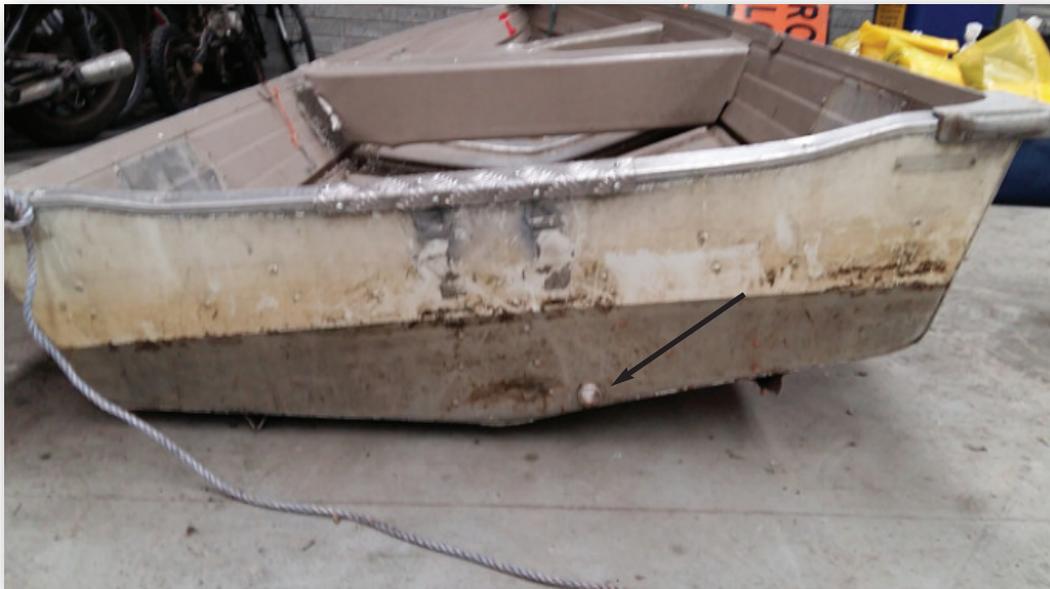
Photograph No. 1 - Transom of boat showing open drain hole.

- 3.6 It is normal practice to remove the drain plug from any boat stored ashore. This is to prevent the boat from filling with water due to rainfall (see Appendix 7.2 Photograph No. 1).

- 4.2 The boat was initially out of the water, tied to the fencing of the Castleconnell Boat Club. The drain plug in the transom had been removed as is normal practice to drain the vessel when it is out of the water and should be replaced prior to the vessel being put back in the water.

- 5.2 As the men lacked any experience of boats and boat handling and given the poor visibility and the amount of drugs and alcohol consumed they did not notice that the drain plug was missing in the transom which resulted in the ingress of water.

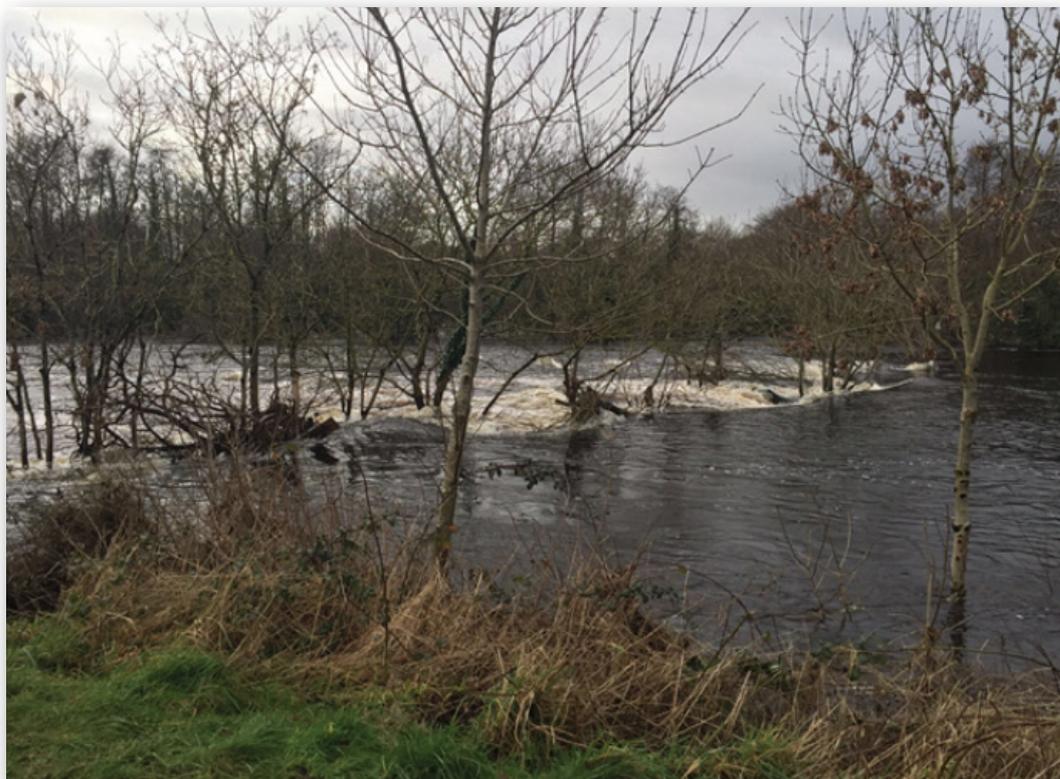
Photograph No. 2 - The river flowing over the spit of land following removal of the boat the day following the incident.

- 3.7 The river initially appeared to the men to be quite calm, however, the level was so high that as the river narrowed and flowed over a spit of land lined with trees further downstream, it became a torrent. This area is known as the 'Gap of the Dam' and is always covered with water as it is the main thoroughfare for the river. It is situated between two spits of land which are normally above the level of the water in the gap and therefore dry with growing vegetation. Whilst the weather was reasonably calm at the time of the incident, the river was in full spate due to the large amount of rainfall in the previous ten to fourteen days (see Appendix 7.2 Photograph No. 2).

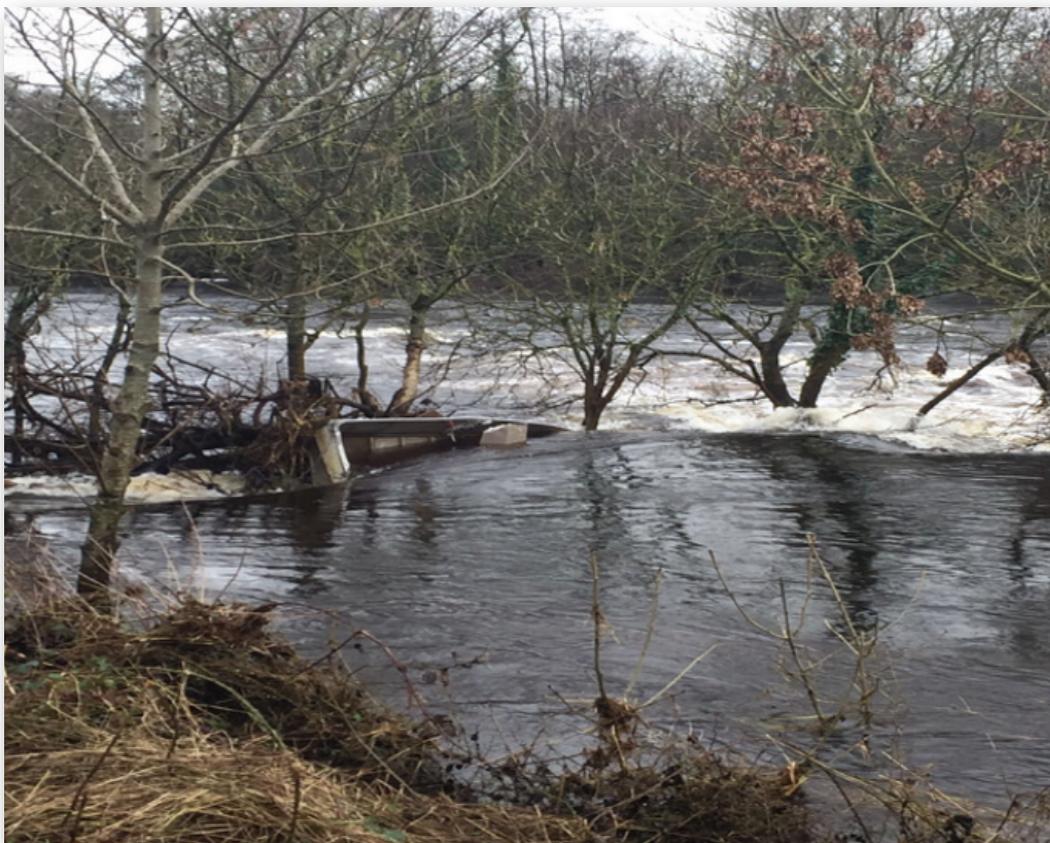
Photograph No. 3 - The boat pinned to the trees later that day.

- 3.9 The men managed to guide the boat into the trees on the spit of land with the river roaring over it like a rapid. The boat was tipped over as it grounded on submerged rocks and the spit, and was pushed into the trees. The four men were thrown into the shallow water (see Appendix 7.2 Photograph No. 3).

- 3.10 The strong current forced the upturned boat against the trees and the leg of one of the men became trapped under the capsized boat. The other three tried to lift the boat off, but to no avail. One of them was washed away from the boat and managed to grab a branch to stop himself being washed through the gap and away downstream. Of the remaining two, one found himself sinking into the bottom and his feet became trapped in the branches and undergrowth under the water.
