**REPORT INTO A
FATAL INCIDENT
ON LOUGH GILL
29th JANUARY 2019**

**REPORT NO. MCIB/285
(No.2 OF 2020)**

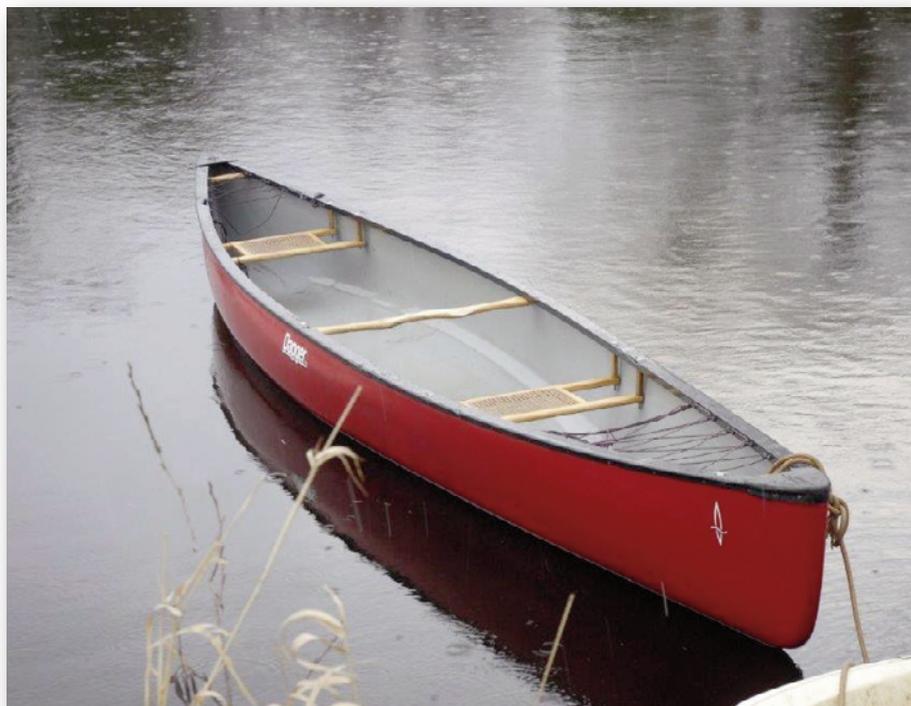
Photograph No. 1 - The Canadian Canoe.

The vessel is described as a Canadian Canoe, constructed of Polyurethane materials, with double ends. The vessel is of open design with two thwarts. It is propelled manually by persons using single paddles. (see Appendix 7.1 Photographs 1, 2 and 3)

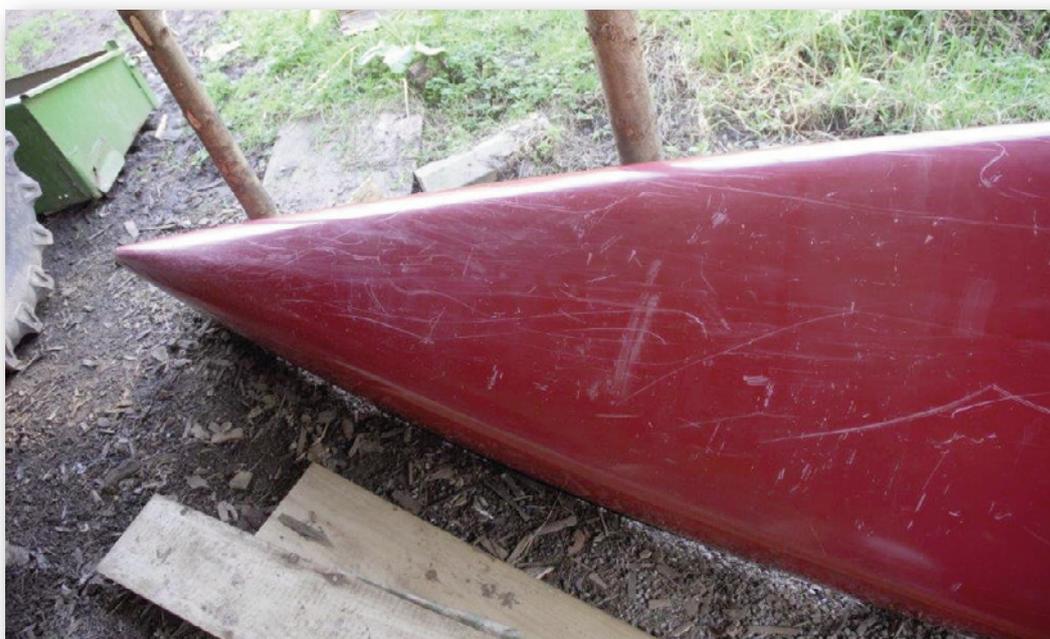
Photograph No. 2 - Canadian Canoe underside.

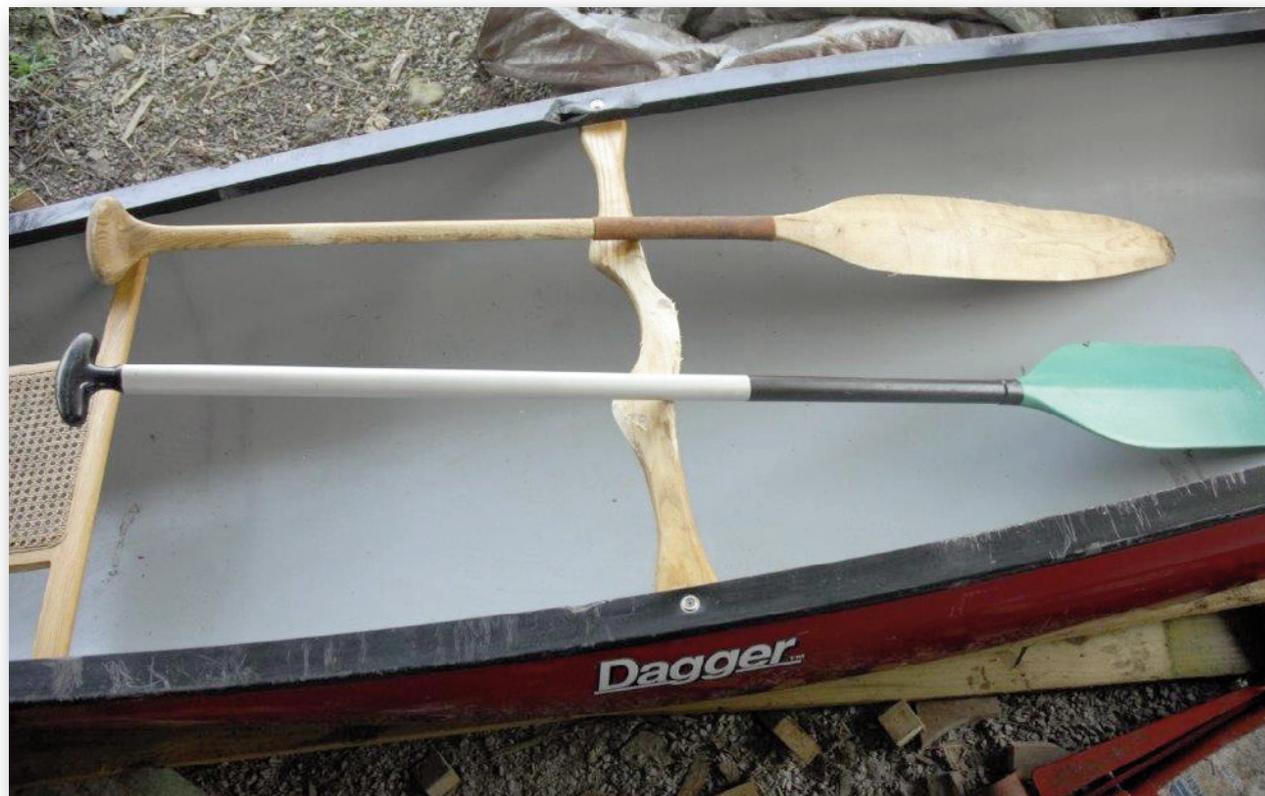
Photograph No. 3 - Canadian Canoe, showing paddles recovered.

- 4.6 The canoe and the Casualty were found in separate locations indicating they became separated after the incident. There were no grab lines fitted to the canoe and no additional equipment was recovered from the scene, apart from two paddles inside the canoe. By leaving his torch and knife at the campsite and not packing away his tools it would indicate that he did not intend to travel far from the camp, nor in darkness, on the lake.

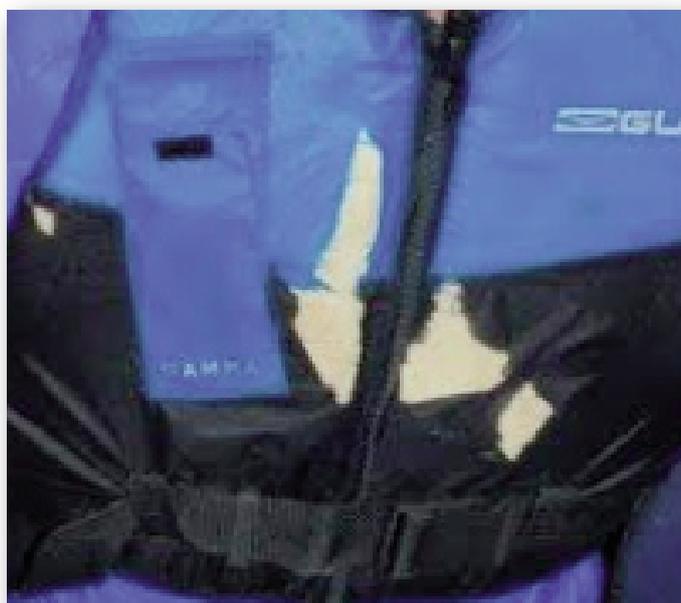
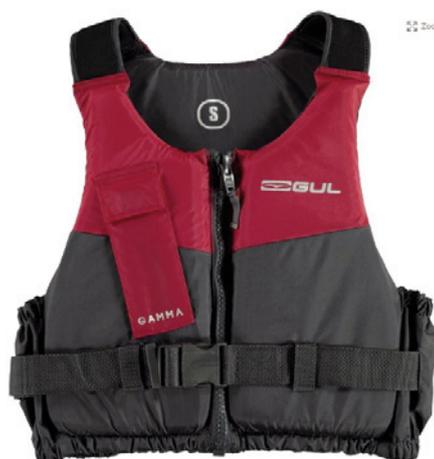
Photograph No. 6 - PFD/Buoyancy aid (actual) showing abrasions and an original.

The Casualty was wearing a Gul brand 50N Personal Flotation Device (PFD). No other safety equipment was found at the scene or at the camp site. (see Appendix 7.1 Photograph 6).

- 3.6 The Coast Guard helicopter crew reported that the Casualty was lying face down in the water when located. His PFD had numerous scrapes and rips. There were also superficial abrasions to the forehead and both arms, indicating that he may have been in that position for some time.

- 4.8 The Coast Guard helicopter crew reported that the Casualty was lying face down in the water when found. His PFD had numerous scrapes and rips on the front and given the superficial abrasions found this would indicate that he was in this position for some time, moving in and out on the shore with the waves. The PFD being worn was rated at 50N and such PFDs are regarded as buoyancy aids.

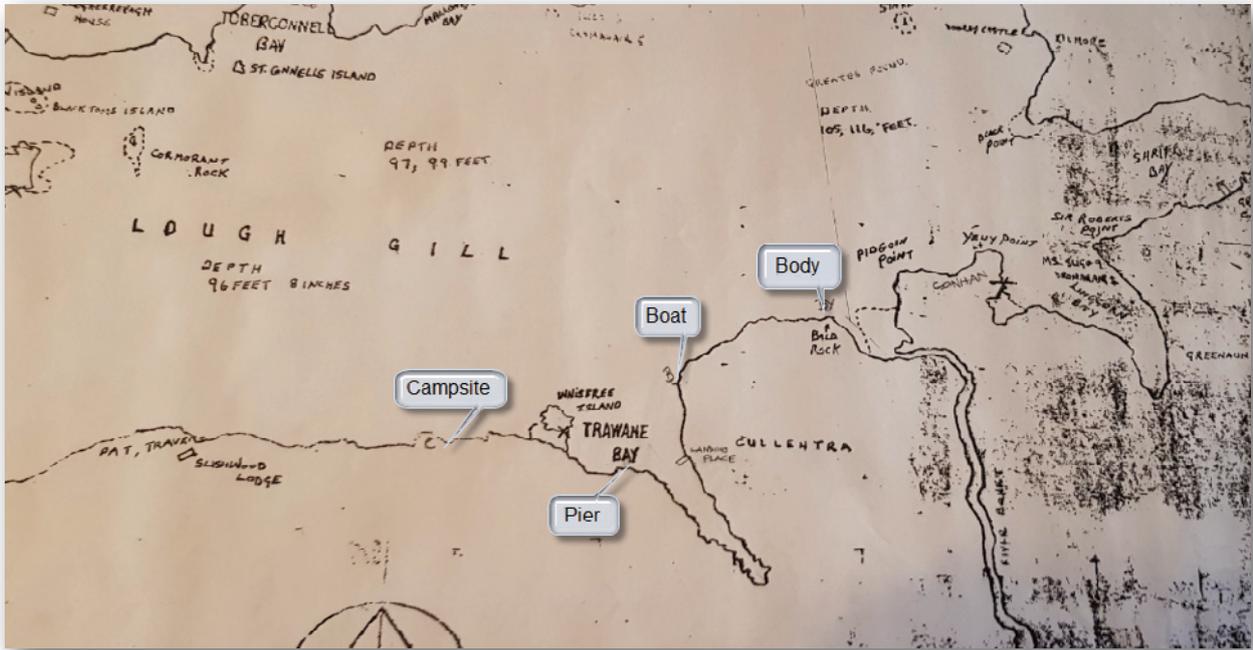
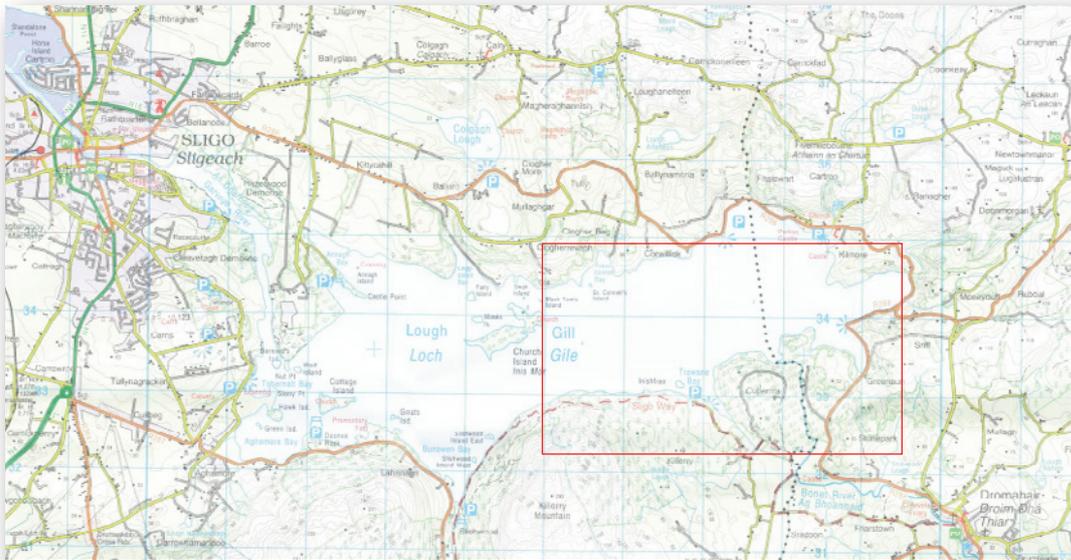
Appendix 7.2 Map of Lough Gill

- 3.5 There were no witnesses to the actual incident nor are the exact circumstances known from any direct evidence. An unofficial chart used by local boat users of the lake was examined and the location of the campsite was established, as were the locations of the canoe and Casualty (see Appendix 7.2 Map of Lough Gill).

- 4.3 The chart provided shows that the passage inshore of the island of Inishfree, near Slisn Woods, was relatively sheltered. However, when canoeing to or from Cullentra Woods, the first 100 metres of his route from Slisn would have been exposed to wind, making this type of canoe difficult to control and would have rendered it unstable (see Appendix 7.2 and 7.2.1).

- 5.5 The charts provided clearly shows that the passage inshore of the Isle of Inishfree was sheltered. However, when leaving Cullentra Woods, if the Casualty went there, the first 100 metres of his route would have been exposed to wind, making the canoe difficult to control even in reasonable weather.
