REPORT ON FATALITY ARISING
FROM A CURRAGH INCIDENT
NEAR MacDARA'S ISLAND,
CO. GALWAY
ON
23rd APRIL 2012

REPORT No. MCIB/215 (No.10 of 2013)

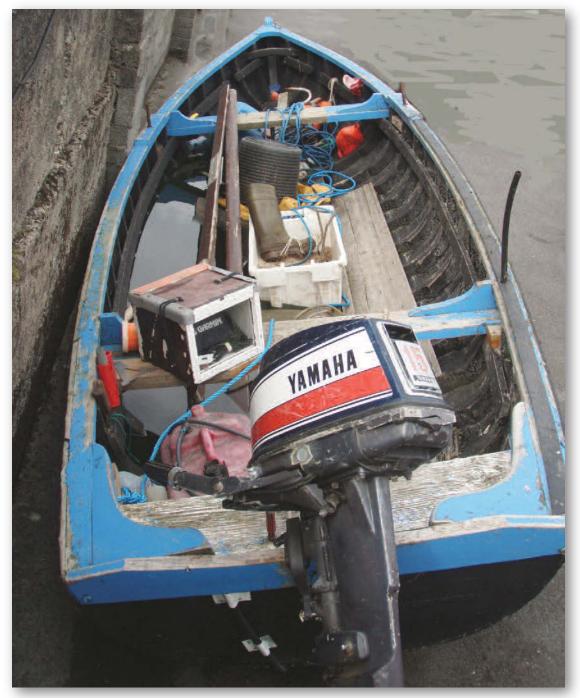
The Carraig Ainne

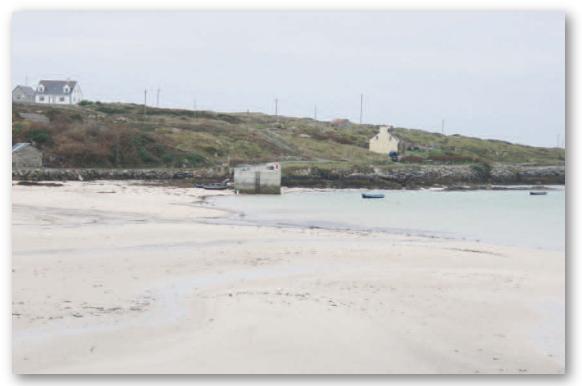
Dooyeher Pier

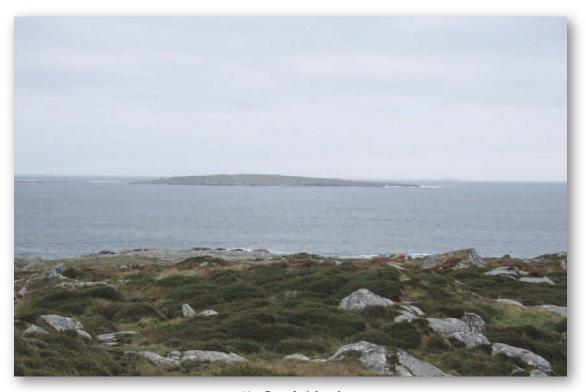
MacDara's Island
