**REPORT OF INVESTIGATION INTO  
A FATAL INCIDENT INVOLVING A  
CAPSIZED PUNT OFF  
BROWNSTOWN HEAD,  
TRAMORE BAY, CO. WATERFORD  
ON  
10th JANUARY 2013**

**REPORT No. MCIB/229  
(No.11 of 2013)**

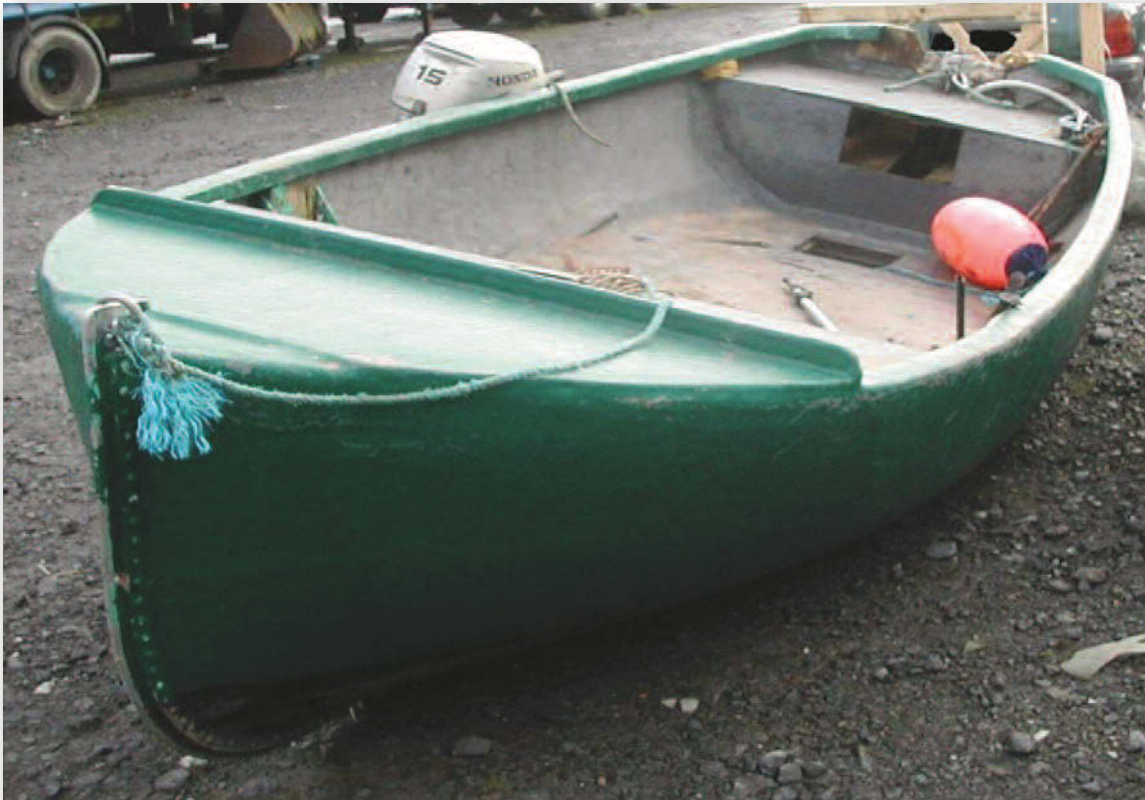
### Appendix 7.1 Photographs of Mr Tate's boat ashore.

- 5.1 As an un-decked open boat, it was very vulnerable to breaking waves coming over the side and filling the boat with water. However, in order for a single large wave to totally swamp the vessel, it must have been floating very low in the water with very little freeboard. This conclusion is supported by the general condition of the vessel when inspected following the incident which showed it to be quite waterlogged in places and probably much heavier than as originally built. The aft buoyancy chamber had also been cut open providing storage for the fuel tank, further reducing the inherent buoyancy of the boat.

Mr Tate's boat ashore.

- 6.1 It is recommended that owners and/or skippers check their small boats regularly and that the inherent buoyancy of a vessel is not tampered with in any way.

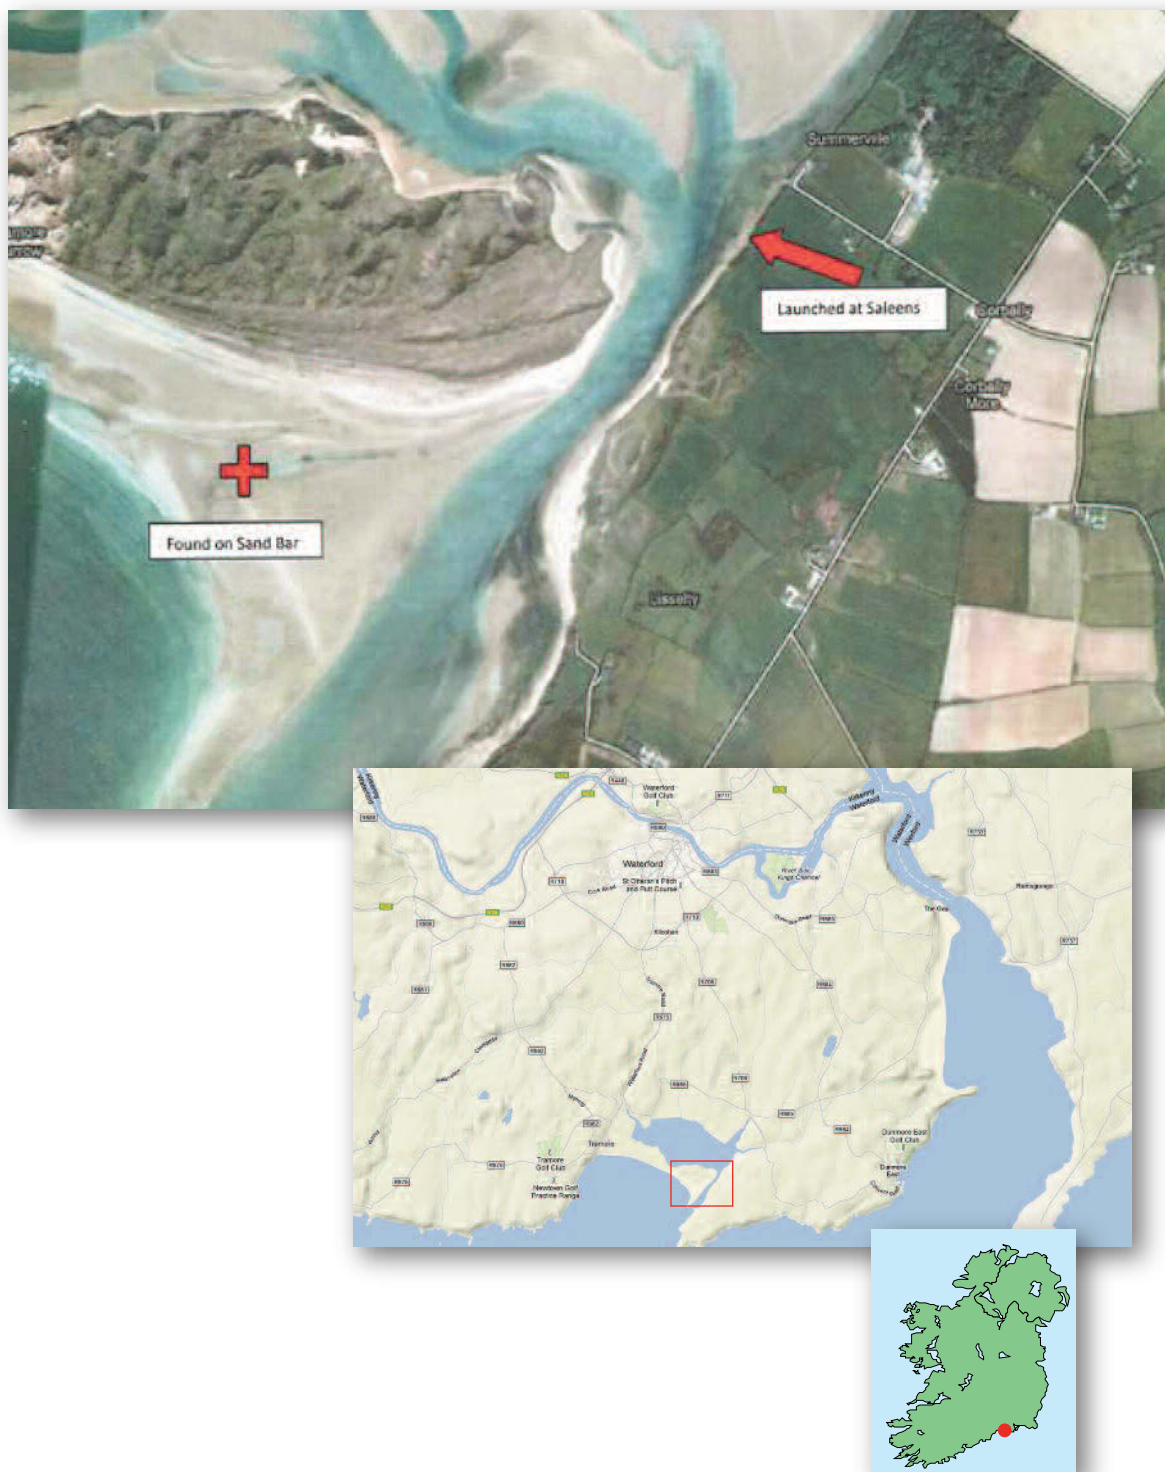
**Appendix 7.5** Aerial photo of Tramore Bay showing launch site and approximate location of boat when found.

- 3.26 At 08:38 hrs, R117 found the casualty approximately 200 to 300 metres to the east of the boat, floating in an upright position, and winched him aboard. They requested an ambulance to be available at Waterford Airport as soon as possible.
