**REPORT OF INVESTIGATION
INTO CASUALTY OFF
AUGHRIS POINT,
CLADDAGHDUFF, CO. GALWAY
21st APRIL 2009**

**REPORT No. MCIB/166
(No. 5 of 2010)**

Report MCIB/166 published by The Marine Casualty Investigation Board
17th June 2010

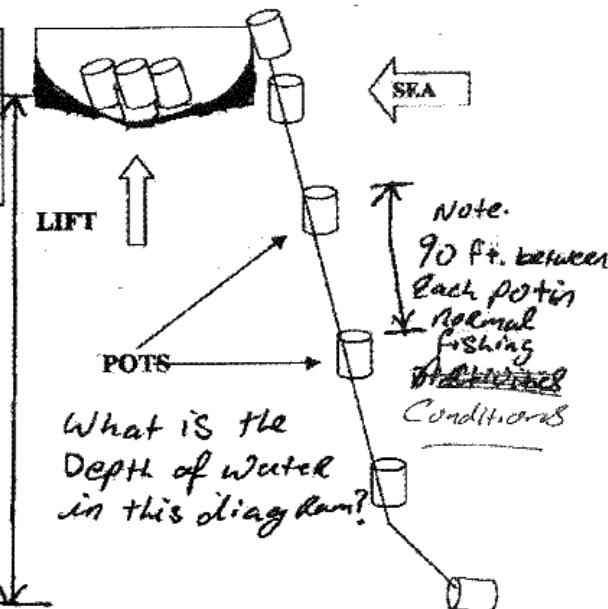
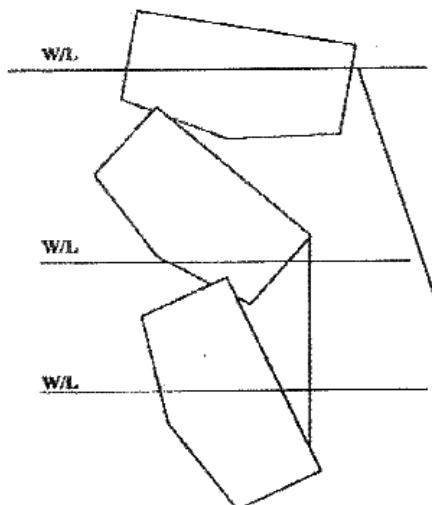
Here the vessel is in the upright position engaged in hauling. Wave action will tend to lift and lower the vessel and apply side or lateral forces, which will result in rolling accelerations.

Note:
at any one time in the location that they were fishing there would never be any more than one pot been hauled at any one time due to the depth of water they were fishing.
Approx: 3m.
SEABED

The weight of the pots now tethered to the side of the currach restricts that side of the vessel from rising freely as a result of wave action. The rolling period is also affected.

As the rolling increases due to energy dissipation combined with the vertical restriction, the net effect is to increase the movement of the extremities.

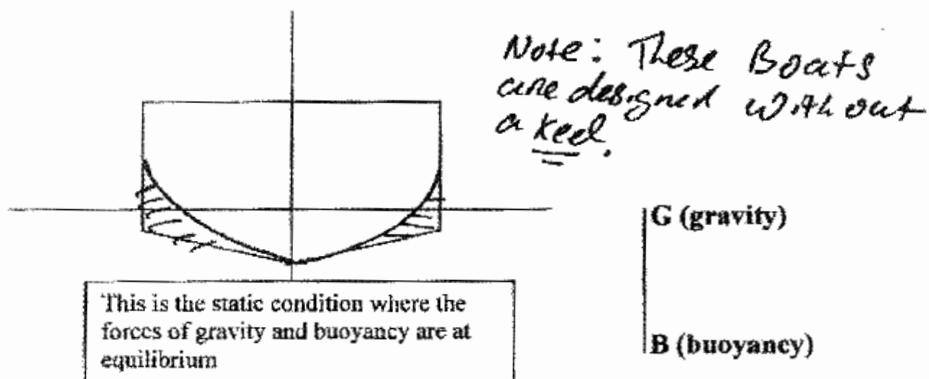
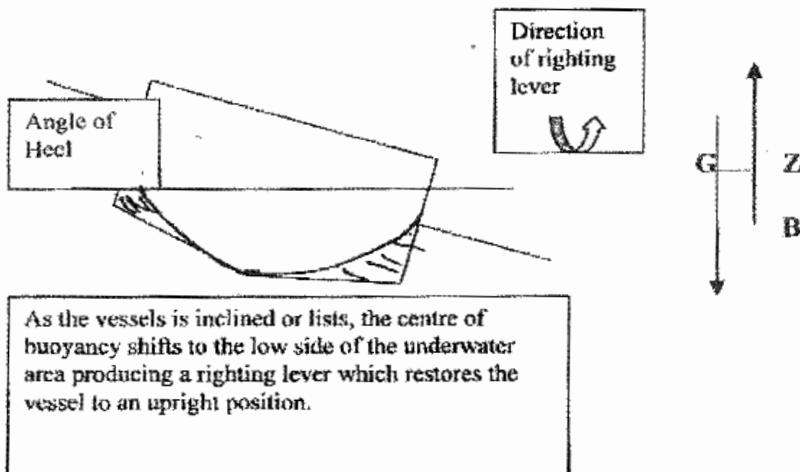
- 6.9 The most significant factor in establishing the cause of this incident is the fact that when the vessel was found, a line of pots were tied off to the thwart (seat) between pots number 4 and 5. This indicates that of the string of 10 pots, (each pot weighing approximately 10 kg when dry and empty), 4 were onboard and the remaining 6 were hanging over the side and along the seabed in an approximate depth of 8 to 10 metres. This would at best restrict the vessel's vertical motion in a seaway and at worst snag the seabed thus compromising the stability/survivability of the vessel. Eventually the rolling accelerations would result in the vessel capsizing. See simplified explanation at Appendix 8.4.

In actual fact the centre of gravity and buoyancy moving in relation to one another eventually sets up an upsetting moment culminating in the vessel capsizing as follows:

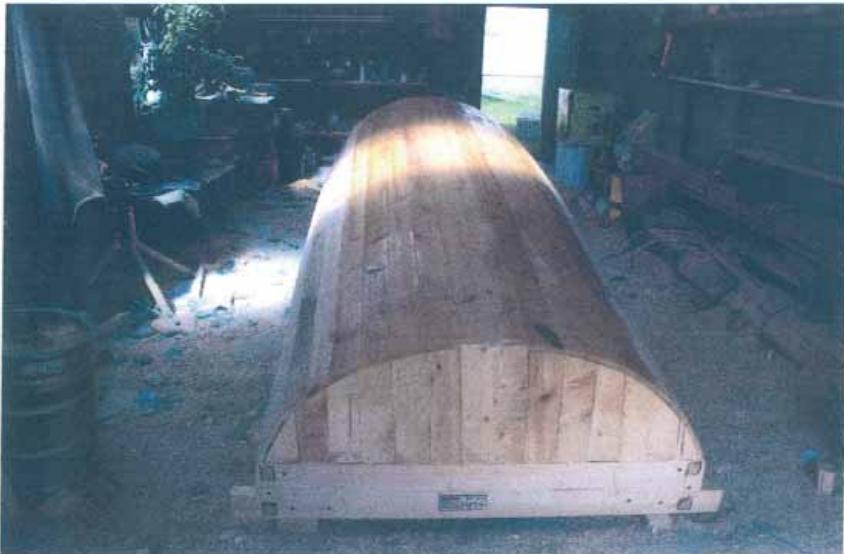
Figure 5.

Shows the hull coated with resin so to allow the timber to soak it and stick the fiberglass layer to the hull. It can also be seen from the figure that the currach has a round bottom and does not have a keel as depicted in the simplified drawings of 8.4 and onwards.
