**REPORT INTO FATAL INCIDENT  
INVOLVING A CAPSIZED PUNT AT  
DUNDALK HARBOUR,  
CO. LOUTH  
ON  
12th FEBRUARY 2012**

**REPORT No. MCIB/212  
(No.4 of 2013)**

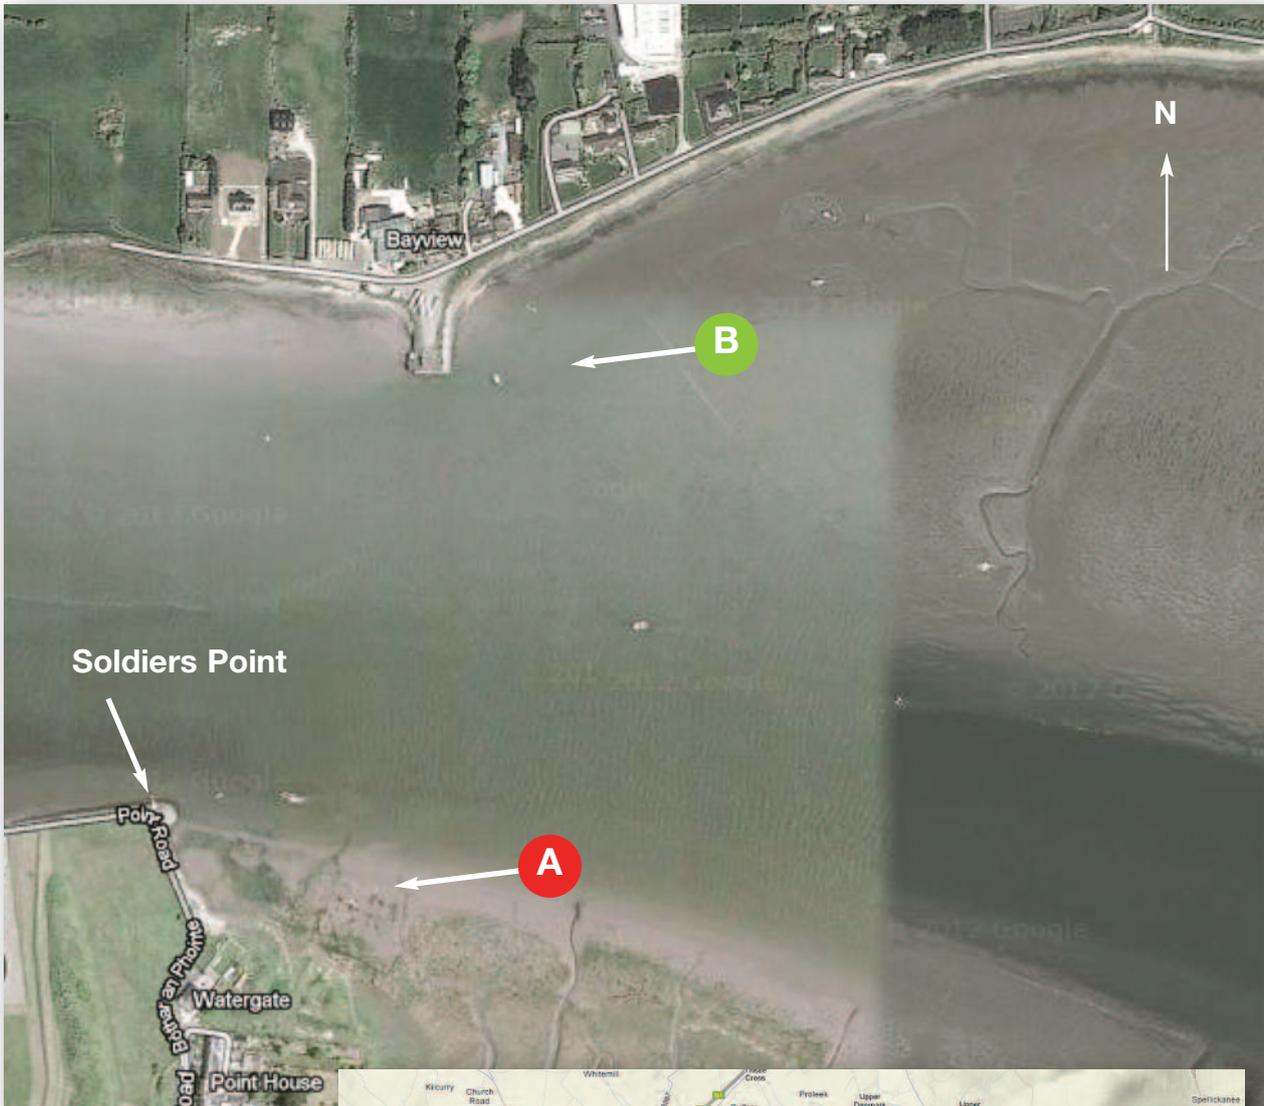
Appendix 7.3 Aerial view of incident site in Dundalk Estuary.

Aerial view of incident site in Dundalk Estuary. Marked are the estimated positions of Mr Fergus's boat (A) and Mr O'Brien's boat (B).
