**REPORT OF INVESTIGATION  
INTO THE LOSS OF THE  
FV "HONEYDEW II"  
OFF RAM HEAD,  
CO. WATERFORD  
ON 11th JANUARY 2007**

**REPORT No. MCIB/135**

Report MCIB/135 published by The Marine Casualty Investigation Board  
31st August 2009

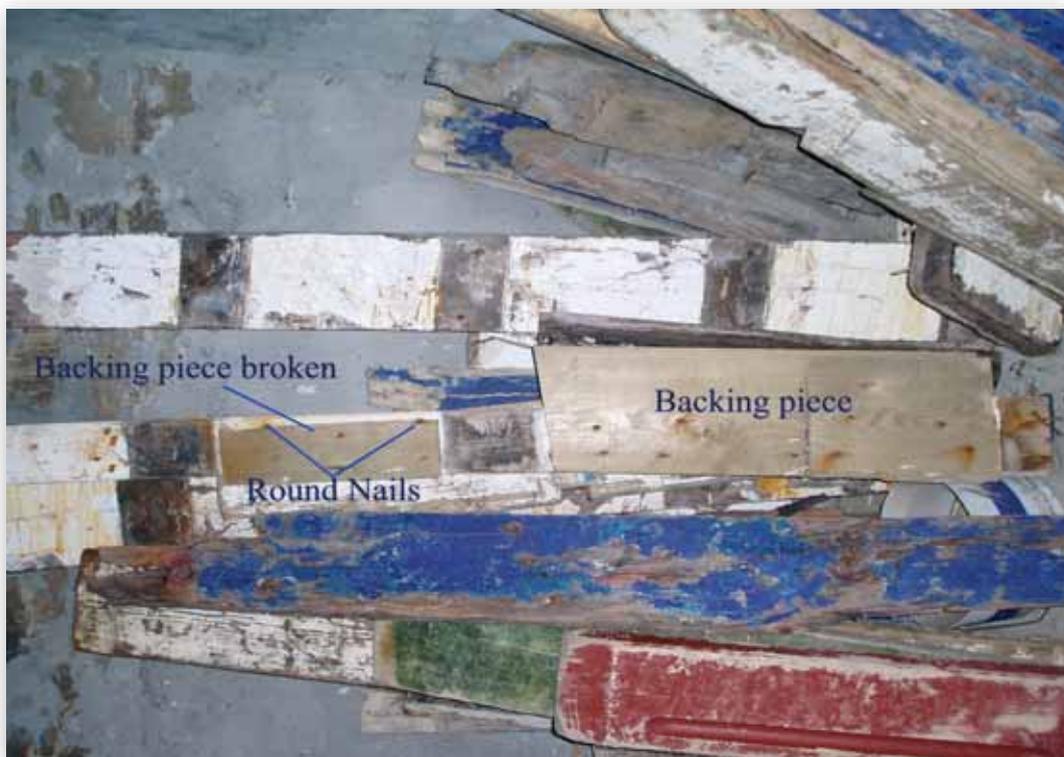
Appendix 9.16(d) Photograph of bulwark timber.

- 7.2.1 The primary reason for the loss of the FV "Honeydew II" is that a wave or waves caused sections of the port bulwark between the stem post and frame five to fail catastrophically and be forced inward. This allowed a large quantity of water to rapidly flood into the shelter deck space. The wave within the shelter deck caused the light plywood cover around the hydraulic tank to break up. A considerable quantity of water probably became lodged behind the sill at the port side of the deckhouse causing an immediate port list.

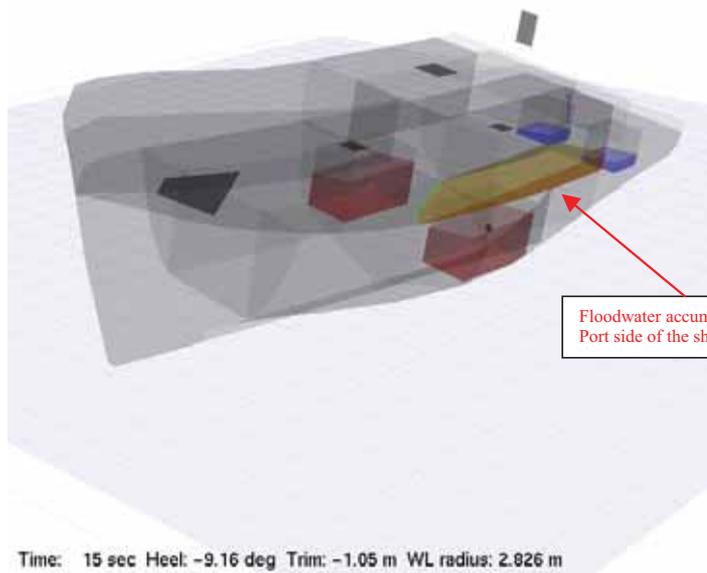
Appendix 9.19 Casualty simulation.

Initially at time equals zero it is assumed there has been ingress of water through the shelterdeck due to damage caused by a large wave.

Water is assumed to enter the shelterdeck space through the damaged bulwark/shelter.

Floodwater accumulates on the Port side of the shelterdeck

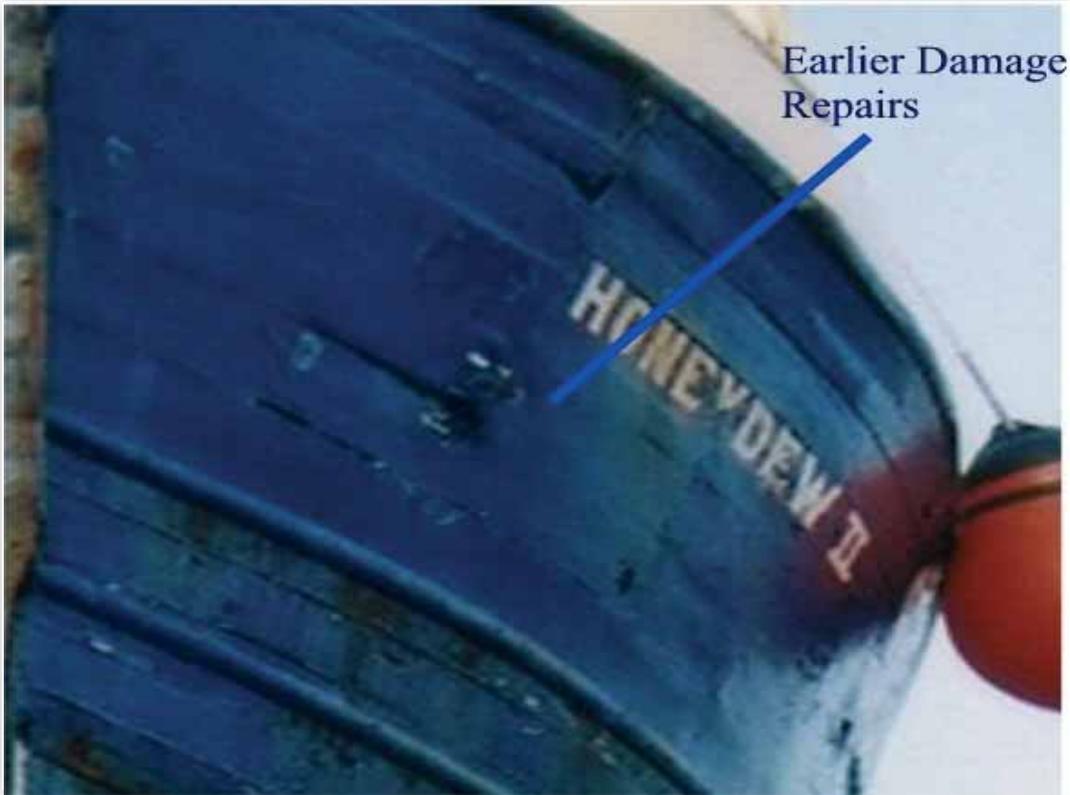
Appendix 9.20(a) Photograph of port bow.

- 7.2.2 The bulwark planking at the bow of the vessel on both port and starboard side had been previously renewed. The area was prone to berthing damage and some of the repairs may have been recent and only temporary in nature. Photographs in Appendix 9.20(a) and 9.20(b) show this area.

- 7.2.3 Previous impacts in this bow area may have created unseen damage to the half frame behind this planking.
- 7.3 The broken plywood, together with small items of fishing gear had the effect of blocking or at least severely restricting the freeing ports. Even if the freeing ports were not obstructed it is unlikely they would have been capable of coping with an inrush of water. The quantity of water on the shelter deck made capsize inevitable. The further downflooding through the engine room intake and crew cabin area and possibly also the fish hold booby hatch caused the vessel to sink quickly from the capsized position.

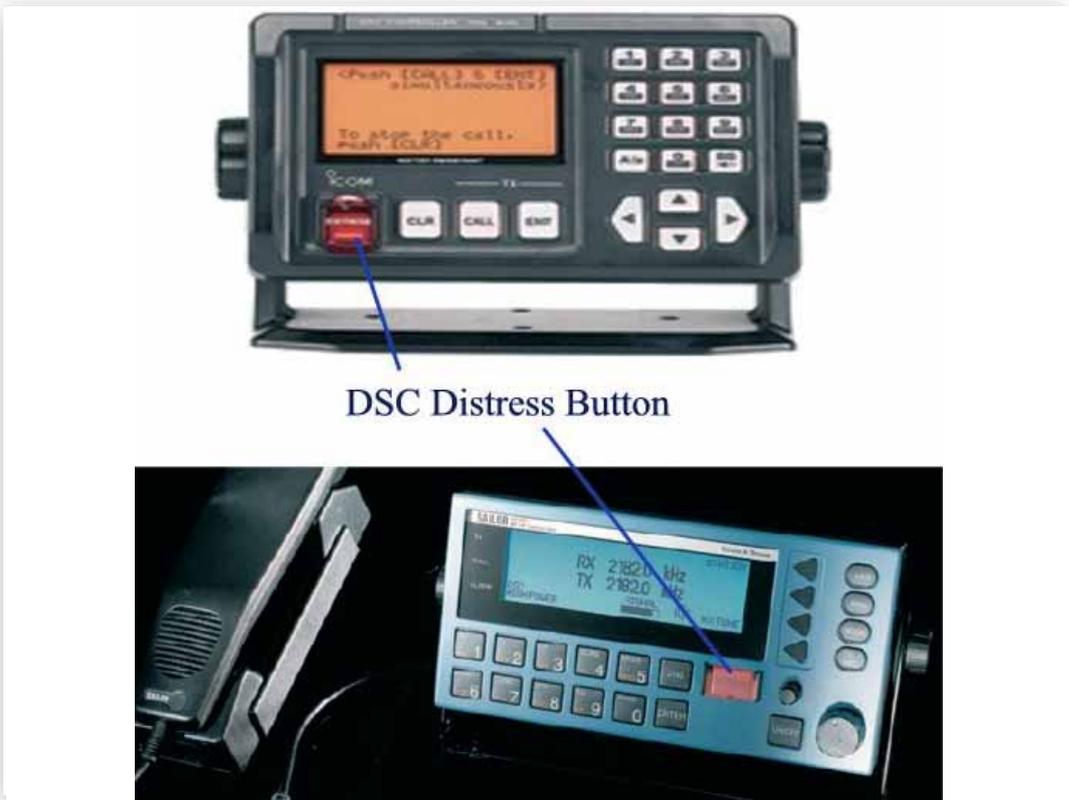
Appendix 9.21 Photographs of radios (Similar to ones fitted)

- 7.5.1 The VMS fitted did not form part of the GMDSS equipment and had no role in distress alerting.
- 7.6 The failure of the vessel to transmit a radio distress signal cannot be readily explained. The radio equipment recorded as having been fitted on the FV "Honeydew II" appeared to be satisfactory and was operating normally three hours before the incident. In the absence of the required radio survey, the adequacy of its emergency power supply and ability to transmit DSC distress alerting are not clear. A photograph in Appendix 9.21 shows the MF and VHF radios fitted to the FV "Honeydew II", the DSC alert button clearly visible.
