**REPORT INTO A FATAL INCIDENT
ON LOUGH DERG
CLOSE TO THE SHORE NEAR
GARRYKENNEDY
2nd AUGUST 2012**

**REPORT No. MCIB/221
(No.13 of 2013)**

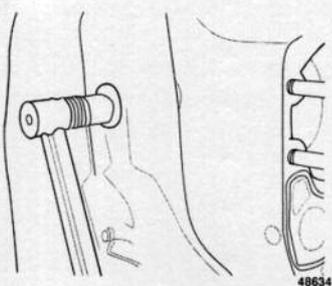
48634

- 4.3 Examination of the outdrive revealed that the pivot pin on the port side of the outdrive had been loose and not correctly in place before the incident. The degree of damage to the outdrive as a consequence of the impact indicates to the Board that, even if the pivot pin had been correctly in place, it would not have been able to sustain the force of the impact. Thus it would not have prevented the damage to the outdrive and the subsequent breaching of the transom of the boat.

3. Align and install the other pivot pin. Tilt the housing up and down to see if it moves freely. Use a 1/2 in. hex socket and tighten the pivot screws to 105-120 ft. lb. (142-163 N.m).
