**DRAFT REPORT OF THE  
INVESTIGATION INTO THE  
INCIDENT AT LOUGH MASK,  
CO. MAYO,  
WITH THE RESULTANT LOSS  
OF LIFE ON 9th MAY 2007**

**REPORT No. MCIB/141**

Report MCIB/141 published by The Marine Casualty Investigation Board  
5th December 2008

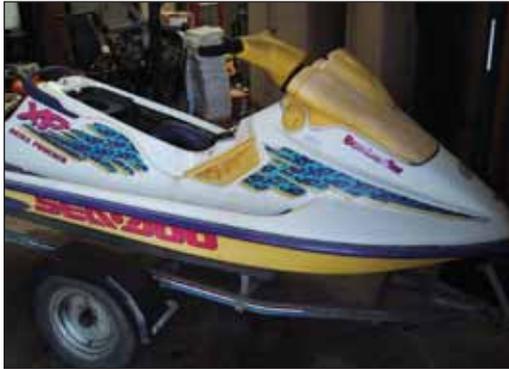
Figure 1. Seadoo

On inspection of the crafts stern and main section, no indentation or structural damage was noted. The hull was in an intact state, with slight gel coat abrasion damage.

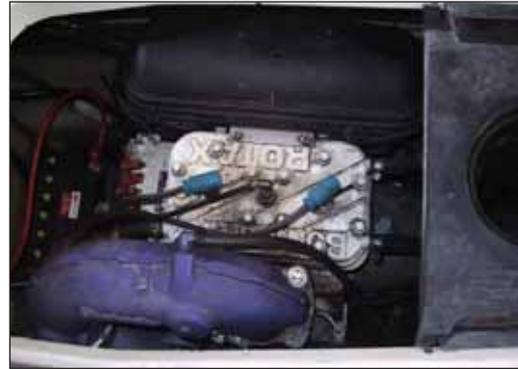
Figure2. Engine Compartment

1. Steering System.  
(Minimal play due to excessive wear on the connecting pinions)
2. Engine power management.  
(Throttle cable connection from trigger to engine control.)
3. Dead man Switch  
(Switch was not fitted to the craft at the time of inspection.)
4. Engine Operational run.  
(With the assistance of external battery booster, the engine ran achieving average compression.)
5. Crafts Battery test.  
(Incapable of retaining charge and unable to be recharged through the alternator charging system.)
6. Variable Trim System.  
(The Variable Trim System was not in operation due to damage to the control rods.)

Exhaust damage due to loose retaining bolts
