The Marine Casualty Investigation Board was established on the 5th, June 2002 under The Merchant Shipping (Investigation of Marine Casualties) Act 2000

**INVESTIGATION INTO
THE LOSS OF THE
“PISCES”
AT
FETHARD-ON-SEA,
CO. WEXFORD
ON 28th JULY, 2002.**

1. The following is the final draft report on the investigation carried out by the Marine Casualty Investigation Board into the foundering of the vessel "PISCES" with the loss of five lives on 28 July, 2002 near Fethard-on-Sea, Co. Wexford.
2. The investigation was carried out in accordance with Section 26 of the Merchant Shipping (Investigation of Marine Casualties) Act, 2000.
3. The purpose of this investigation is to establish the cause, or causes, of this incident and to make recommendations for the avoidance of similar marine casualties in the future.
4. The Marine Casualty Investigation Board is precluded by law from attributing blame or fault.
5. The Marine Casualty Investigation Board would like to express its appreciation and gratitude to all who assisted in this investigation, and in particular:

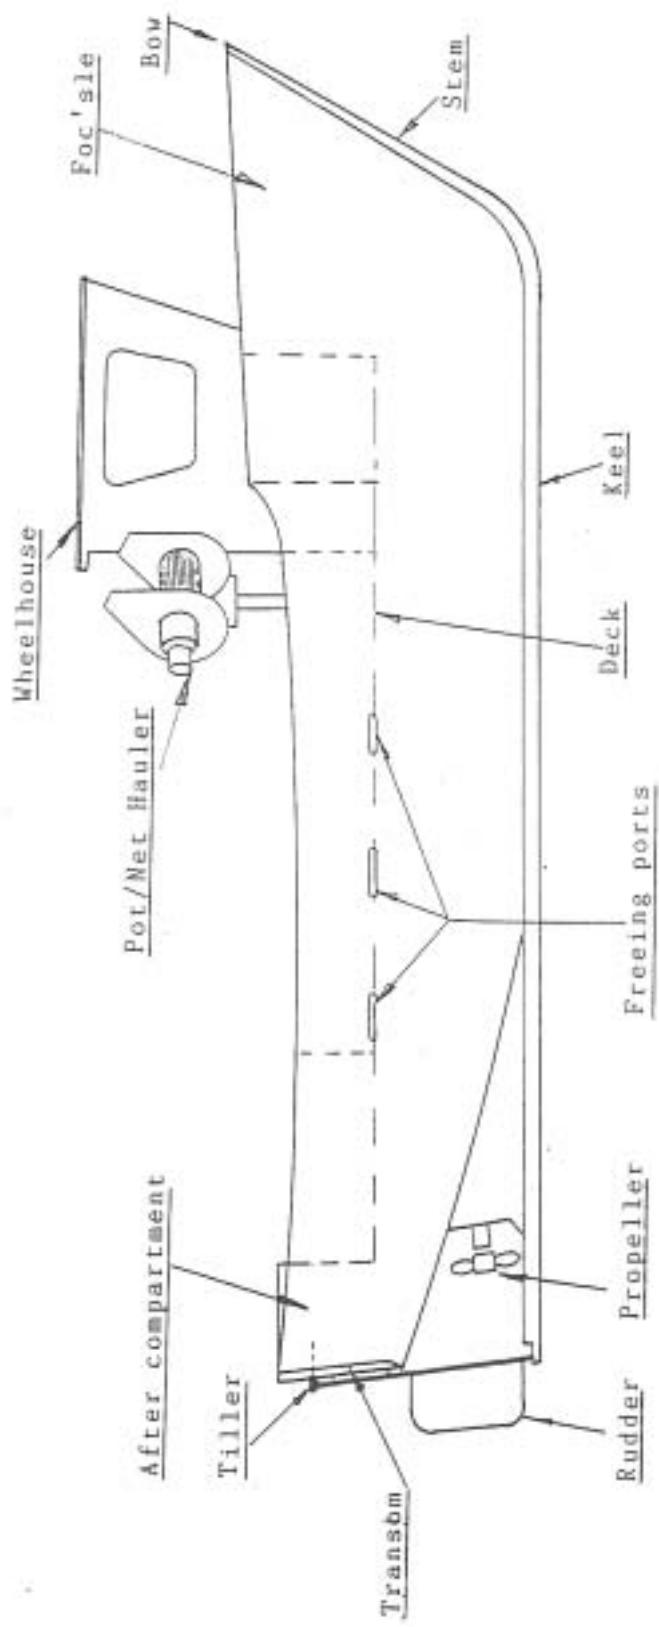
Appendix 1: General arrangement of "PISCES".

The rudder was operated by a manual hydraulic arrangement whereby the operation of the helm produced a corresponding displacement of fluid in a hydraulic ram located in the after-decked compartment. This ram was attached to the rudder tiller (a lever which passed through the transom) which, in turn, was attached to the top of the rudderstock (bar on which the rudder is mounted). This arrangement ensured that any movement of the helm (steering wheel) in the wheelhouse caused a corresponding movement of the rudder (see Appendix 1).

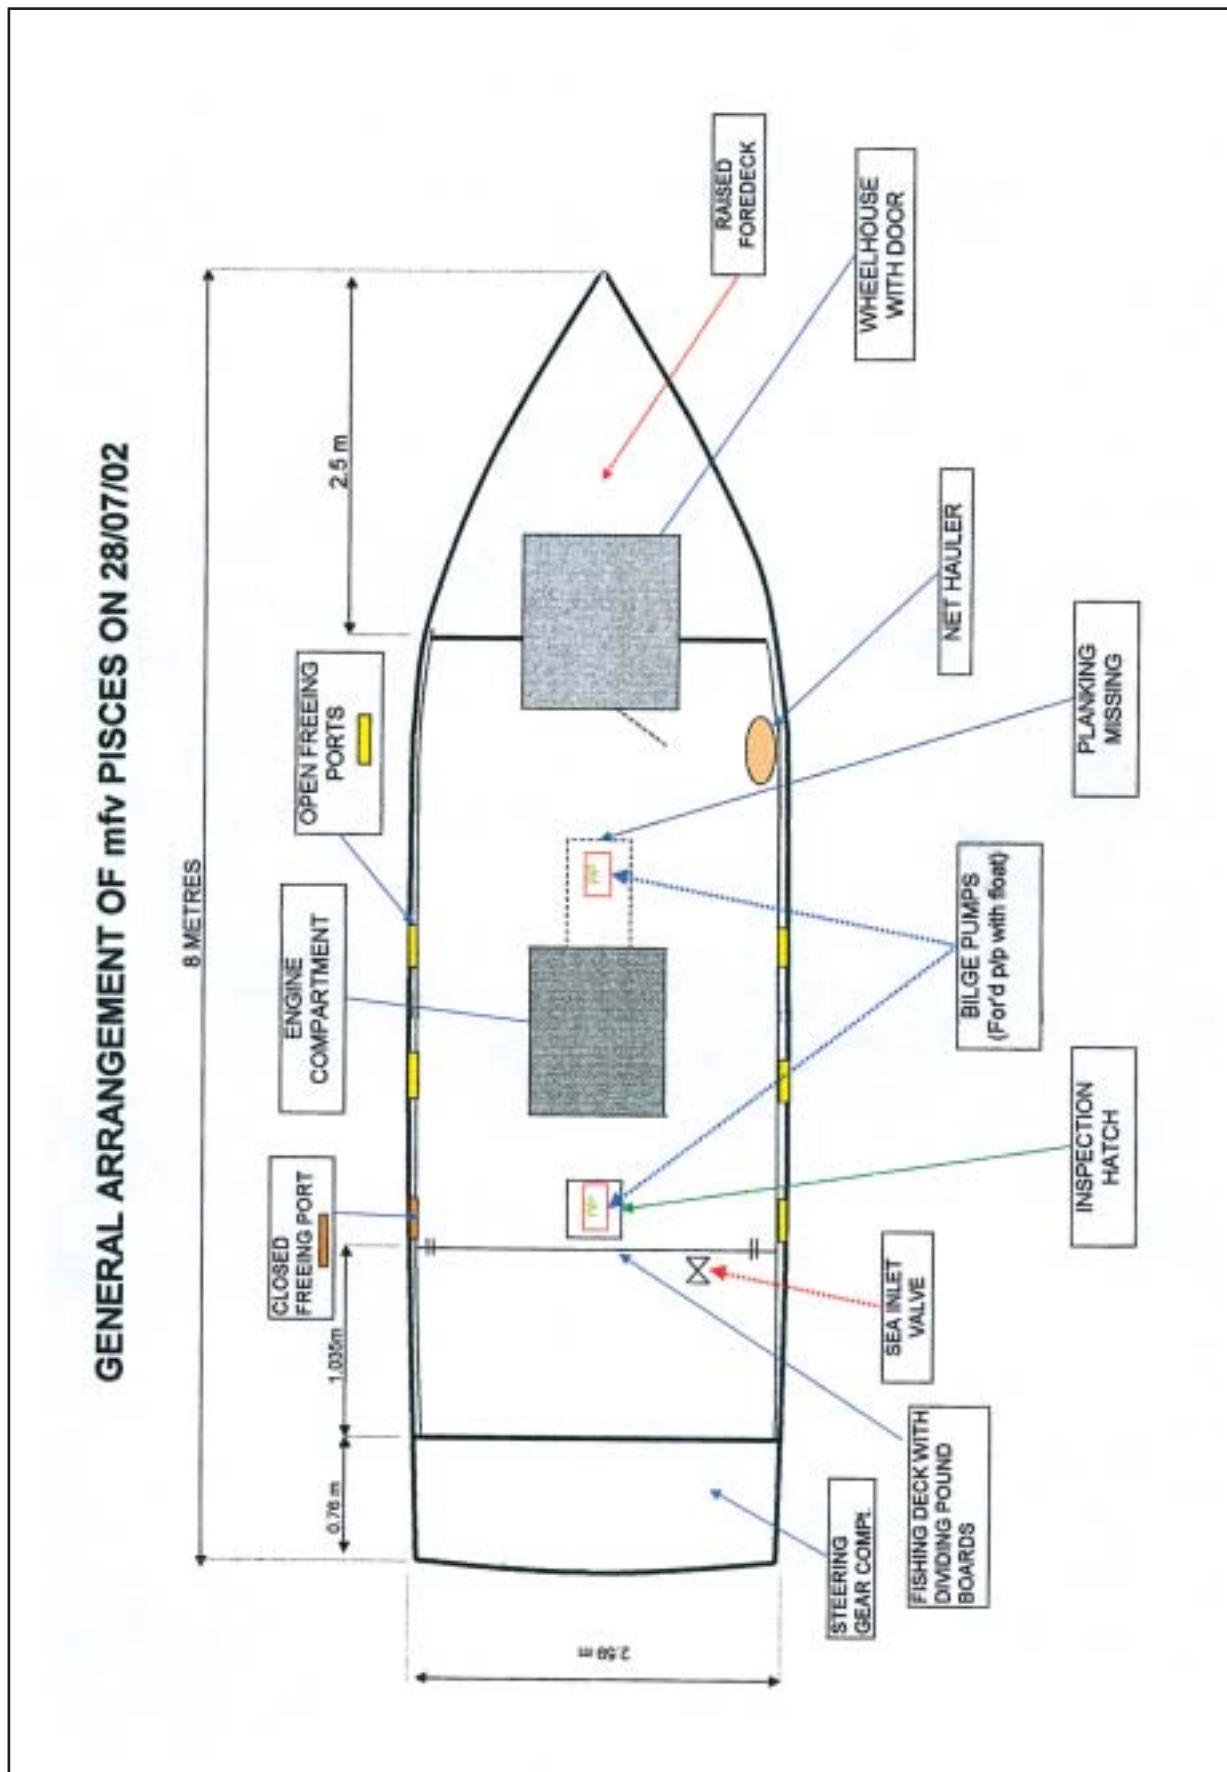
Appendix 2: General arrangement of MFV "PISCES" on 28/7/'02.

The "Pisces" had originally been built as an open boat in the area aft of the wheelhouse and the sides of the vessel would have been intact from the gunwhale to the waterline. This arrangement ensured that the vessel had more than adequate "freeboard", (i.e. the distance measured from the top of the gunwhale to the waterline) which provided good protection from water entering the vessel as it rolled in a sea way or rough weather conditions. However, the vessel was later modified by the addition of a new working deck in the area aft of the wheelhouse. It is understood that this modification was carried out between 1991 and 1993.

When this new deck was fitted, six freeing ports (drainage openings) were cut in the sides of the vessel at the level of this new deck to facilitate the run-off of any water on the deck. However, this modification changed the effective freeboard from the original distance of bulwark to waterline of 550mm (about 22 inches) to a new distance of deck edge to waterline of 76mm (about 3 inches) (see Appendix 3). It should be noted that this arrangement would also permit water to flow on to the deck through these openings as no arrangements were fitted to prevent this backflow.

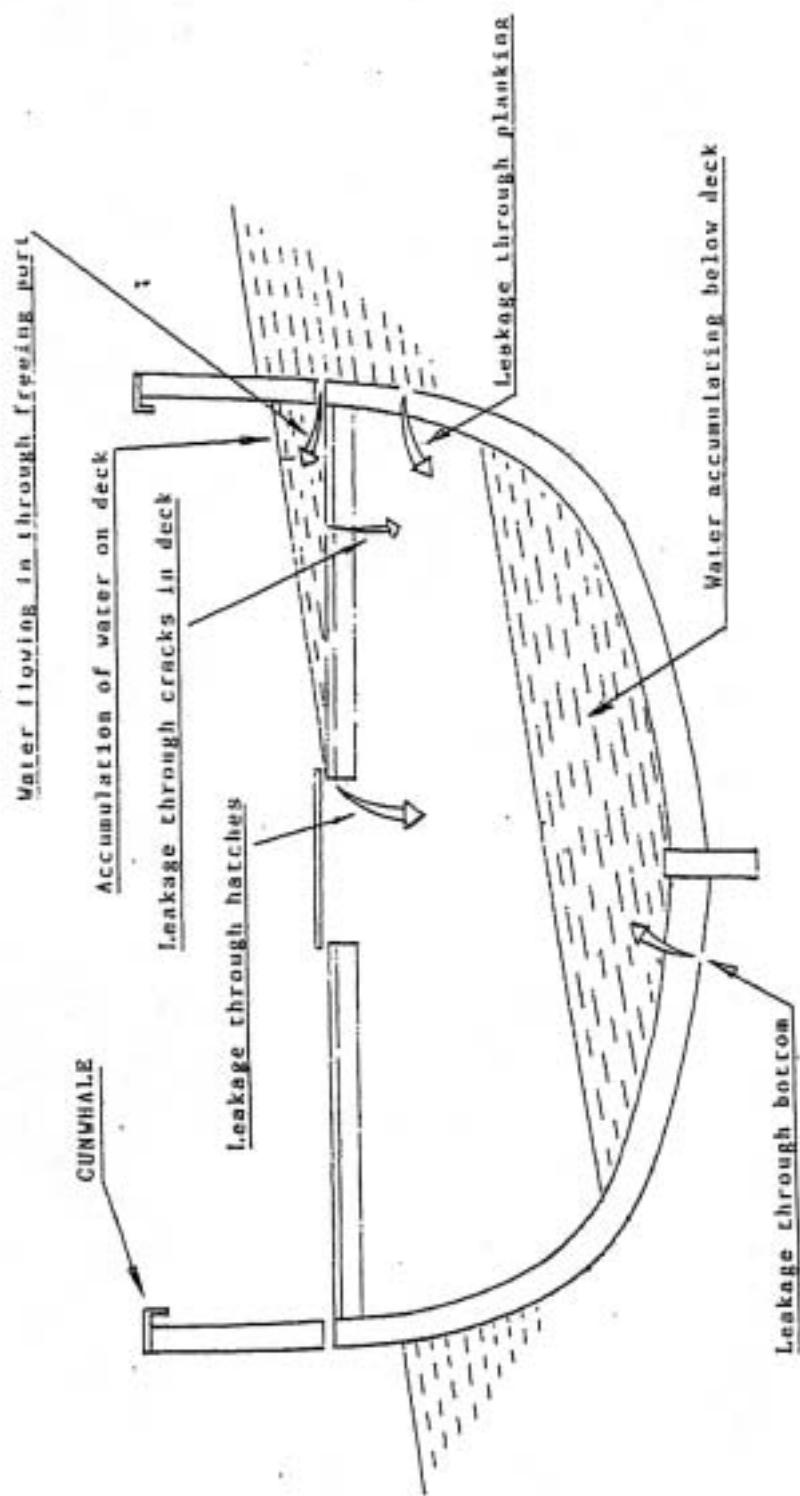
Appendix 9

Diagrams showing water ingress and angle of heel.

Vessel listed to one side
