**REPORT INTO THE SINKING OF  
THE IRISH REGISTERED  
FISHING VESSEL “PAULA”  
ON 24TH JANUARY 2005**

The Marine Casualty Investigation Board was established on the 25<sup>th</sup> March, 2003 under The Merchant Shipping (Investigation of Marine Casualties) Act 2000

Published by The Marine Casualty Investigation Board  
26th February 2007

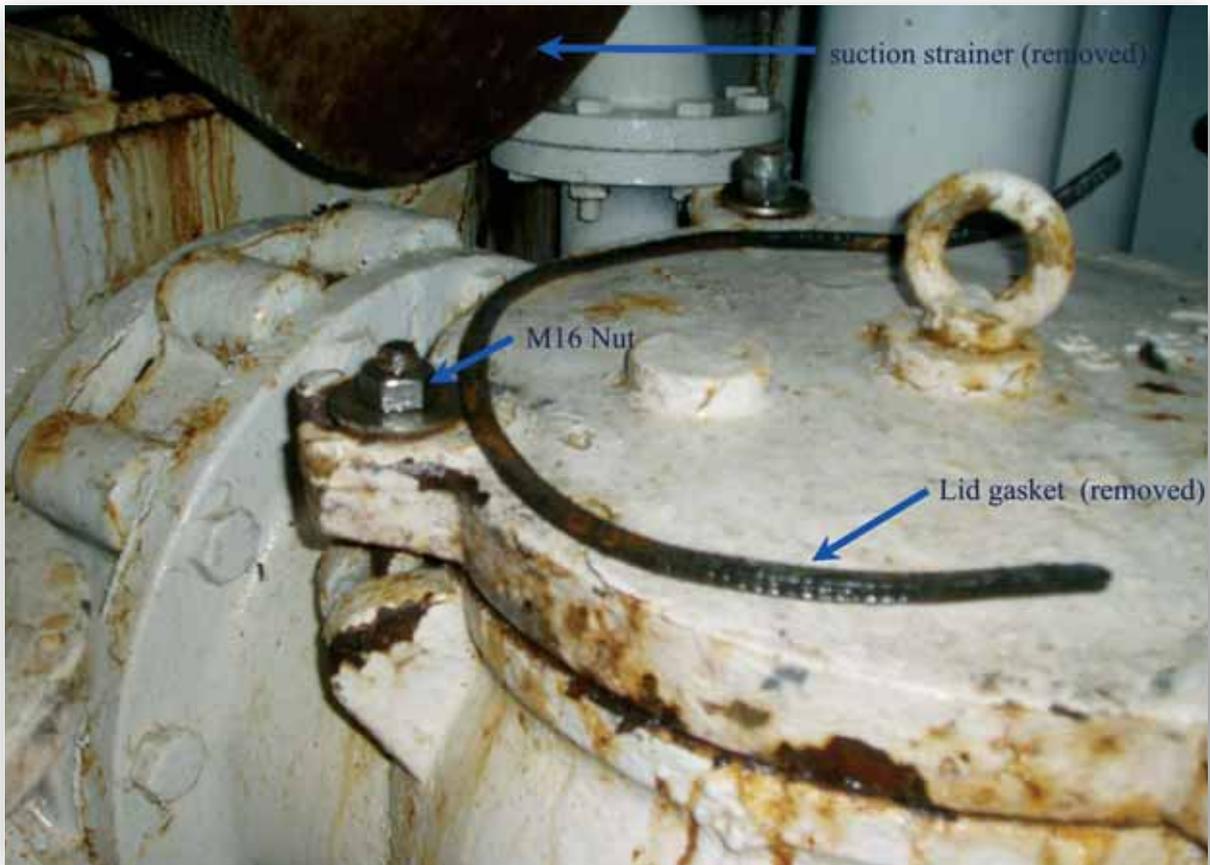
### Appendix 8.5.1 Photograph of suction strainer cover

- 6.1 The primary cause of the accident was the inability of those onboard to stop or reduce a rapid ingress of sea water into the engine room through the open top cover of the portside main sea water suction strainer housing.
- 6.2 This ingress was caused by the port outboard shipside valve not being in the fully closed position before the housing cover was removed.
- 6.3 A statement by the salvage diver states that he found the valve-operating handle three turns open. The normal travel on the valve-operating wheel from the fully open to fully closed position is nine turns.

- 5.12.1 The diver closed this valve and replaced the suction strainer cover, pumps were then used to pump out the flooded compartments and the vessel refloated.

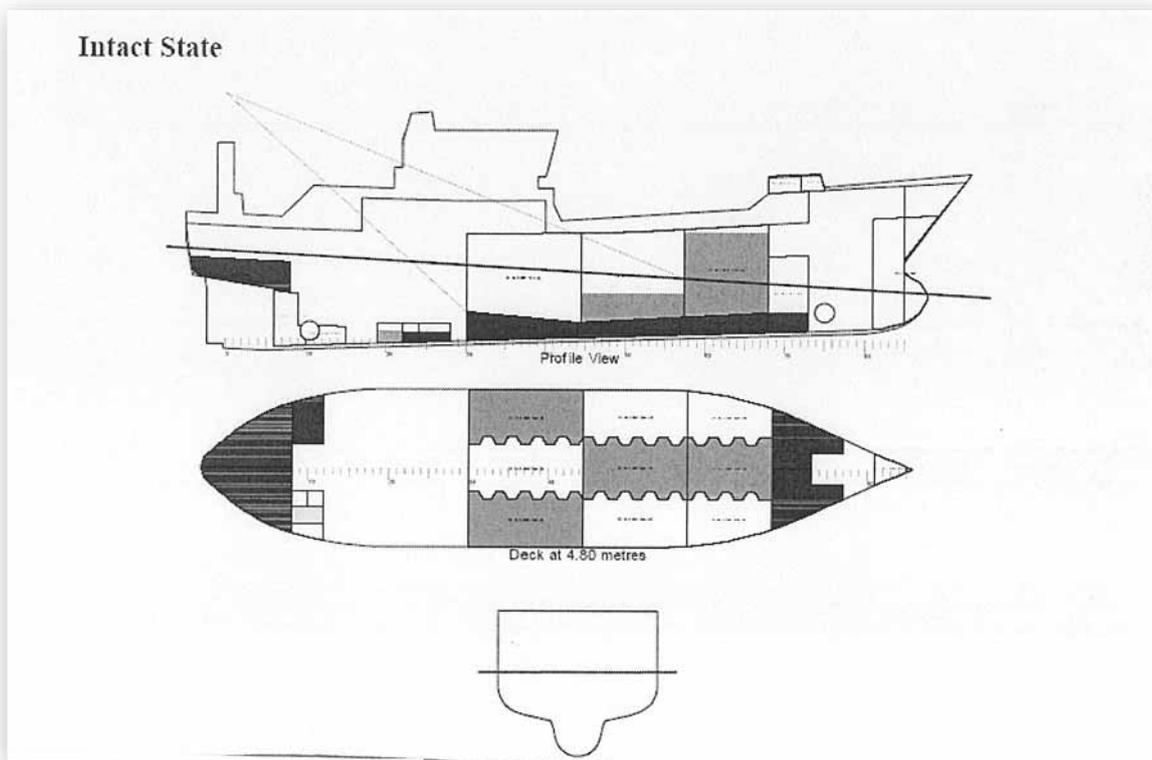
### Appendix 8.6.1 Diagram intact state

and lay against the quay wall. Diagrams in appendix 8.6.5 and 8.6.7 and photographs in appendix 8.1 show the final condition of the “Paula”. Diagrams in appendix 8.6.1 to 8.6.7 show the progress of the flooding and the affect of the flooding in various spaces.
