**REPORT INTO THE
FATAL INCIDENT ON BOARD
'MFV ENDURANCE'
APPROXIMATELY
200 NAUTICAL MILES OFF
SOUTH WEST COAST
ON
8th NOVEMBER 2016.**

**REPORT NO. MCIB/267
(No.2 OF 2018)**

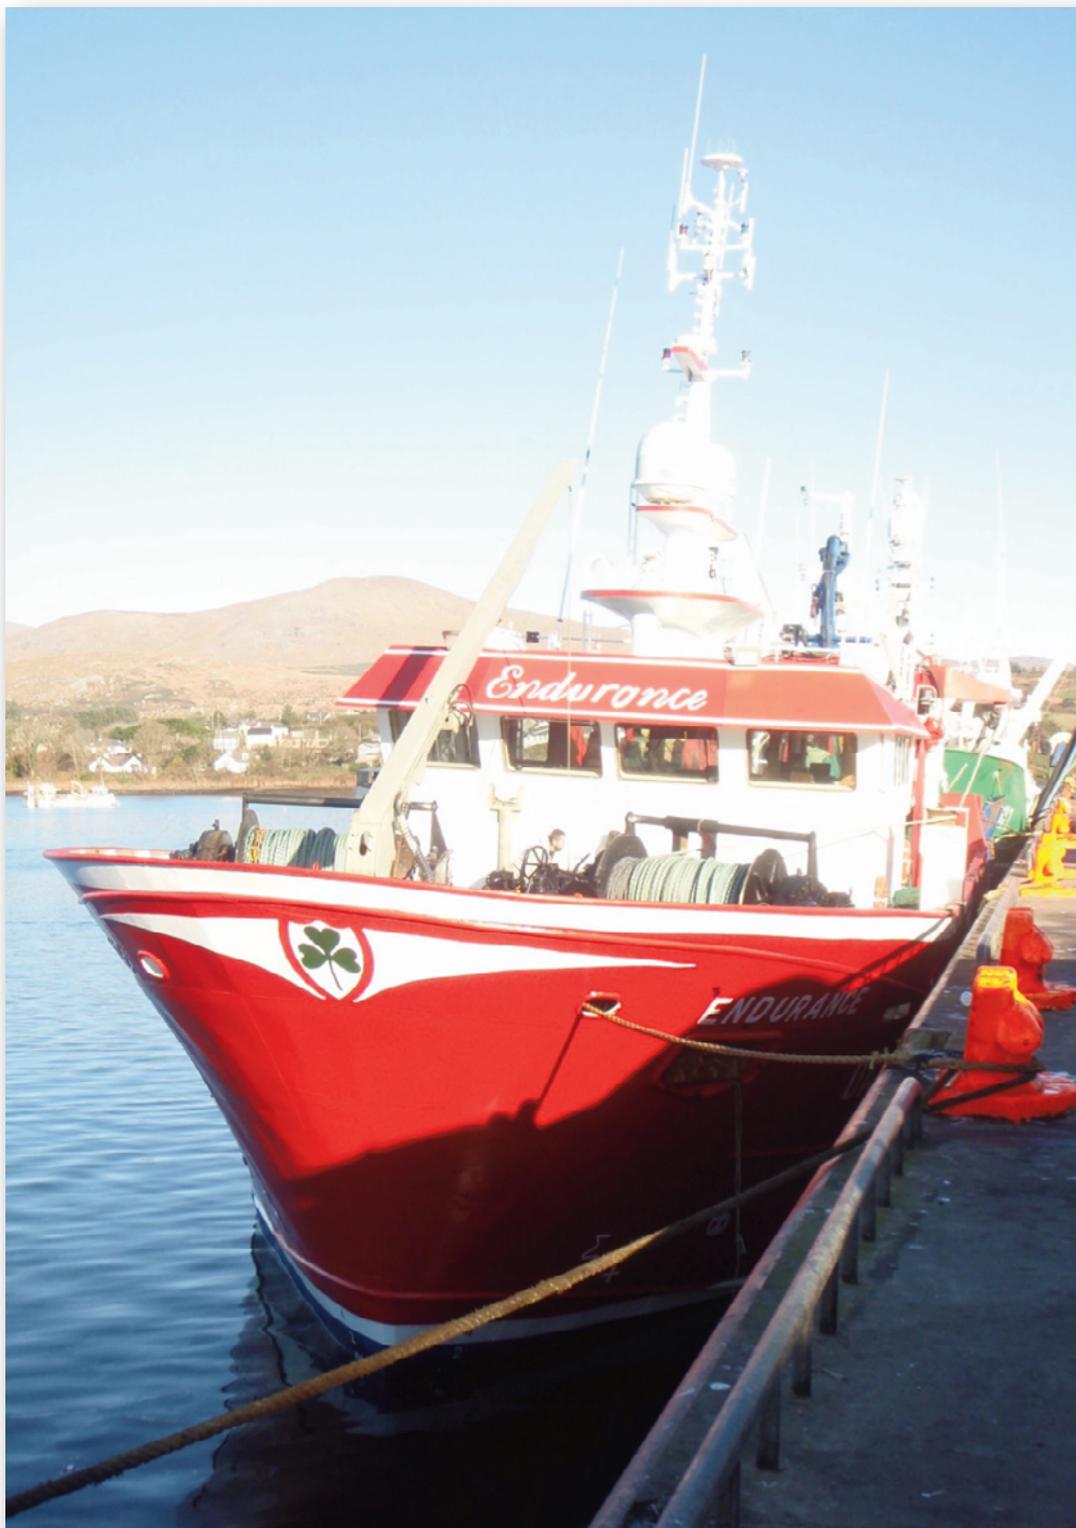
Photograph No.1: Bow of vessel.

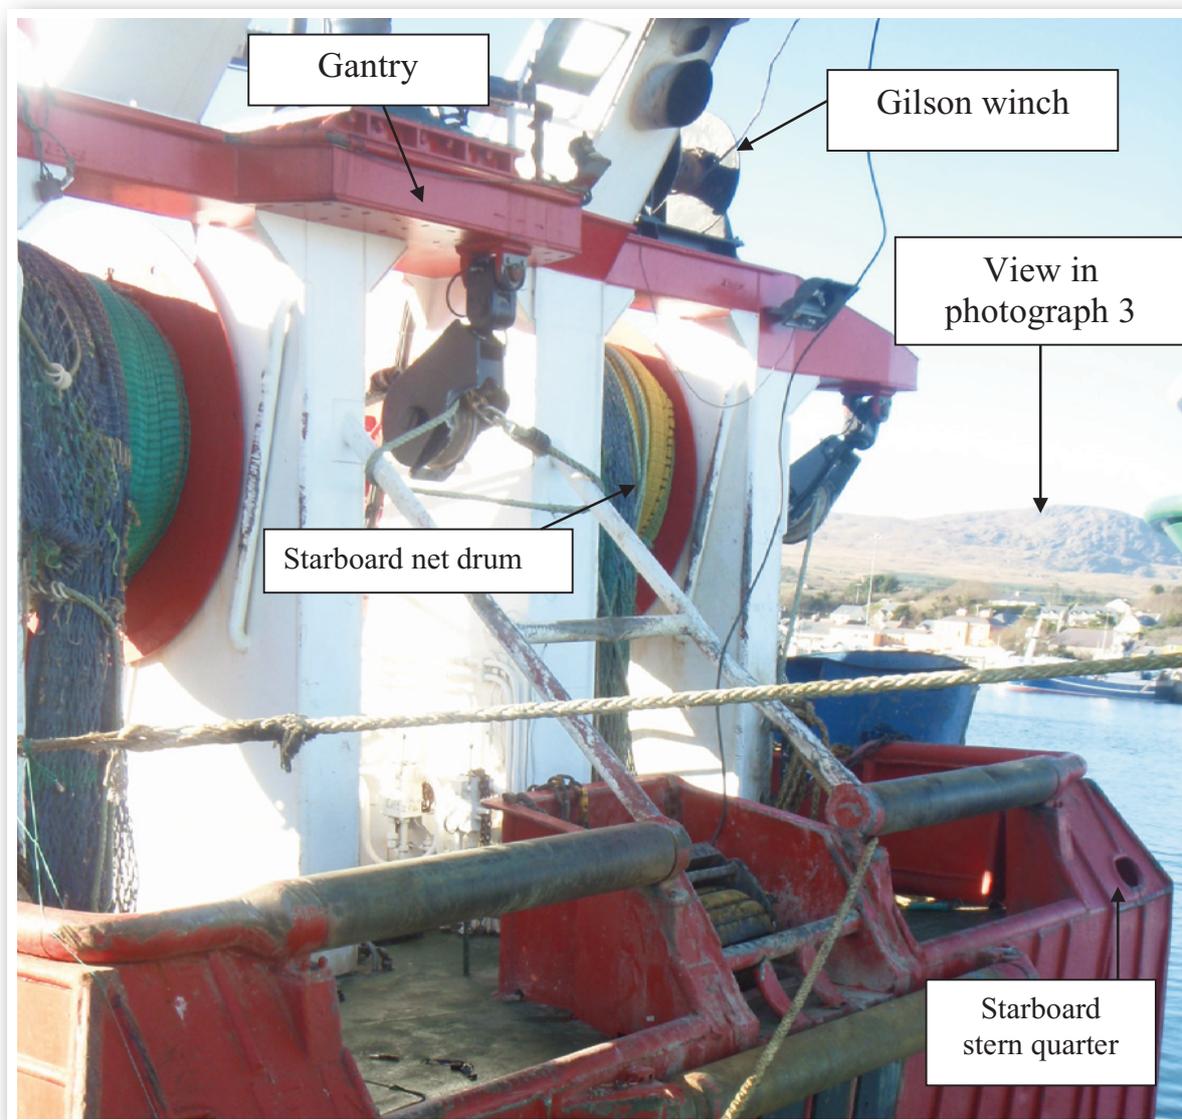
Photograph No.2: Stern of the vessel.

- 6.1. The design and layout of the stern of the vessel should be evaluated by the owner with a view to improving the lateral restraint of the nets and their associated ropes and chains whilst they are deployed over the stern. The object of any such evaluation should be to improve the size of the refuge areas available to the crew in the event of rapid shifts in the lie of nets, chains and/or ropes as the vessel rolls and pitches in the water under the influence of the wind conditions and the sea state.
