**REPORT INTO THE SINKING
OF
“FV ALIZE”
OFF HOOK HEAD,
CO. WEXFORD
4 JANUARY 2020**

**REPORT NO. MCIB/297
(No.2 OF 2021)**

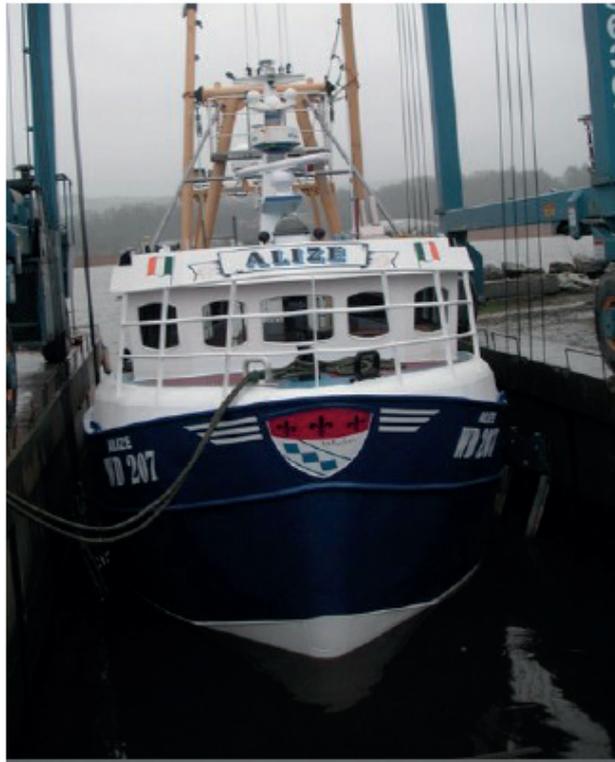
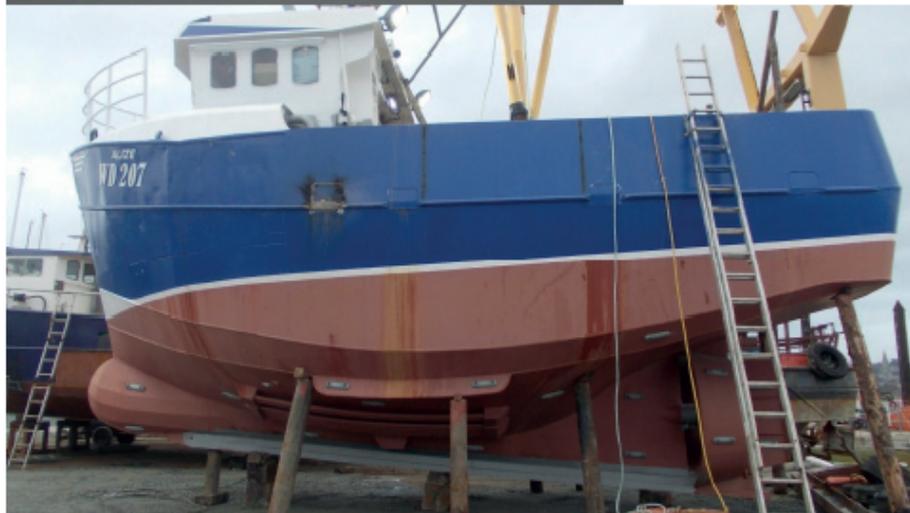
Appendix 7.6 Figure No.2 - 2015 - CoP Declaration of Compliance certificate

Factor 0.8
 B 5.2
 Tr 5.3 GM 0.62 M.....**FAIL**

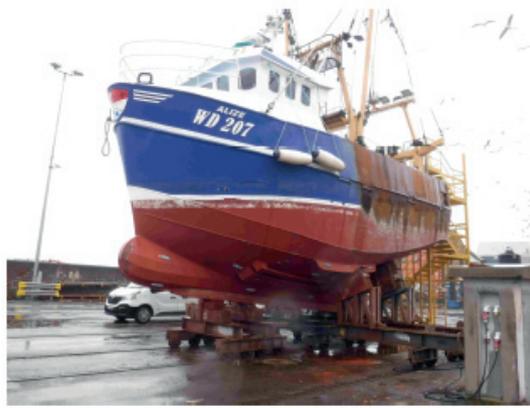
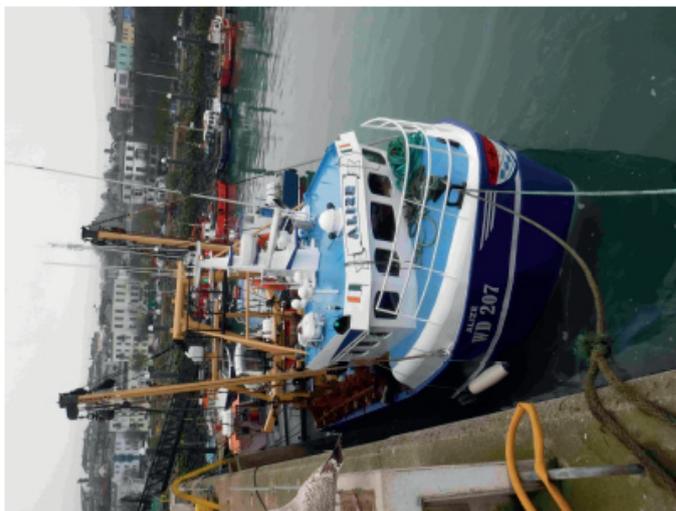
Appendix 7.7 Figure No. 3 2018 - CoP Declaration of Compliance certificate

13/04/18 Departure Condition			
Number of readings taken	4		
Time	Rolls	Roll Period	
	32	5	6.4
	25.4	4	6.35
	32.2	5	6.44
	25.1	4	6.525
Average Roll Period			4.7975

GM	0.752
GMmin	0.613
GMmin +10%	0.895
PASS	Fail
