**REPORT OF AN
INVESTIGATION INTO THE
FIRE ON AND LOSS OF THE
'FV KAYLEIGH'
SOUTHWEST OF
SHEEPS HEAD, CO. CORK
4th MARCH 2020**

**REPORT NO. MCIB/298
(No.11 OF 2020)**

Report MCIB/298 published by the Marine Casualty Investigation Board.
Produced 22nd December 2020.

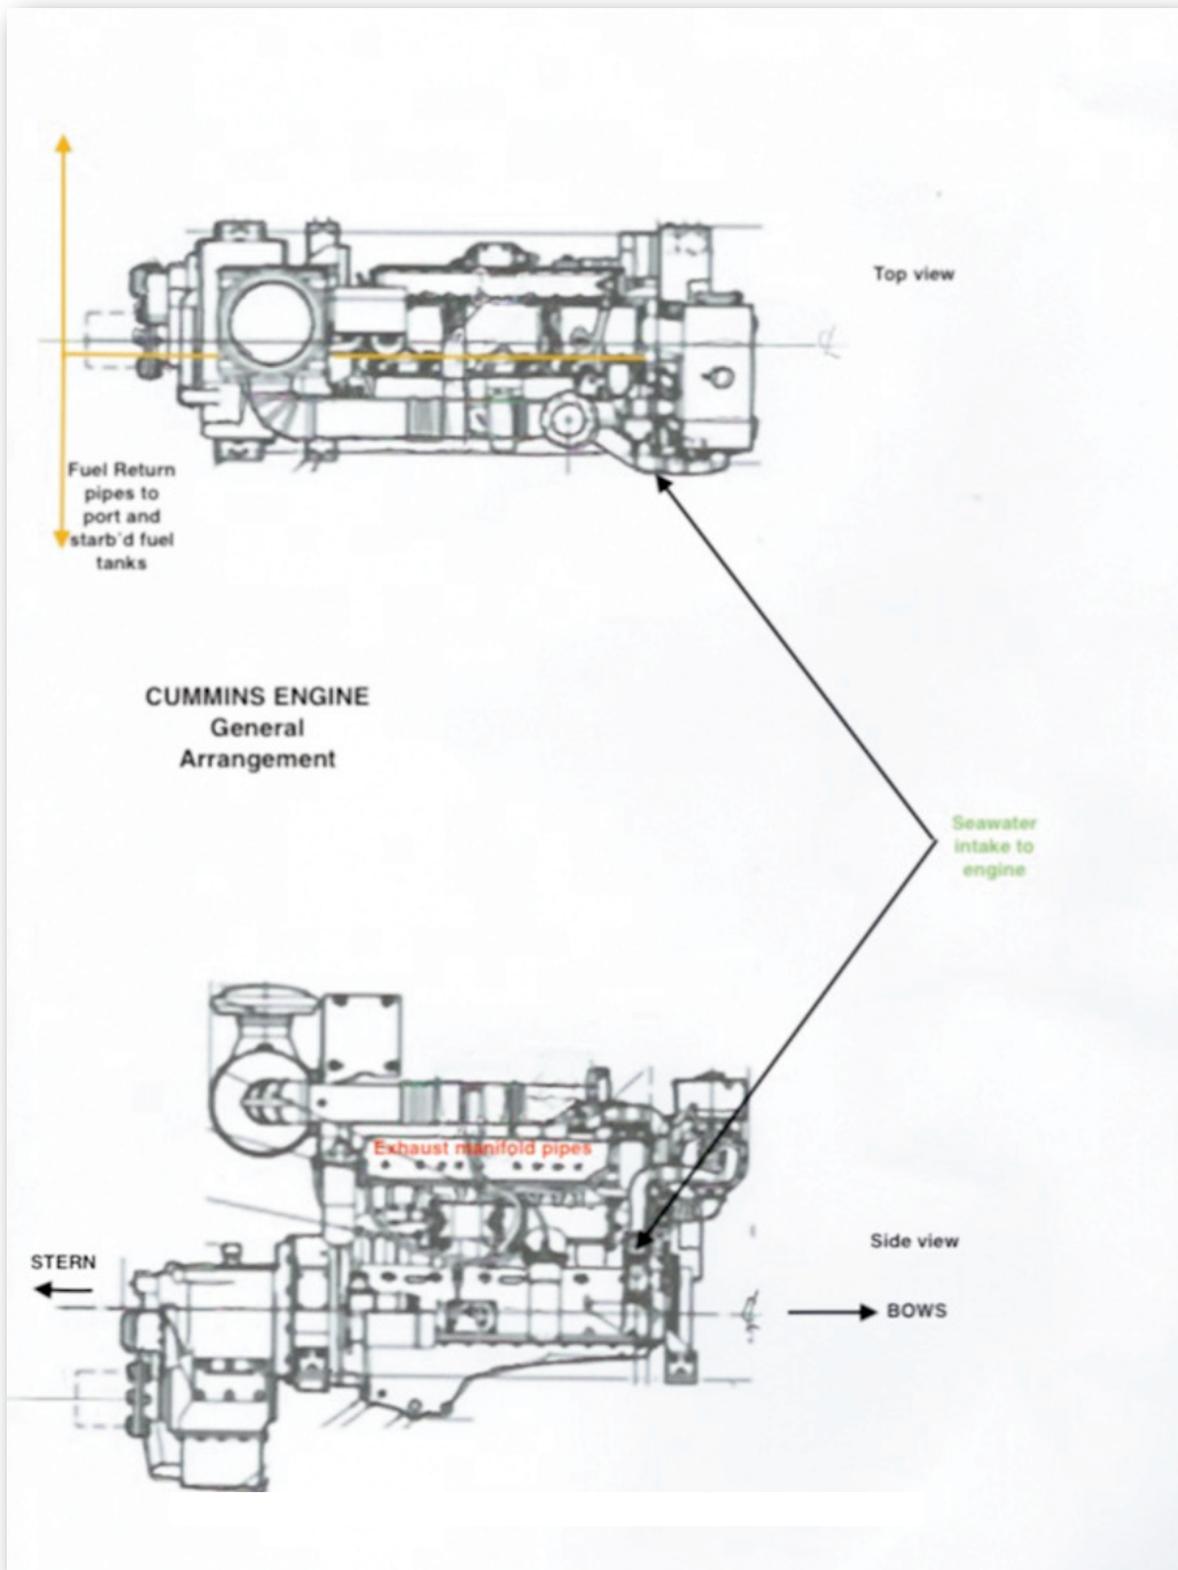
Fig.2: Cummins Engine - General Arrangement

(see Appendix 7.4: Fig.2 Cummins Engine - General Arrangement.
Fig.3 Seawater Intake - Sketch of pipe arrangement.)
