**REPORT OF AN INVESTIGATION
INTO A FATAL INCIDENT
INVOLVING THE FISHING VESSEL
“MIRROR OF JUSTICE”
TEELIN, CO. DONEGAL
26 AUGUST 2020**

**REPORT NO. MCIB/302
(No.2 OF 2022)**

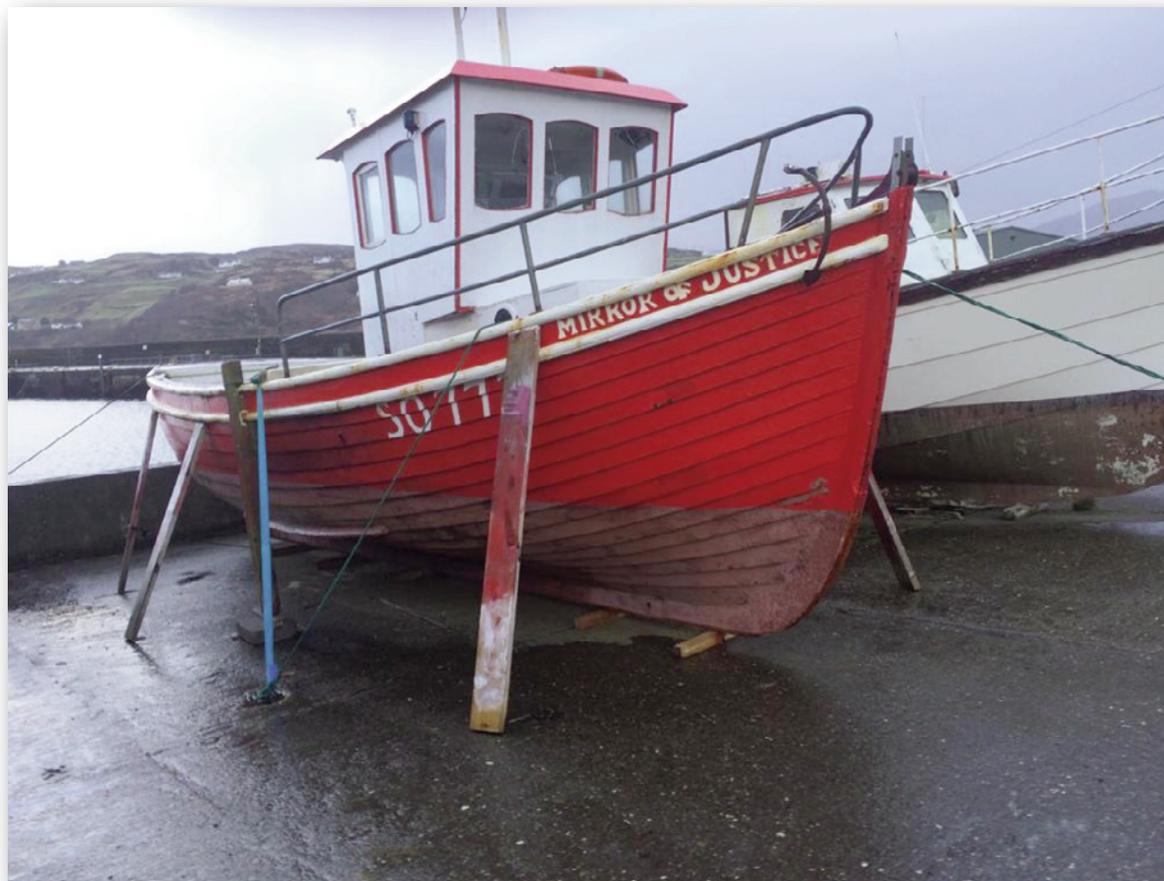
Appendix 7.1 Photograph No. 1 - “FV *Mirror of Justice*”

See Appendix 7.1 Photograph No. 1 - *“FV Mirror of Justice”*.

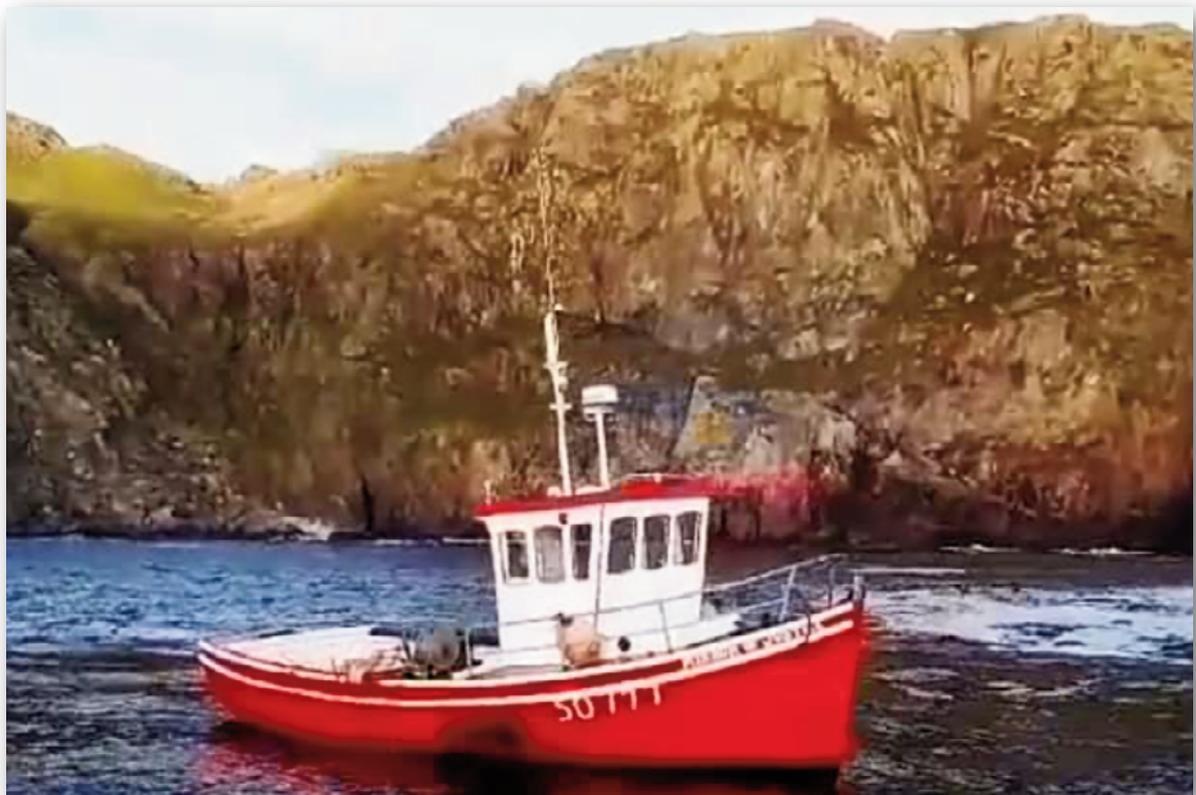
Appendix 7.2 Photograph No. 2 - “FV Mirror of Justice” at Sea

See Appendix 7.2 Photograph No. 2 - *“FV Mirror of Justice”* at Sea.
