**REPORT OF AN INVESTIGATION
INTO THE FIRE AND LOSS OF
“FV HORIZON”
OFF THE OLD HEAD OF
KINSALE, CO. CORK
14 MAY 2021**

**REPORT NO. MCIB/309
(No.3 OF 2022)**

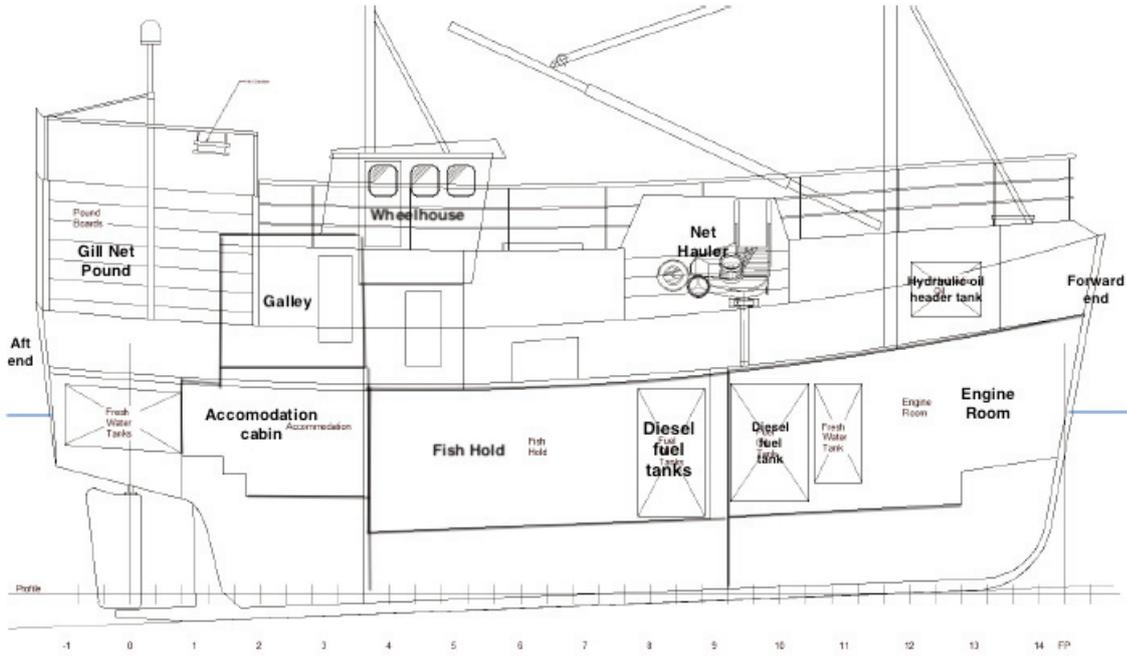
Appendix 7.3 General Arrangement Profile Showing Accommodation and Galley

FV 'Horizon' profile - compartment arrangement
