**REPORT OF AN INVESTIGATION  
INTO THE FIRE AND LOSS  
OF THE YACHT BLACK MAGIC  
OFF THE  
SOUTH COAST OF CORK  
13 DECEMBER 2021**

**REPORT NO. MCIB/313  
(No.2 OF 2023)**

Report MCIB/313 published by the Marine Casualty Investigation Board.  
23rd March 2023.

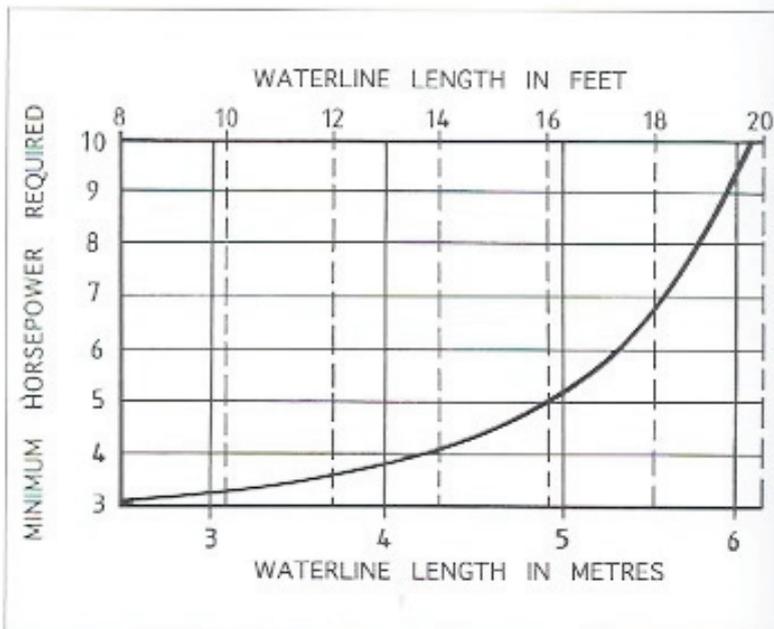
4.3.2 The engine power standard recommended by the reference book “The Boat Data Book” for a yacht with approximately 22 ft waterline length is depicted graphically in both graphs contained in paragraphs 2.4.2.1 and 2.4.2.2. The graph shown in paragraph 2.4.2.1 indicates that a yacht such as yacht Black Magic with a waterline length of approximately 22 ft would require an outboard engine significantly more than 10 hp to achieve 5.2 kts. The graph shown in paragraph 2.4.2.2 indicates the power required from an inboard engine for the same size of yacht would be in the region of 6-7 hp. The Skipper required an average speed of 4.2 kts over the ground to reach the destination on time. Therefore, it is estimated that a yacht such as yacht Black Magic would require an outboard engine with a power capacity in the region of at least 8 hp to achieve 4.2 kts.

- 1 The waterline length is the basis.
- 2 A 50% overload has been allowed for.
- 3 With headwinds or steep seas the speed will drop. In very severe conditions double the horse power shown may be scarcely adequate to maintain way.
- 4 This graph is a guide only. Easily driven hulls and those lightly laden may need less power. Heavy boats with deeply immersed transoms and a lot of windage are likely to need more power.

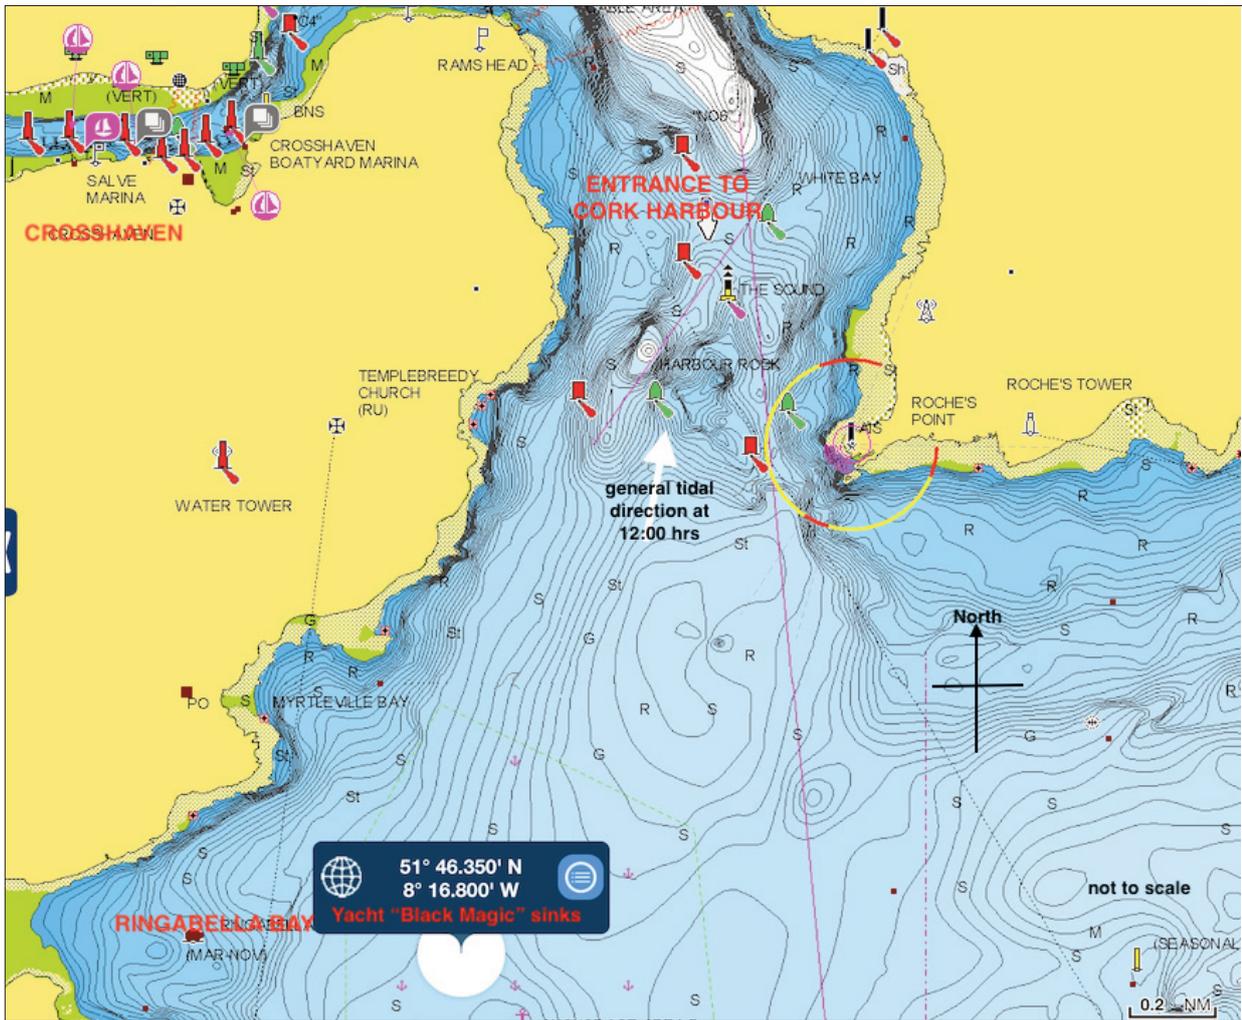
Appendix 7.9 Chart - Position of Sinking of Yacht Black Magic

N - ADDITIONAL INFORMATION  
1152 MOP REPORTS YACHT ON FIRE CROSSHAVEN  
( 47 INCOMING 999 CALLS )  
1153 TASKED XHAVEN RNLI  
1154 TASKED R117  
1154 " BOY CONNOR" B'CAST MAYDAY RELAY  
1156 RNLI PROCEEDING  
1158 " MAWRENA" CONFIRMS 1 POB TAKEN FROM BURNING YACHT  
1201 "ANNABELLA" CONFIRMS 1 POB TAKEN FROM YACHT  
1206 RIB " DELTA 1" HAS CASUALTY ONBOARD TO RCYC.  
1217 CASUALTY ASHORE, ASSESSED BY RNLI MEDICAL - IN GOOD HEALTH  
1248 XHAVEN RNLI CONFIRMS YACHT HAS SUNK (51 46.35 N 008 16.8 W)/ NO DEBRIS OR POLLUTION.  
1300 XHAVEN LB RTB
