**REPORT OF AN INVESTIGATION
INTO A MARINE CASUALTY
INVOLVING THE
FISHING VESSEL SÉIMI
IN OR AROUND
ARRANMORE ISLAND,
CO. DONEGAL
4 FEBRUARY 2023**

**REPORT NO. MCIB/326
(No.7 OF 2024)**

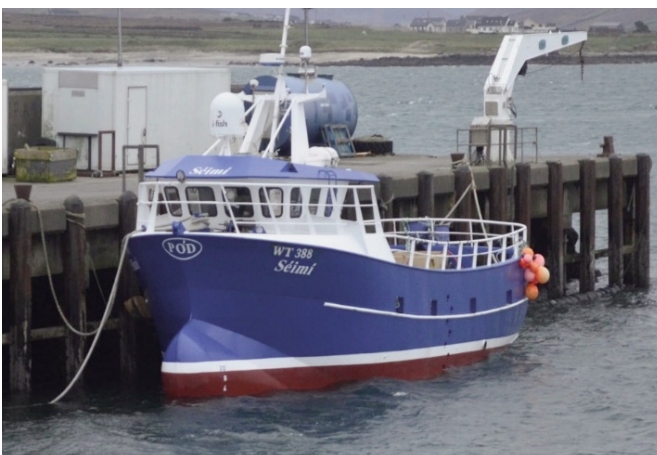
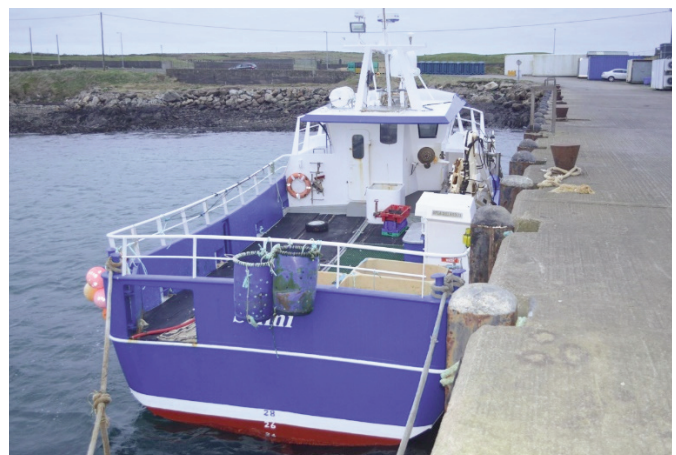
Photograph No.1: FV Séimi at her home port of Ballyglass pier in Broadhaven, Co. Mayo.

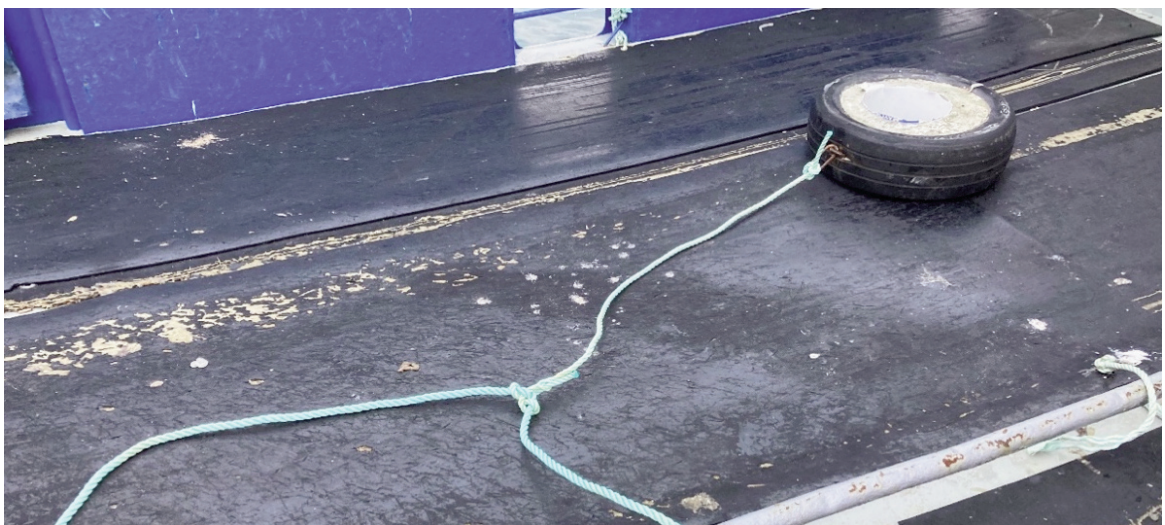
Photograph 2: Typical Block Weight.

- 3.3.7 The crewmember assigned to duty on deck ensures that all the pots are set successfully from their stowed position along the deck and out through a door in the bulwark at the stern of the vessel. This was recognised onboard as the most dangerous task in setting pots as it required a person to be on deck in the vicinity of pots and rope being dragged along the deck and out the aft door. The crewmember on deck is there only to watch for snags and help ensure the pots are set smoothly. For this set it was the duty of Crewmember E to be on deck. At the start and end of each line of pots is a heavy block which effectively anchors the line of pots in place. At approximately 20.00 hrs on the night of Saturday 4 February 2023 the last pot of the line left the deck, through the door and overboard. As the last pot went overboard Crewmember A (the Skipper) in the wheelhouse watched Crewmember E on deck (via the monitor in the wheelhouse that displays the after deck camera image) manoeuvring the heavy weight attached to the end of the string of pots (see Photograph No.2) into position to launch it through the stern door.

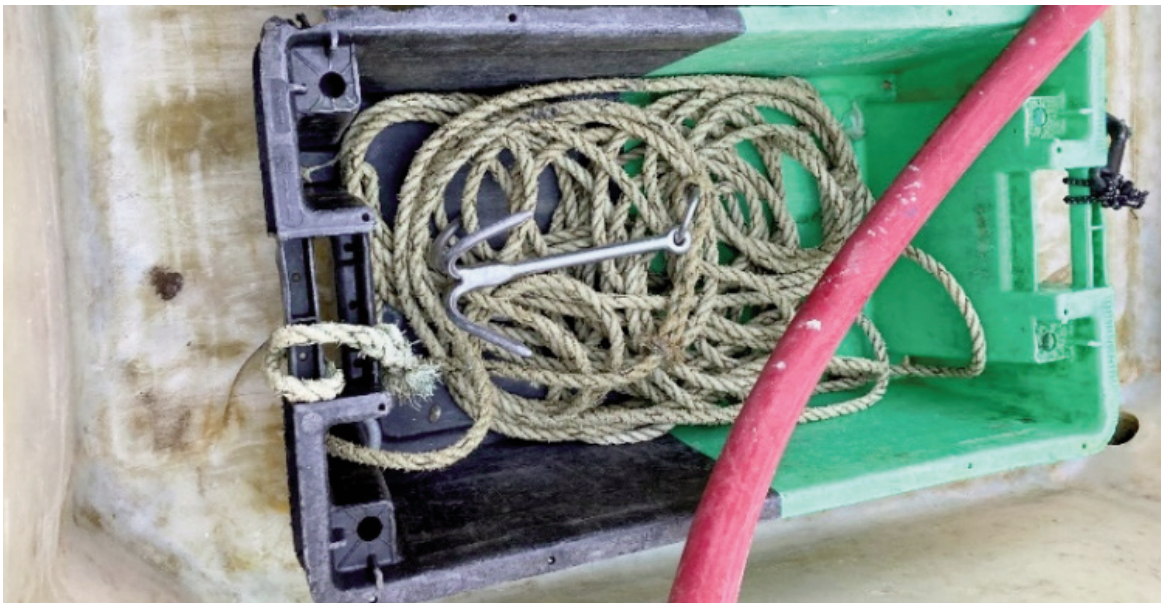
- 3.4.3 Crewmember E was initially lost from sight but with the aid of searchlights he was located in the water and the vessel was manoeuvred alongside. Using a grappling hook (see Photograph No.7) the Casualty was brought alongside and recovered. It took the crew two attempts to get the Casualty close enough to the vessel that they could get him onboard. Although FV Séimi did have an MOB recovery net onboard, the crew did not elect to use it in this circumstance. Instead, the Skipper was held over the side of the vessel by two of the other crew and was able to grab hold of the Casualty.

Photograph No.7: Grappling Hook.

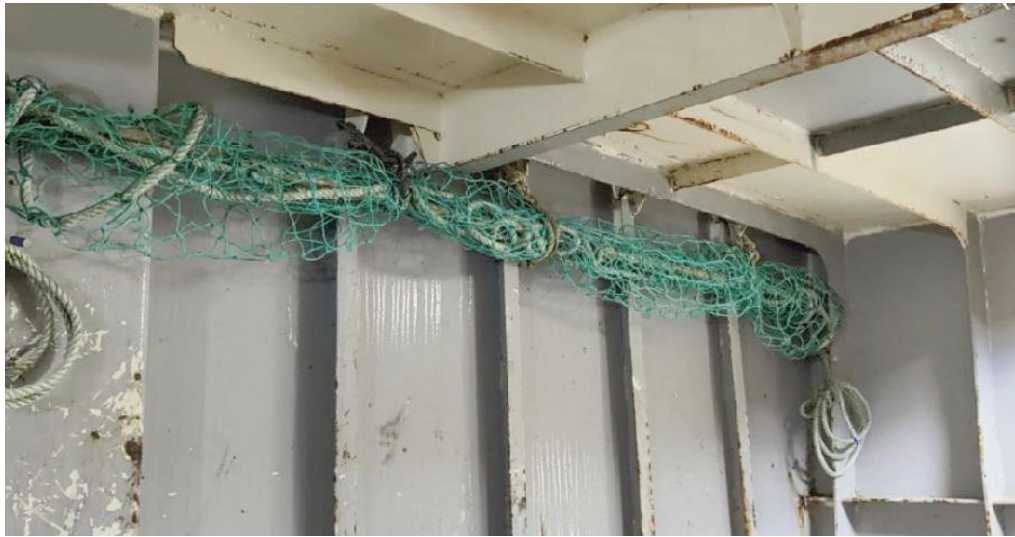
2.4.2 FV Séimi carried a MOB recovery net (see Photographs No.8 and No.9). This was not used to assist with the recovery of the Casualty.

Photograph No.8: Man overboard recovery net stowed.

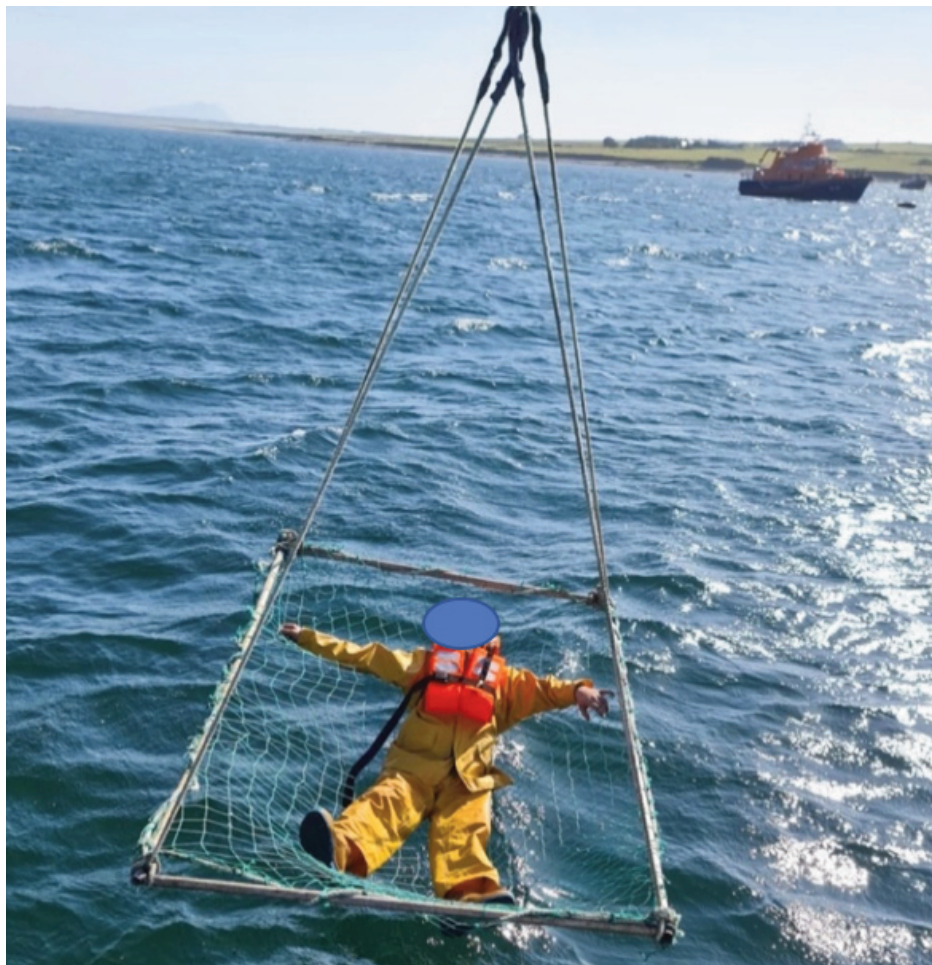
Photograph No.9: Man overboard recovery net in use during a later drill.
