**REPORT OF AN INVESTIGATION  
INTO A MARINE CASUALTY  
INVOLVING A VESSEL  
IN OR AROUND  
BRUCKLESS PIER,  
DARNEY, CO. DONEGAL  
28 SEPTEMBER 2023**

**REPORT NO. MCIB/332  
(No.8 OF 2024)**

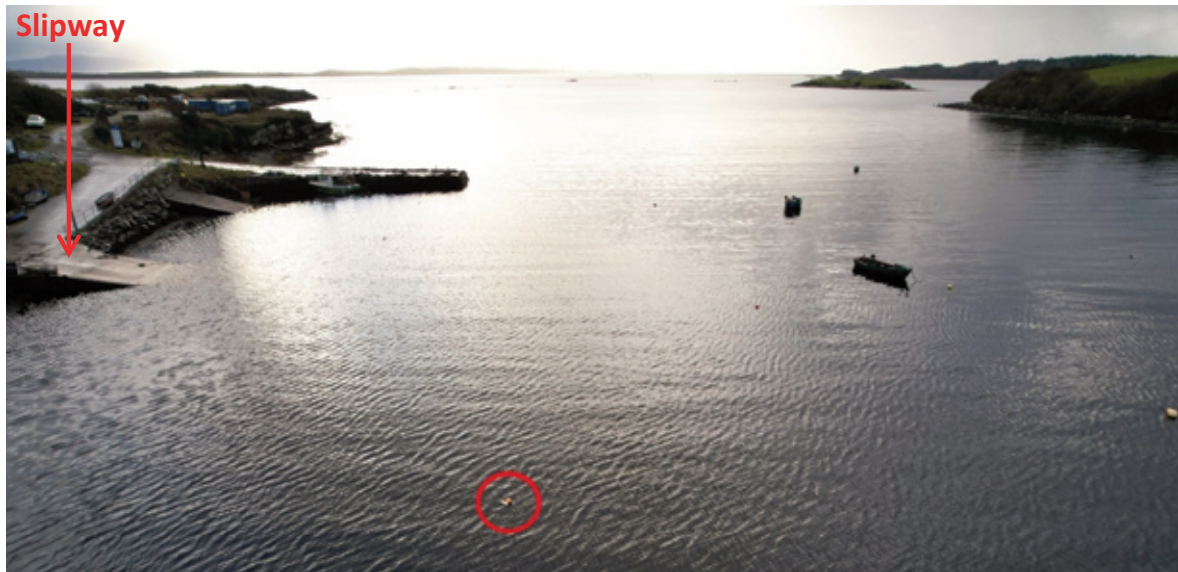
Figure 8: Bruckless Harbour, looking south towards Donegal Bay, highlighting the position at which the Casualty's vessel was moored, and the slipway from which the Casualty had launched when going afloat.

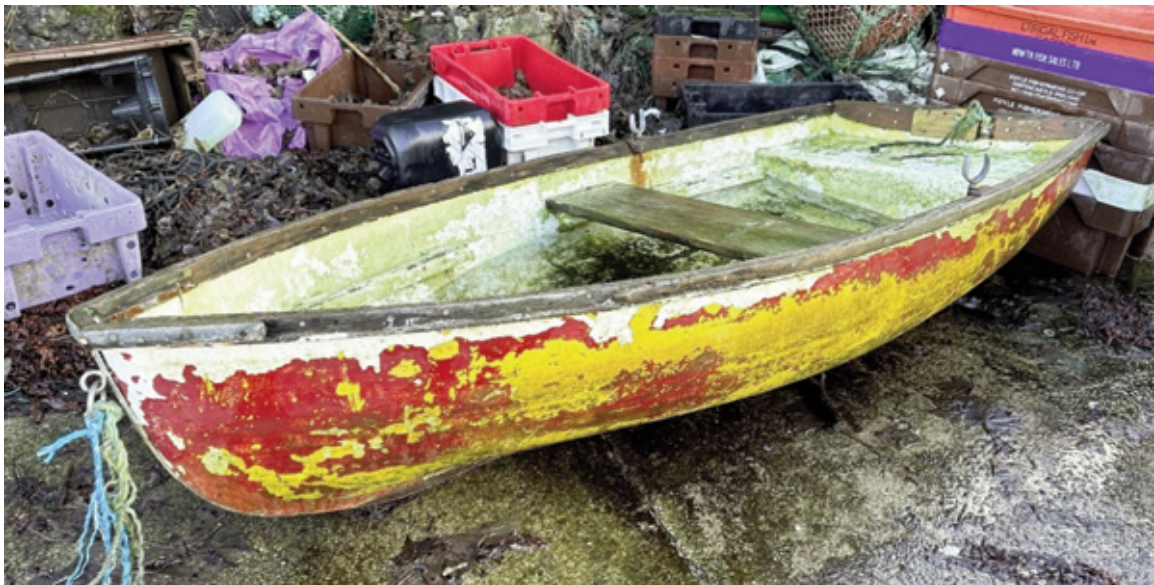
- 3.3.3 He put on his own PFD and launched in another dinghy tender (of the same type as the Casualty's, see Figure 11) and rowed out to the Casualty's motor boat. The conditions were very challenging for him. He initially tried to approach the motor boat from upwind, but was blown downwind behind the boat. He struggled to row back up against the wind and swell.

Figure 11: The dinghy tender used by the other boat owner to reach the Casualty's vessel.
