**REPORT OF AN
INVESTIGATION INTO A
MARINE CASUALTY INVOLVING
A VESSEL IN OR AROUND
CARRICK-ON-SHANNON MARINA,
CO. LEITRIM
ON OR ABOUT
7 AUGUST 2023**

**REPORT NO. MCIB/331
(No.3 OF 2025)**

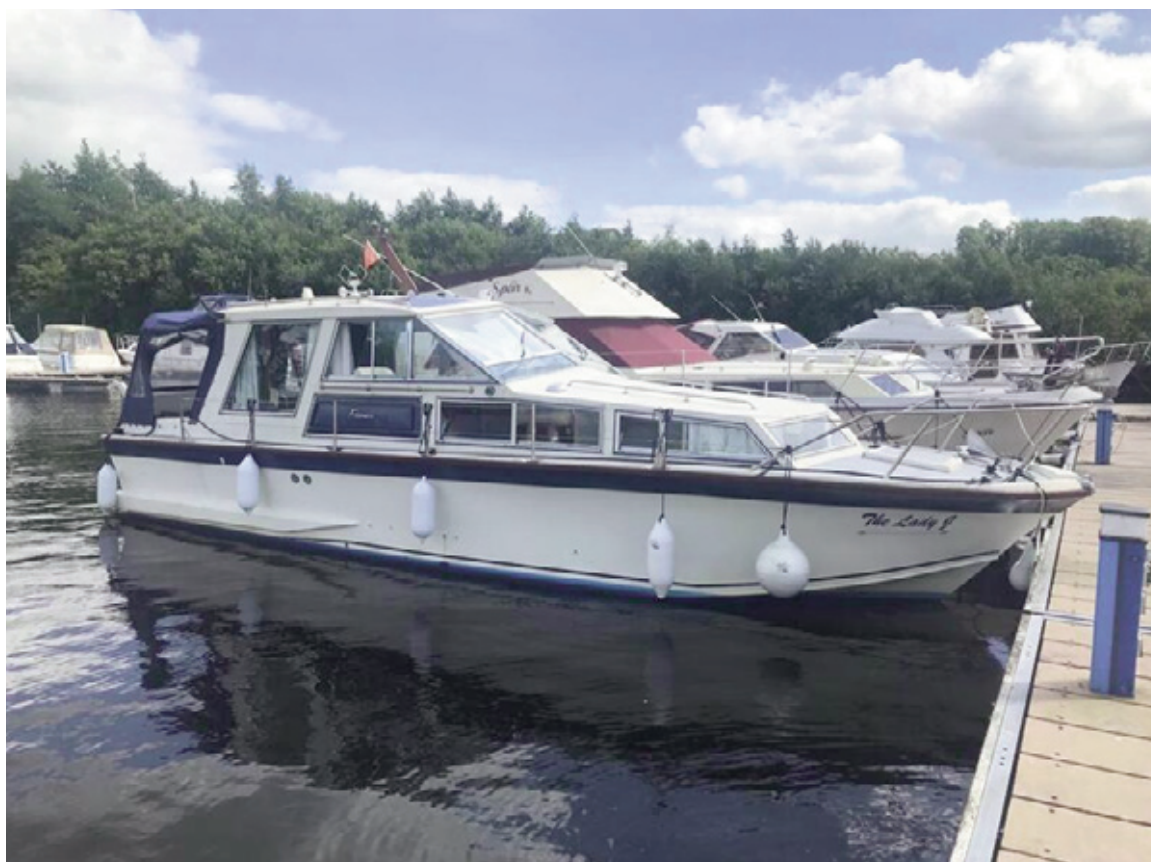
Photograph No.2: Stock image of a standard Freeman 33 similar to DollFinn.

- 4.11.1 Members of AGS's Ballistics and Forensic Investigation Section attended the vessel on Wednesday 8 August 2023. The technical report produced after the inspection of the vessel noted that the rear half of the vessel was destroyed above the deck with almost all combustibles consumed by fire and that the front half of the vessel was less burnt with some soft furnishings and bedding surviving. The MCIB inspection in January 2024 concurred with these findings. See Photographs No.2 and No.3 below comparing a stock photo of a Freeman 33 to the remains of the vessel DollFinn.

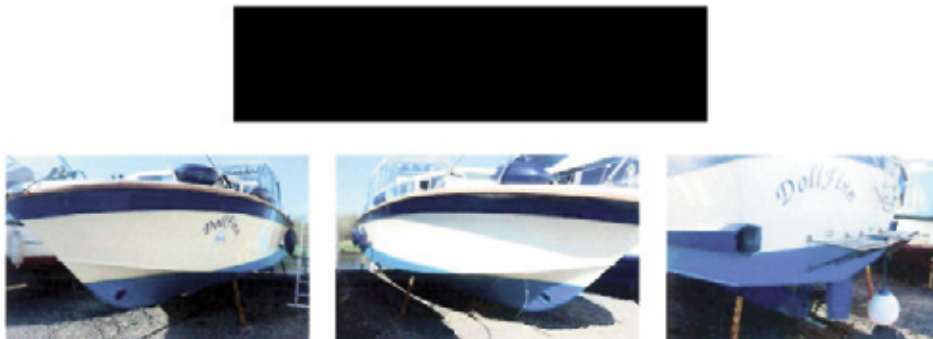
The hull was sounded with a plastic headed hammer giving sound returns with no indication of delamination of the FRP lay-up.

Moisture readings were taken over the entire outer surface of the hull from the rubbing strake down to the keel on both sides. High readings were observed below the waterline and closer inspection revealed a number of gelcoat blisters which proved to be osmotic in nature. This should be considered intermediate stage osmotic blistering and not currently of concern however this vessel should be stored ashore with dry bilges each winter to slow the progression of this condition.

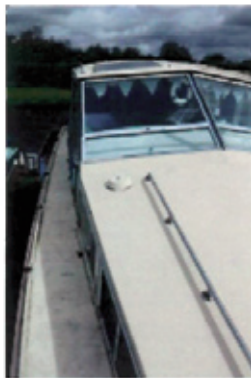
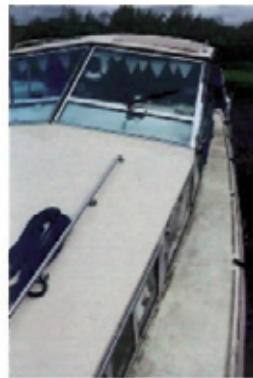
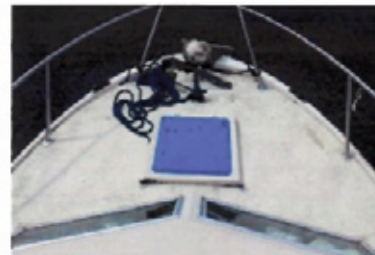
The pulpit rail fitted to the bow was found to be well secured and in serviceable condition. All mooring bollards fitted on deck (with fairleads on the foredeck) were found to be well secured and in serviceable condition.

All hatches, windows and vents were found to be in serviceable condition however a number of window leaks were noted during the survey inspection.

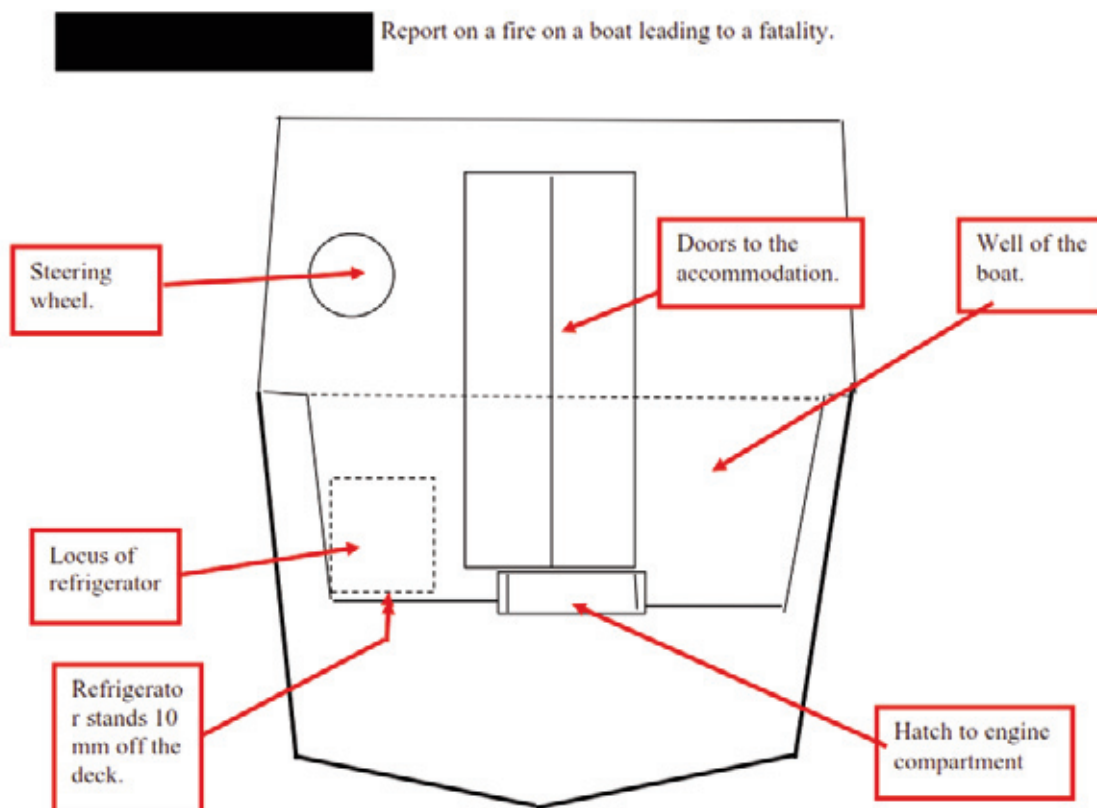
Sketch 2 illustrating a cross sectional elevation view through the well of the boat.

"The pipe supplying LPG gas to the gas -fired refrigerator failed, thereby releasing LPG gas onto the after deck of the boat."
