**REPORT OF AN
INVESTIGATION INTO
A MARINE CASUALTY INVOLVING
FV EXCEL AND MV PETREL PACIFIC
IN OR AROUND
THE NORTH ATLANTIC OCEAN
ON OR ABOUT
6 AUGUST 2023**

**REPORT NO. MCIB/336
(No.10 OF 2024)**

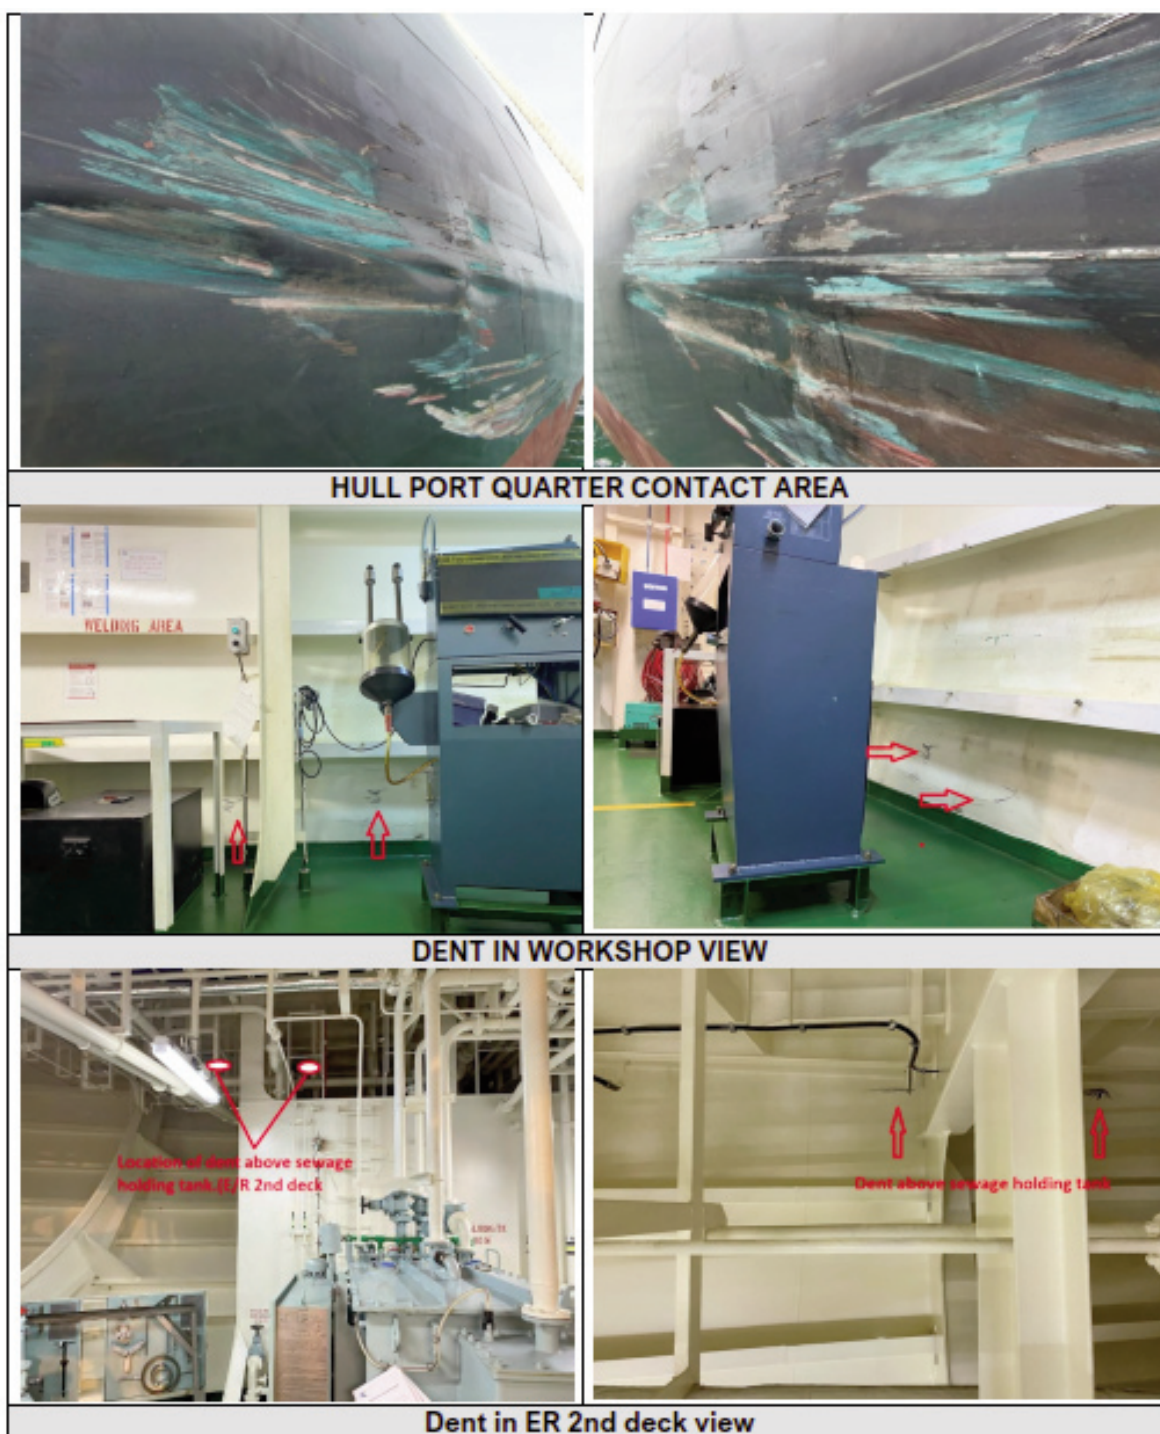
Appendix 7.5 ABS Survey Report MV Petrel Pacific with Photographs of Damage

- 2.7.1 MV Petrel Pacific was inspected by an ABS surveyor on 7 August 2023 whilst the vessel lay at anchor in Saint Brides Bay, UK. A further ABS survey was conducted while the vessel lay afloat at Montreal on 30 August 2023. Damage was noted in way of frame numbers 20 - 23, Engine Room 1st Deck and below 1st Deck (approximately 14480 mm) on port side shell. The collision had caused set-in and slight deformation of port side shell plating. Smooth indentation was observed of approximately 35 mm depth over an area of 1000 x 2000 m2. The affected area was considered cosmetic by the attending surveyor.

Overview of the Contact Area
