REPORT OF AN INVESTIGATION
INTO A MARINE CASUALTY
INVOLVING A VESSEL IN
OR AROUND
INISHBOFIN ISLAND,
CO. GALWAY
ON OR ABOUT
3 JULY 2024

REPORT NO. MCIB/338 (No.4 OF 2025) The Marine Casualty Investigation Board (MCIB) examines and investigates all types of marine casualties to, or onboard, Irish registered vessels worldwide and other vessels in Irish territorial waters and inland waterways.

REPORT NO. MCIB/338 (No.4 OF 2025)

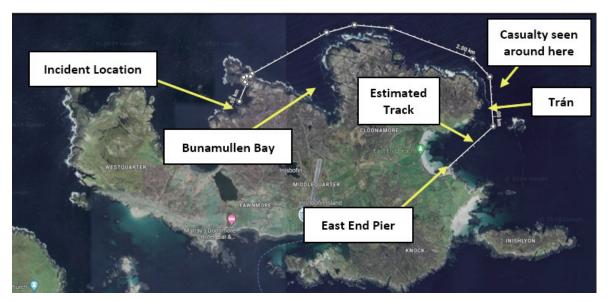
- 2.7.2 The exact particulars of the voyage cannot be determined with certainty. The inverted vessel was found approximately 100 m from the shore at the approximate coordinates of Latitude 53°37′ 45.6″N and Longitude 10°13′ 34.6″W in a small bay on the north side of Inishbofin and to the west of Bunamullen Bay, just south of Gubatarraghna Point. Therefore, it is probable that the Casualty moved around to the north side of the island, where he had lobster pots scattered, including in Bunamullen Bay. The Casualty also had pots in the channel to the west of Bunamullen Bay, extending to the area where the incident occurred.

Photograph No. 5: Inishbofin and the estimated voyage taken by the Casualty.

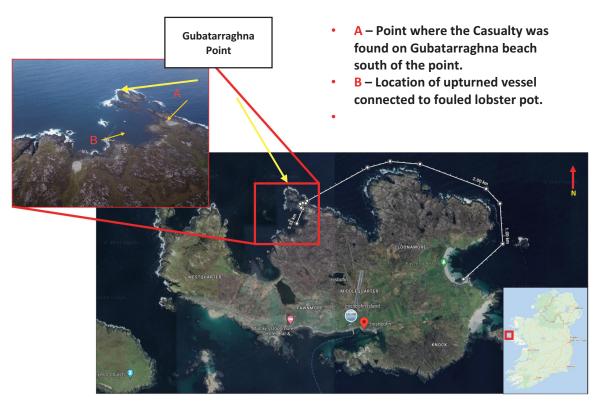
- 2.9.2 The shoreline along the north side of the island is highly exposed to northerly swells and rough seas, with predominantly rocky terrain. In more sheltered areas, the shoreline becomes less rocky. Within the small bay, where the incident occurred, there are two shallows that dry out during low tides, causing waves and swells to break before reaching the shore. In the photograph below, point B marks the approximate location where the inverted vessel was found, while point A indicates the approximate location where the Casualty was found.

Photograph No.6: Aerial map showing voyage from point of departure to incident locations Google Maps.
