**REPORT OF AN INVESTIGATION  
INTO A MARINE CASUALTY  
INVOLVING THE  
PASSENGER VESSEL  
SEA BREEZE III  
IN OR AROUND  
THE SKELLIG ISLANDS,  
CO. KERRY  
ON OR ABOUT  
7 JULY 2024**

**REPORT NO. MCIB/339  
(No.6 OF 2025)**

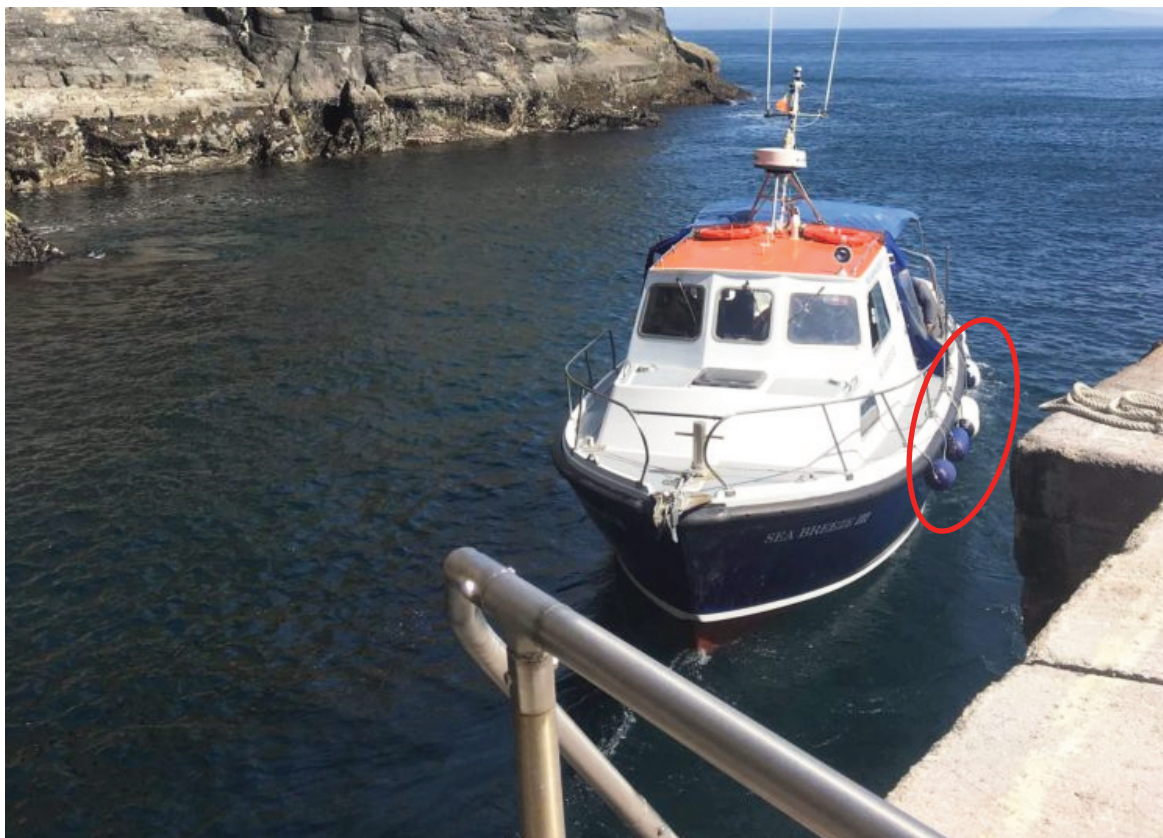
Figure 11: MV Sea Breeze III approaching the concrete landing dock on a previous voyage. Fendering arrangements visible on the port side.

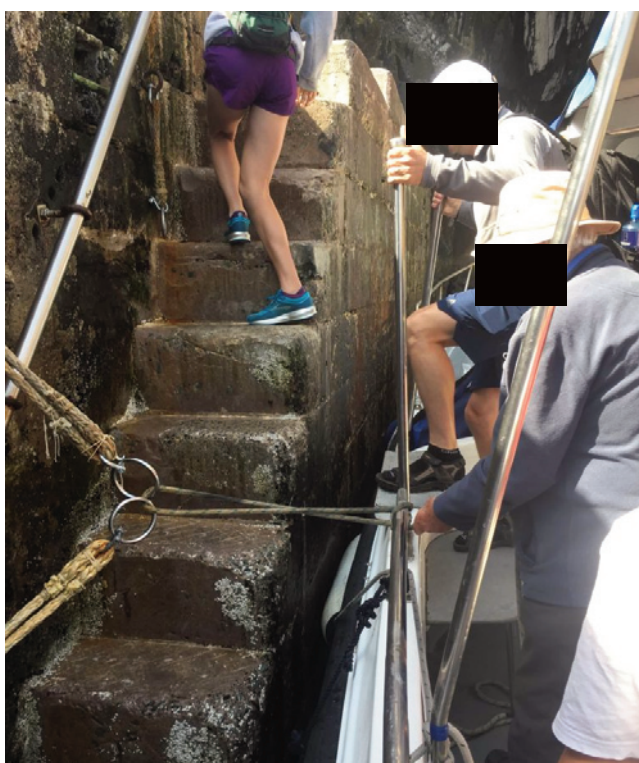
Figure 12: Landing arrangements at Great Skellig on a previous voyage of MV Sea Breeze III.

- 3.9 The landing dock is not fitted with fenders, but rather each vessel carries its own fenders onboard. The Skipper advised that there was nothing unusual in his port side approach alongside. The weather conditions can sometimes make manoeuvring challenging, but on this occasion, berthing was speedily achieved. The Skipper was very clear that there was no hard impact with the landing dock, and this fact was confirmed by the Crewmember. The absence of a passenger list meant that it was not possible to interview the passengers to confirm this point or to ascertain if any passenger had video footage of the landing.
