REPORT OF THE INVESTIGATION INTO THE SINKING OF THE IRISH FISHING VESSEL "TAMARISK" OFF DURSEY ISLAND, CO. CORK ON 29 APRIL 2000.

The Marine Casualty Investigation Board was established on the 5<sup>th</sup>, June 2002 under The Merchant Shipping (Investigation of Marine Casualties) Act 2000

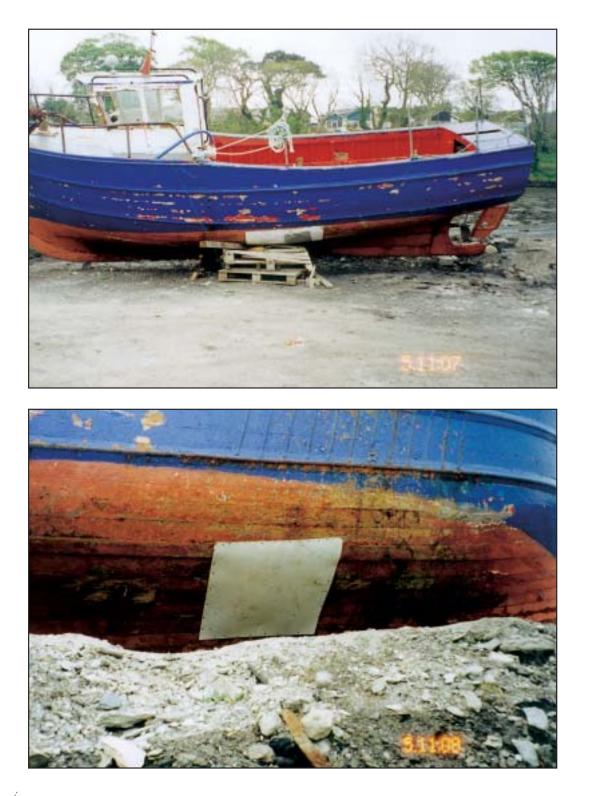
CONTD.

- 6.1 The "Tamarisk" was badly damaged. It was holed on both sides of the bottom in the midship area. See photographs in Appendix 3.
- 6.2 The rudder was dislodged and bent. There was general flooding damage.
- 6.3 Mr. Murphy stated that the wind was light from the SE and from his experience this would tend to push the vessel towards the shore. Also he stated that the tide, which was low, was also tending to set the vessel onto the shore.
- 6.4 All aids to navigation in the vicinity were functioning correctly at the time of the incident.
- 6.5 There were two lifejackets on board the vessel at the time of the grounding. This is in compliance with the Merchant Shipping (Life Saving Appliances) (Amendment) Rules, 1999, which came into operation on the 1st April 2000. It is clear that neither crewmember would have survived this incident had they not been wearing lifejackets.
