REPORT OF THE INVESTIGATION
INTO FATAL INCIDENT INVOLVING
THE “*GURTEEN LASS*”
ON
14th AUGUST 2012

REPORT No. MCIB/224
(No.7 of 2013)

Report MCIB/224 published by The Marine Casualty Investigation Board
Printed 29th October 2013.

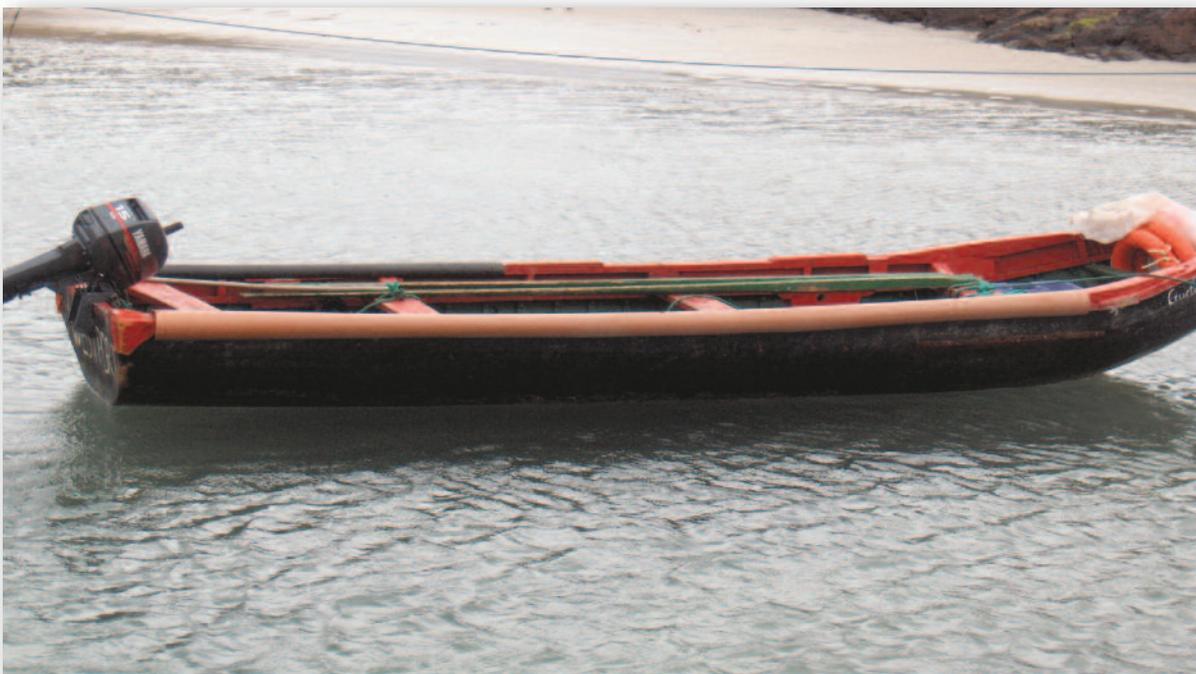
- 2.3.1 The vessel broke up close to the shore on the south part of Clare Island, Clew Bay, Co. Mayo. The area is referred to locally as “Bachelor’s Island”, a rocky formation close to the shore. See Appendix 7.1 and Appendix 7.2.
- 2.3.2 The incident occurred on 14th August 2012. There were no witnesses so the time is undetermined.
- 2.3.3 Weather is reported as good at the time and is not considered to be a factor in the incident. See Appendix 7.3 and Appendix 7.4.
- 2.3.4 The vessel was operated single handed and was powered by an outboard engine. Oars were available as back up.
- 2.3.5 The casualty was the owner/operator of the vessel.
