**REPORT OF INVESTIGATION
INTO A FATALITY ON BOARD
THE MPV "IKOM K"
AT BEAL LOCH,
CASTLETOWNBERE, CO. CORK
ON
27th MAY 2009**

**REPORT No. MCIB/167
(No. 6 of 2010)**

Report MCIB/167 published by The Marine Casualty Investigation Board
17th June 2010

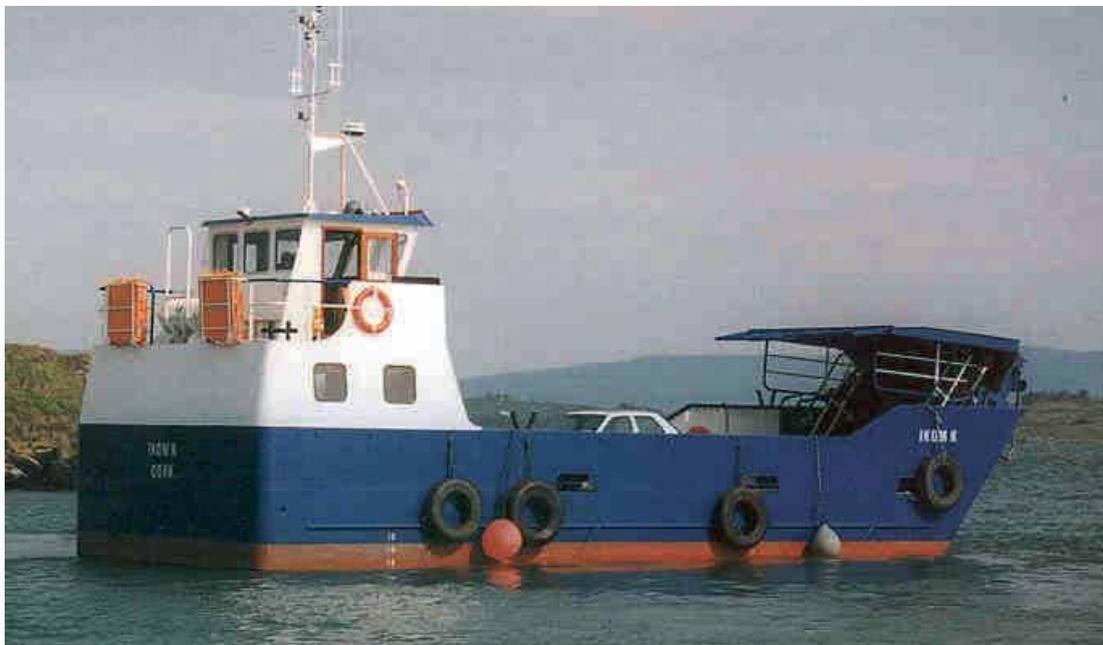
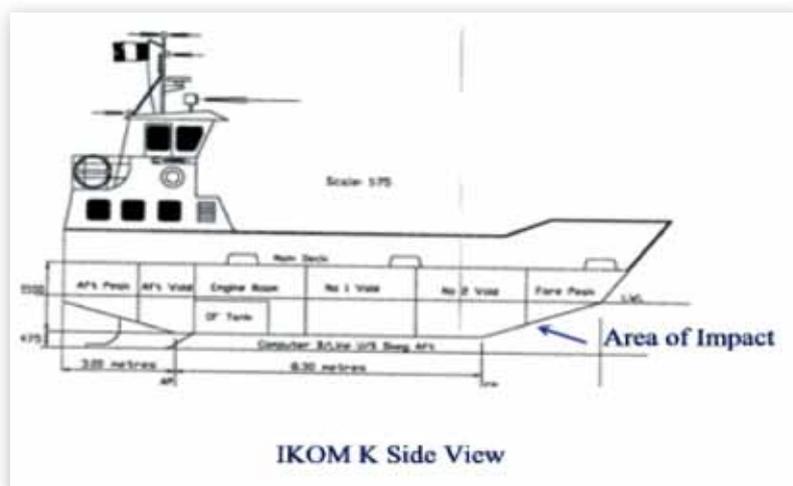
The "Ikom K" held a Class V Passenger Ship Certificate valid until 21st of January 2009. The Marine Survey Office last inspected the ship on the 22nd of January 2009. The lifesaving equipment as set out on the Passenger Ship Certificate, with the exception of two parachute distress flares, were on board and in a serviceable condition after the incident. (See Photograph and General Arrangement drawing).

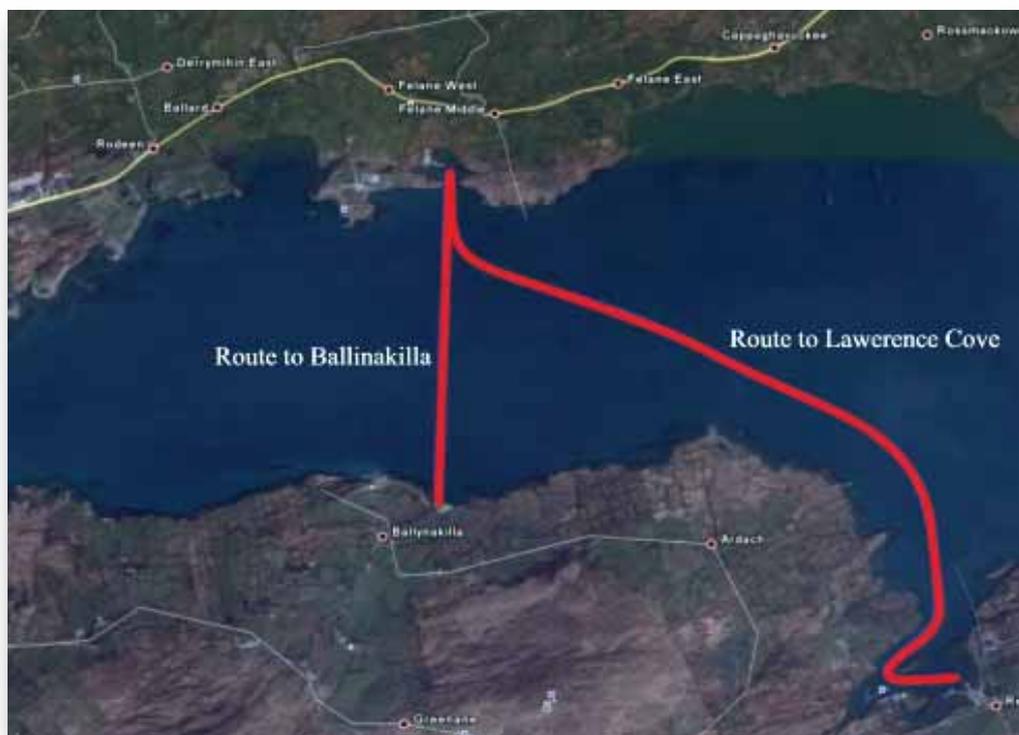
Map 1

- 3.4 The second crewman left the vessel after the first couple of trips of the day to take care of some personal business.
- 3.5 The "Ikom K" made a further return trip to Bere Island between 15.00 hrs. and 16.10 hrs. approximately. As sufficient tide was present it was planned for the 16.30 hrs. crossing to be from Pontoon to 'Trá Gabhla' (Ballinakilla Slipway) and the return service ex. Bere Island would operate from Ballinakilla Slipway instead of Lawrence Cove. (The routes the ship operates are shown on Map 1).

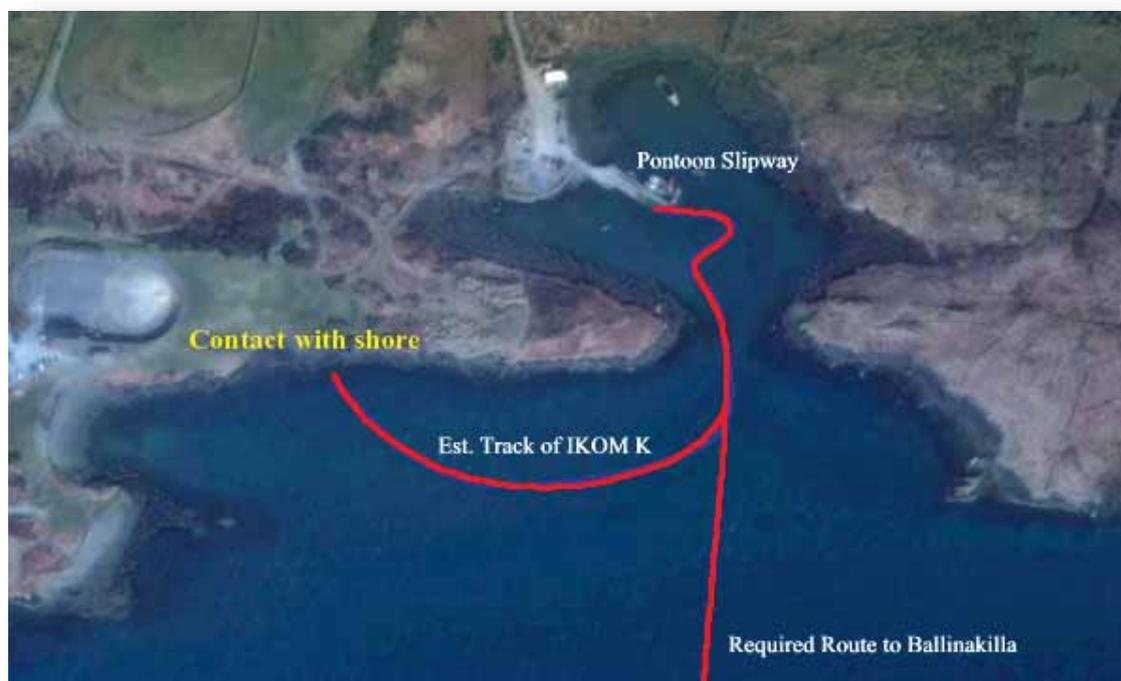
Map 2

- 4.1 The "Ikom K" left Pontoon at approximately 16.35 hrs., with 7 people on board, i.e. the skipper, and six passengers. Five of these passengers were members of the Defence Forces.
- 4.2 The passengers stated that instead of taking a course to the South towards Ballinakilla Slipway the ship appeared to continue to turn to starboard. Shortly afterwards the vessel struck the shore between Pontoon and Berehaven Golf Club.
- 4.3 The impact appeared to have been taken by the starboard forward section of the ship. (The approximate estimated track of the vessel is shown on Map 2).
