**REPORT INTO THE  
CIRCUMSTANCES SURROUNDING  
THE LOSS OF PROPULSION ON  
BOARD THE PASSENGER RO-RO  
MOTOR VESSEL 'STENA EUROPE'  
ON 30TH JANUARY 2003  
SHORTLY AFTER DEPARTING  
ROSSLARE EUROPORT**

**The Marine Casualty Investigation Board was established on the 25<sup>th</sup> March, 2003 under The Merchant Shipping (Investigation of Marine Casualties) Act 2000**

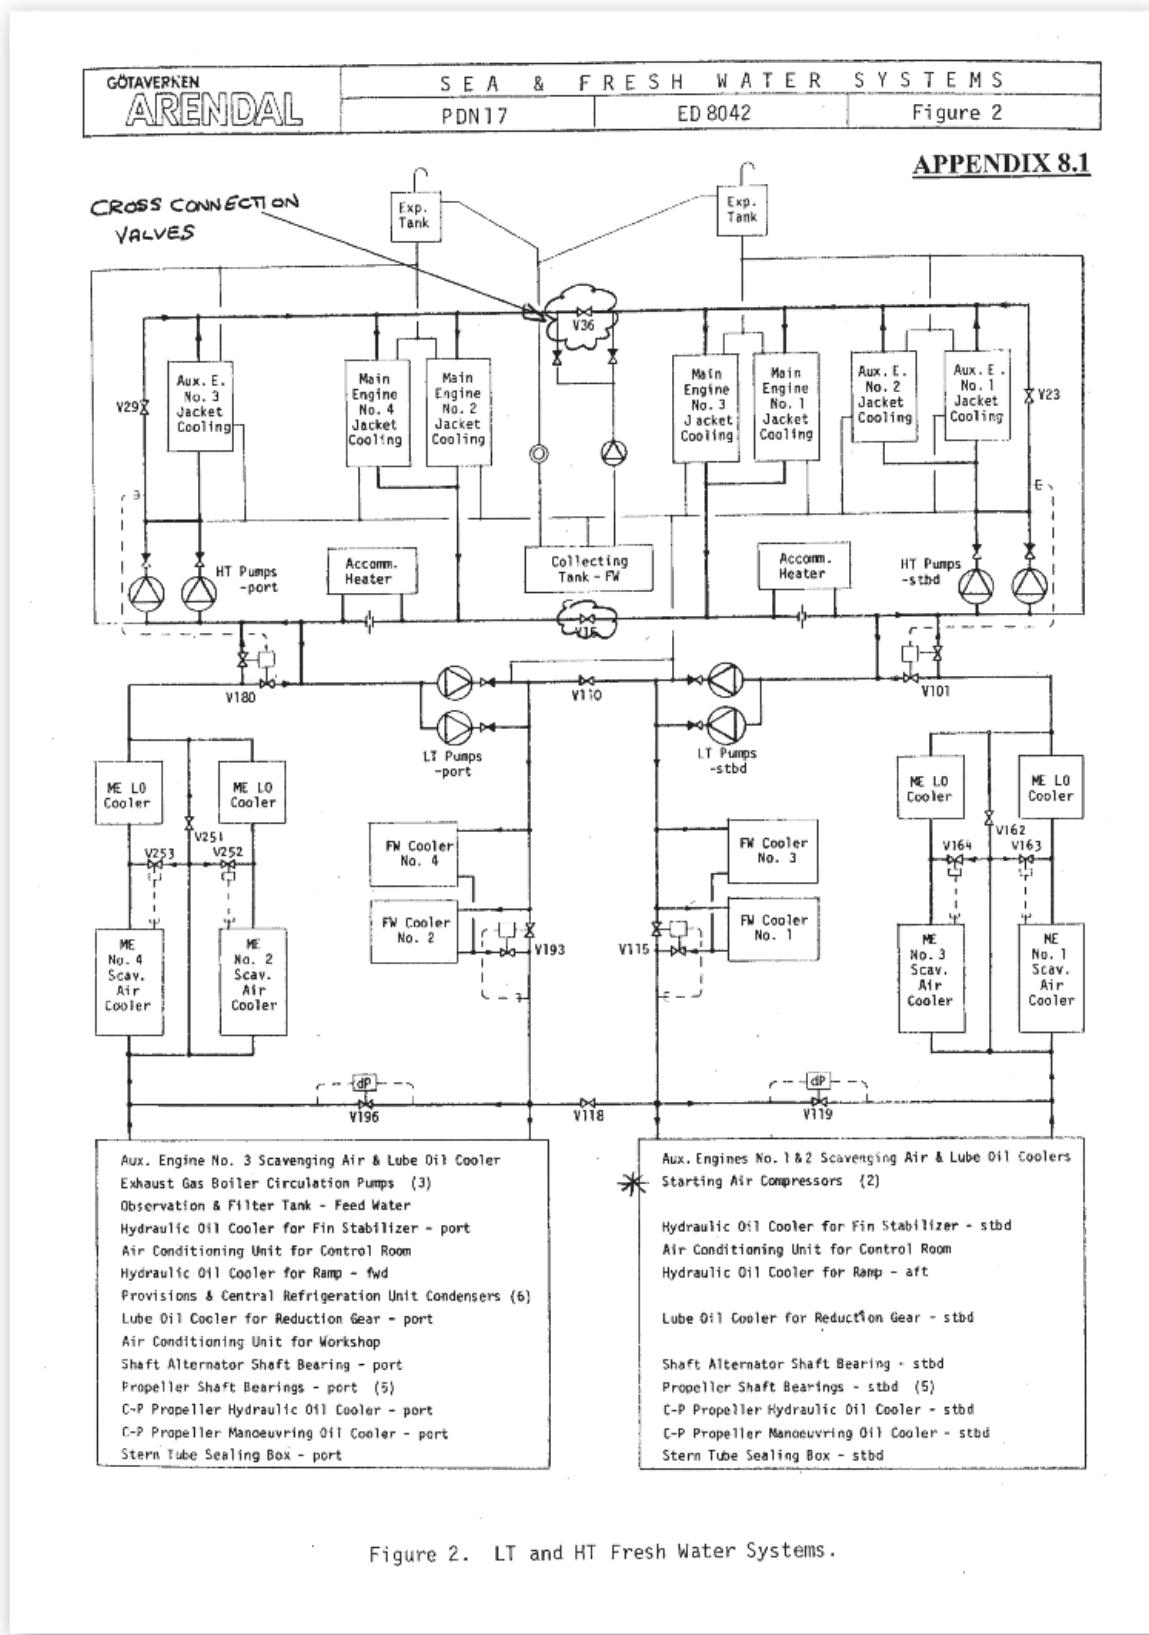
## Appendix 8.1

# Schematic LT HT systems

The LT system is in turn cooled by sea water coolers.

- 4.1.1 At 12.35 hours the port side low temperature cooling water (LTCW) pump supplying no.s 2 and 4 main engines started automatically.
- 4.1.2 The port side LT CW pump cut in was followed almost immediately by No 2 main engine ‘cooling water temperature high’ alarm and a fire alarm indicating a fire in the auxiliary engine room. An engineer was sent to investigate the fire alarm. He noted water and steam coming from the area of the cooling water header tanks.

- 5.1.14 The HT cooling water system cross connection valves V15 and V36 were found to be open, allowing the entire engine cooling system on the port and starboard sides to be adversely affected.
